Upper Trinity Regional Water District

Rains & Floods of 2015

“A Stress Test for Facilities, Personnel & Operations”

Presentation to
NCTCOG Water Resources Council
Sept. 3, 2015

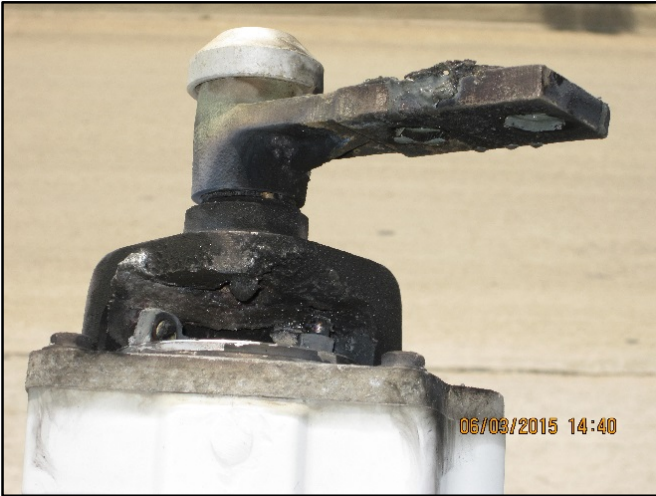
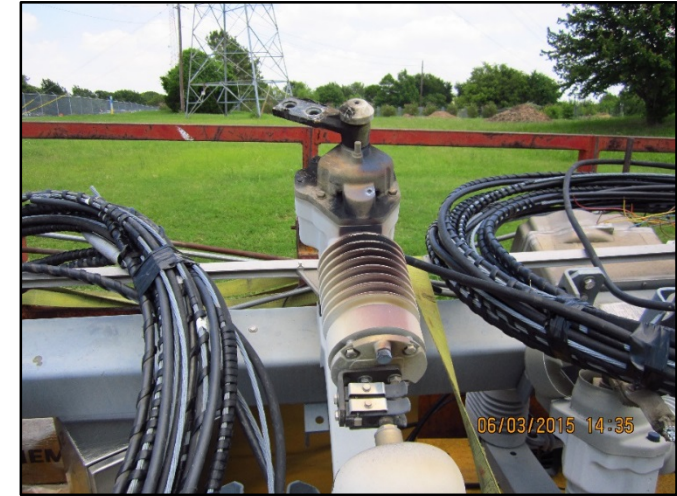
Lightning strike took out CoServ Electrical Service Transfer Switch

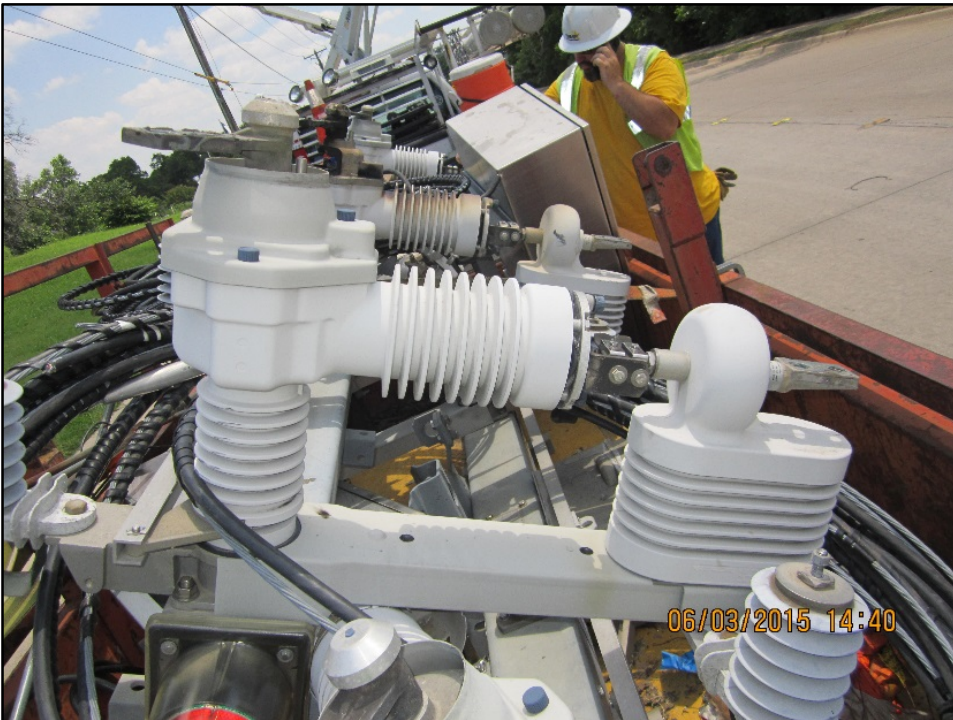
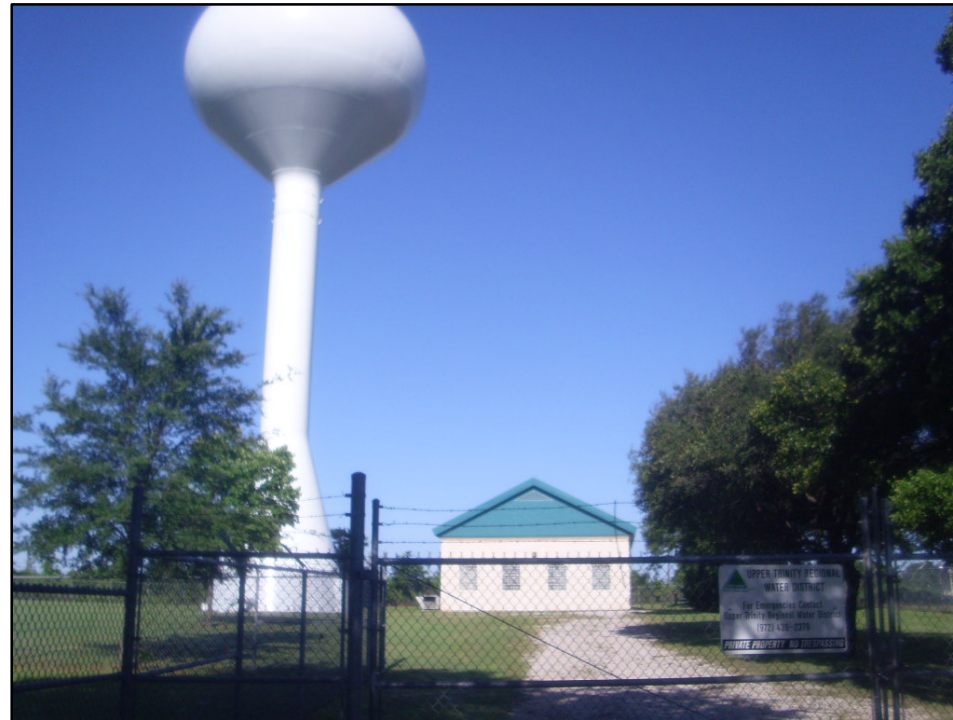
Communications Equipment at Elevated Tank damaged by Lightning

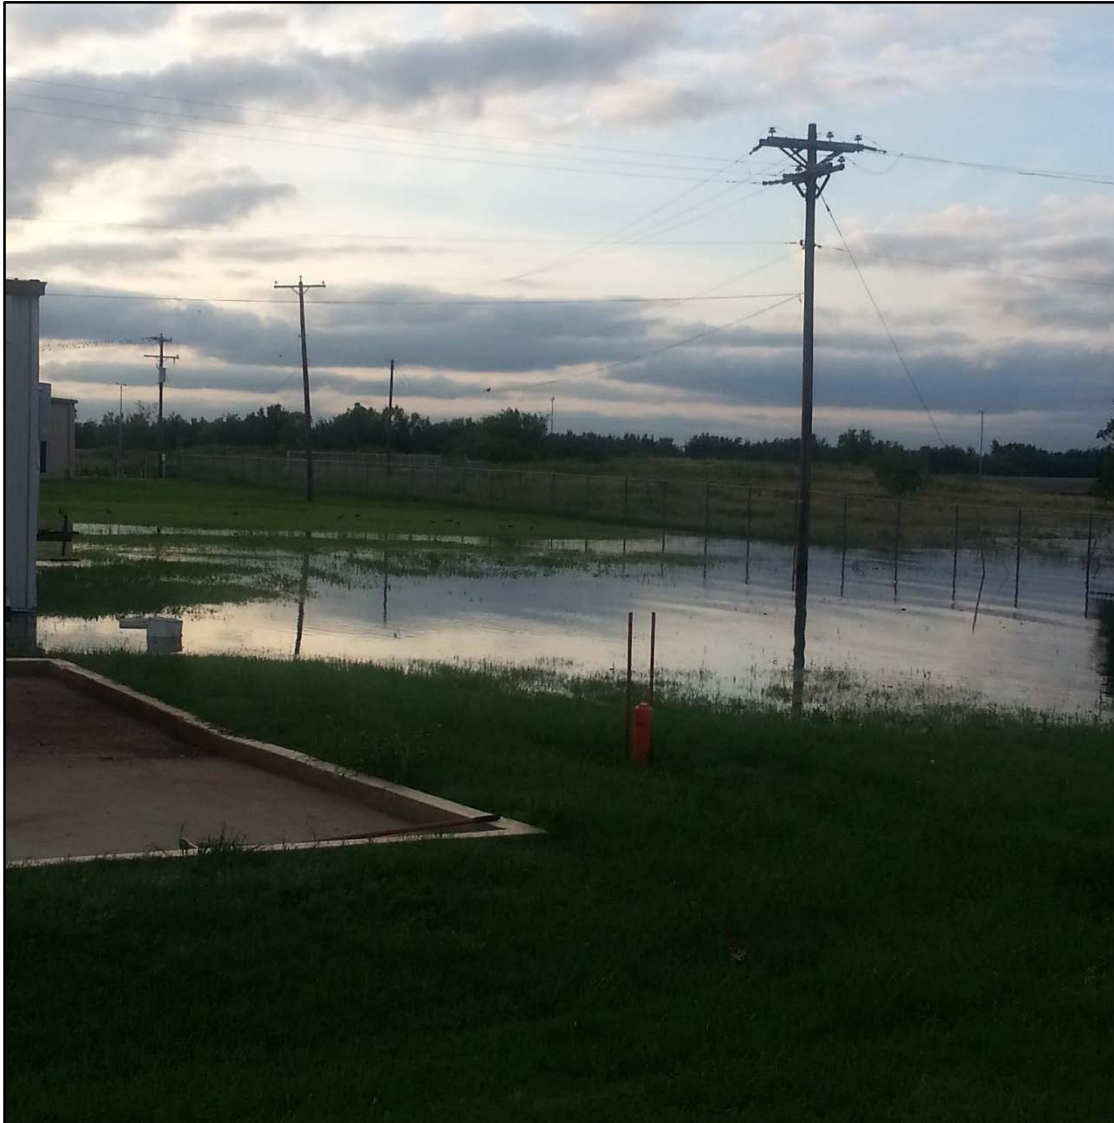
Lake approaches Plant - - Western boundary

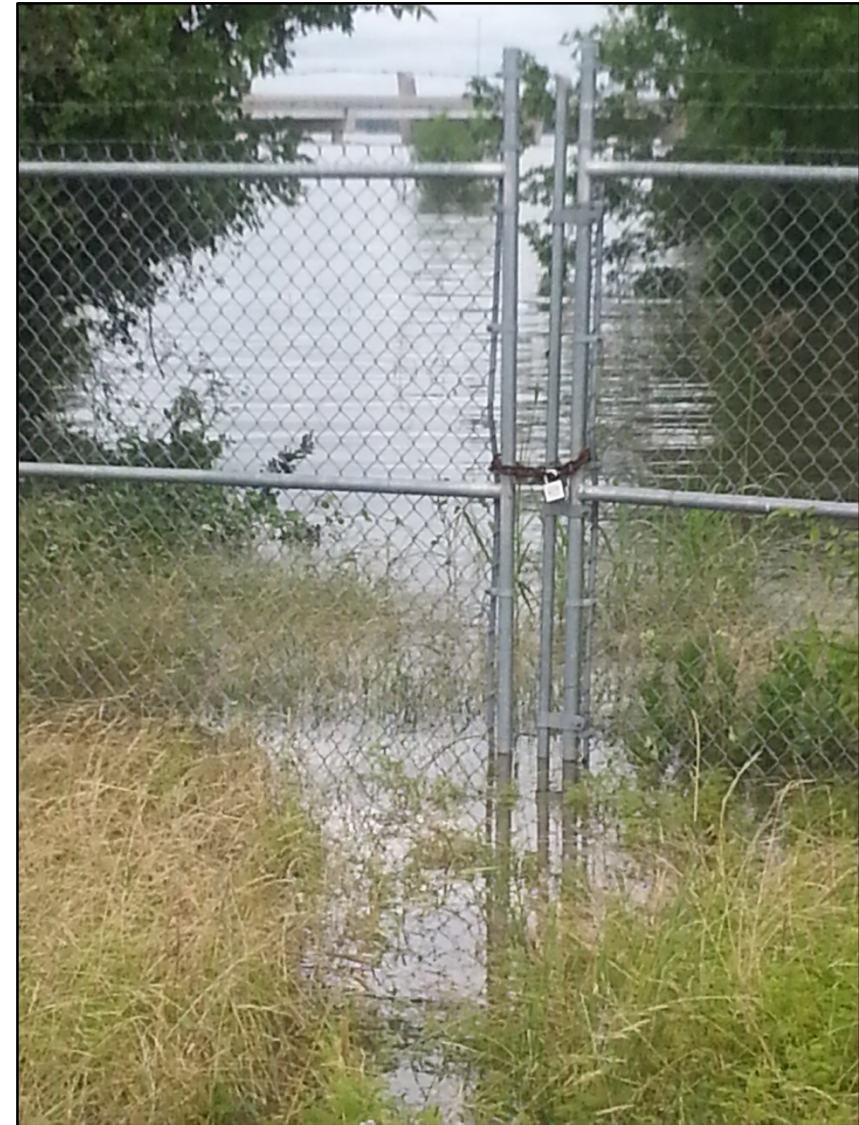
**Plant Outfall channel
Looking toward Toll Bridge**

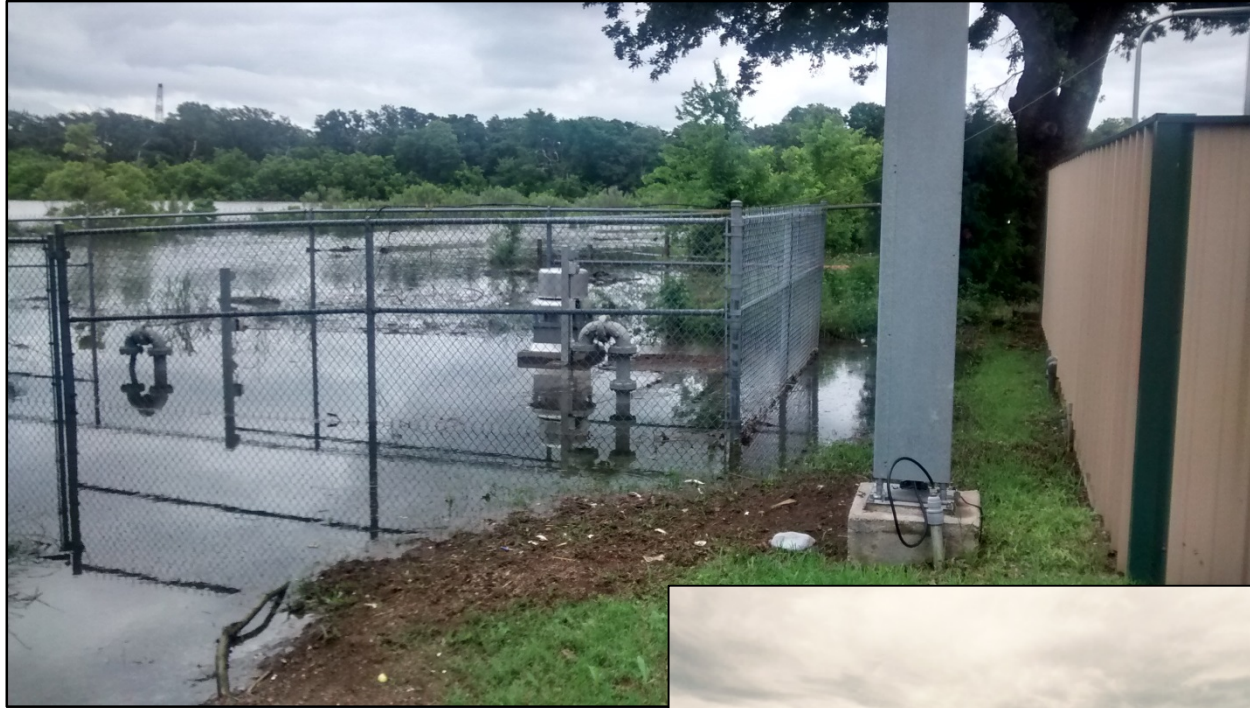
Highland Village Lift Station

**Meter vault
submerged**

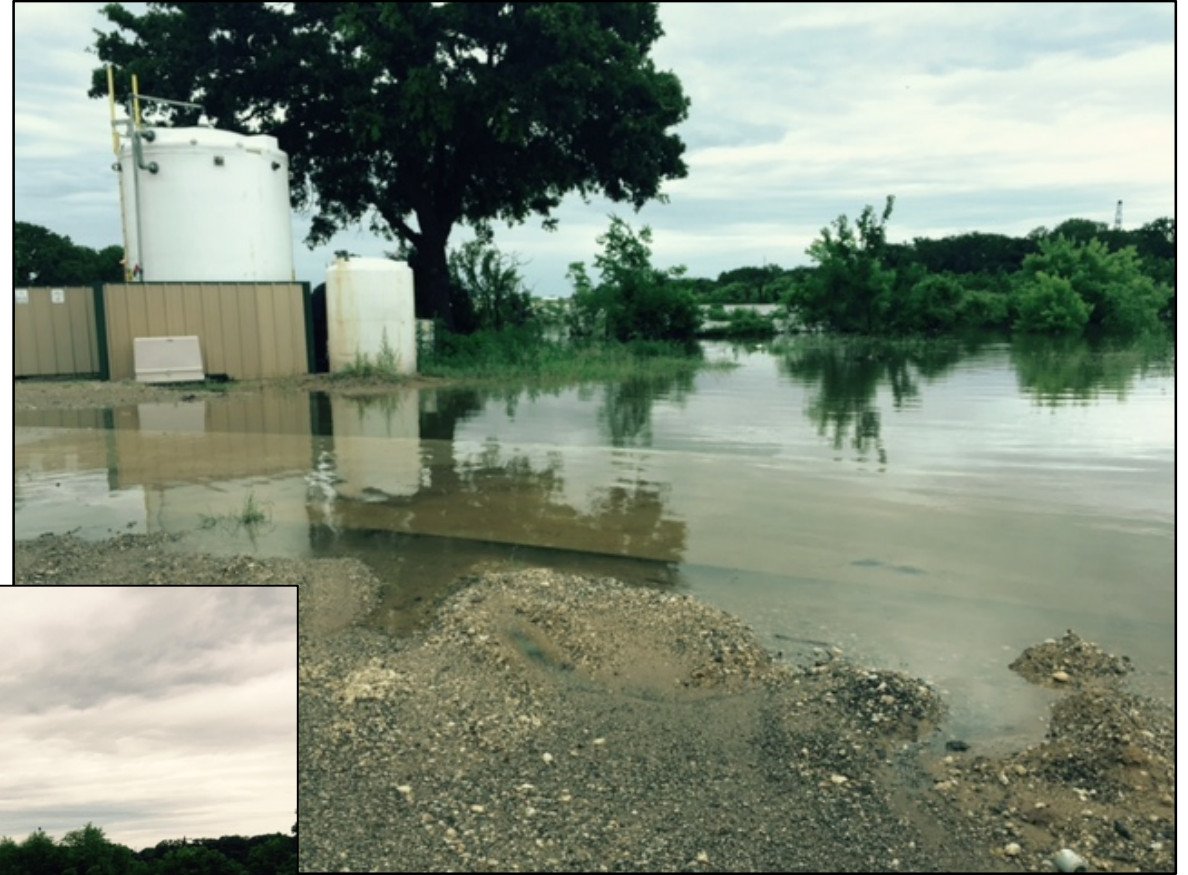
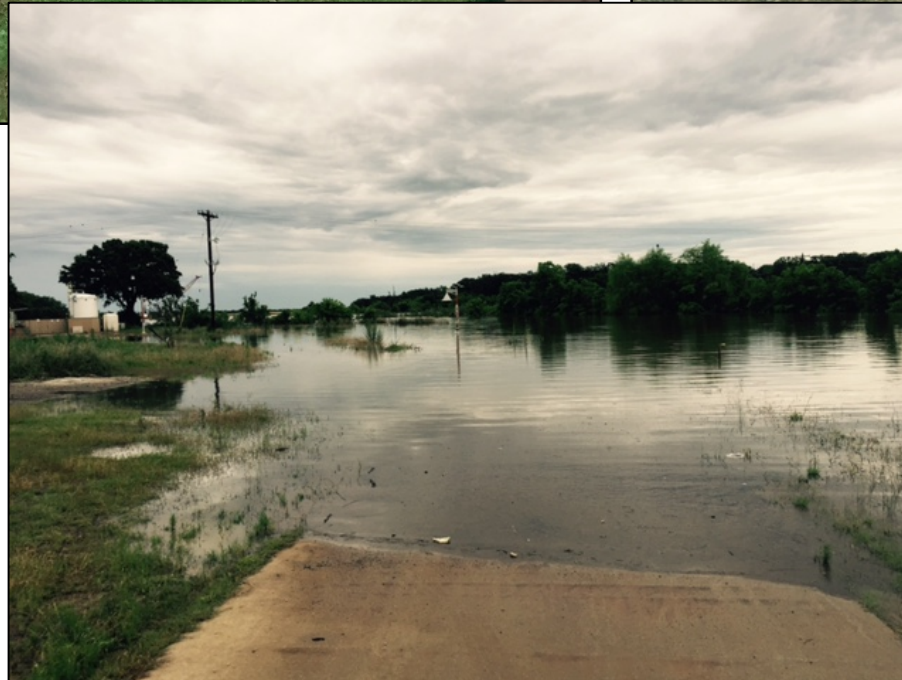
**Access road
flooded**

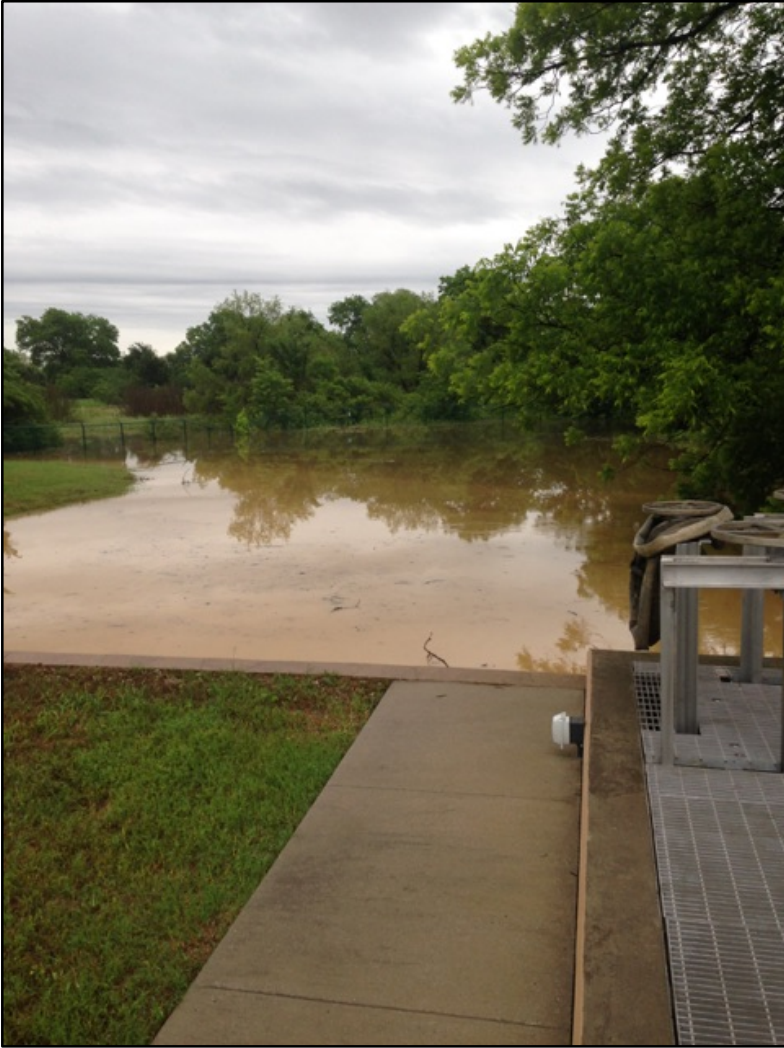
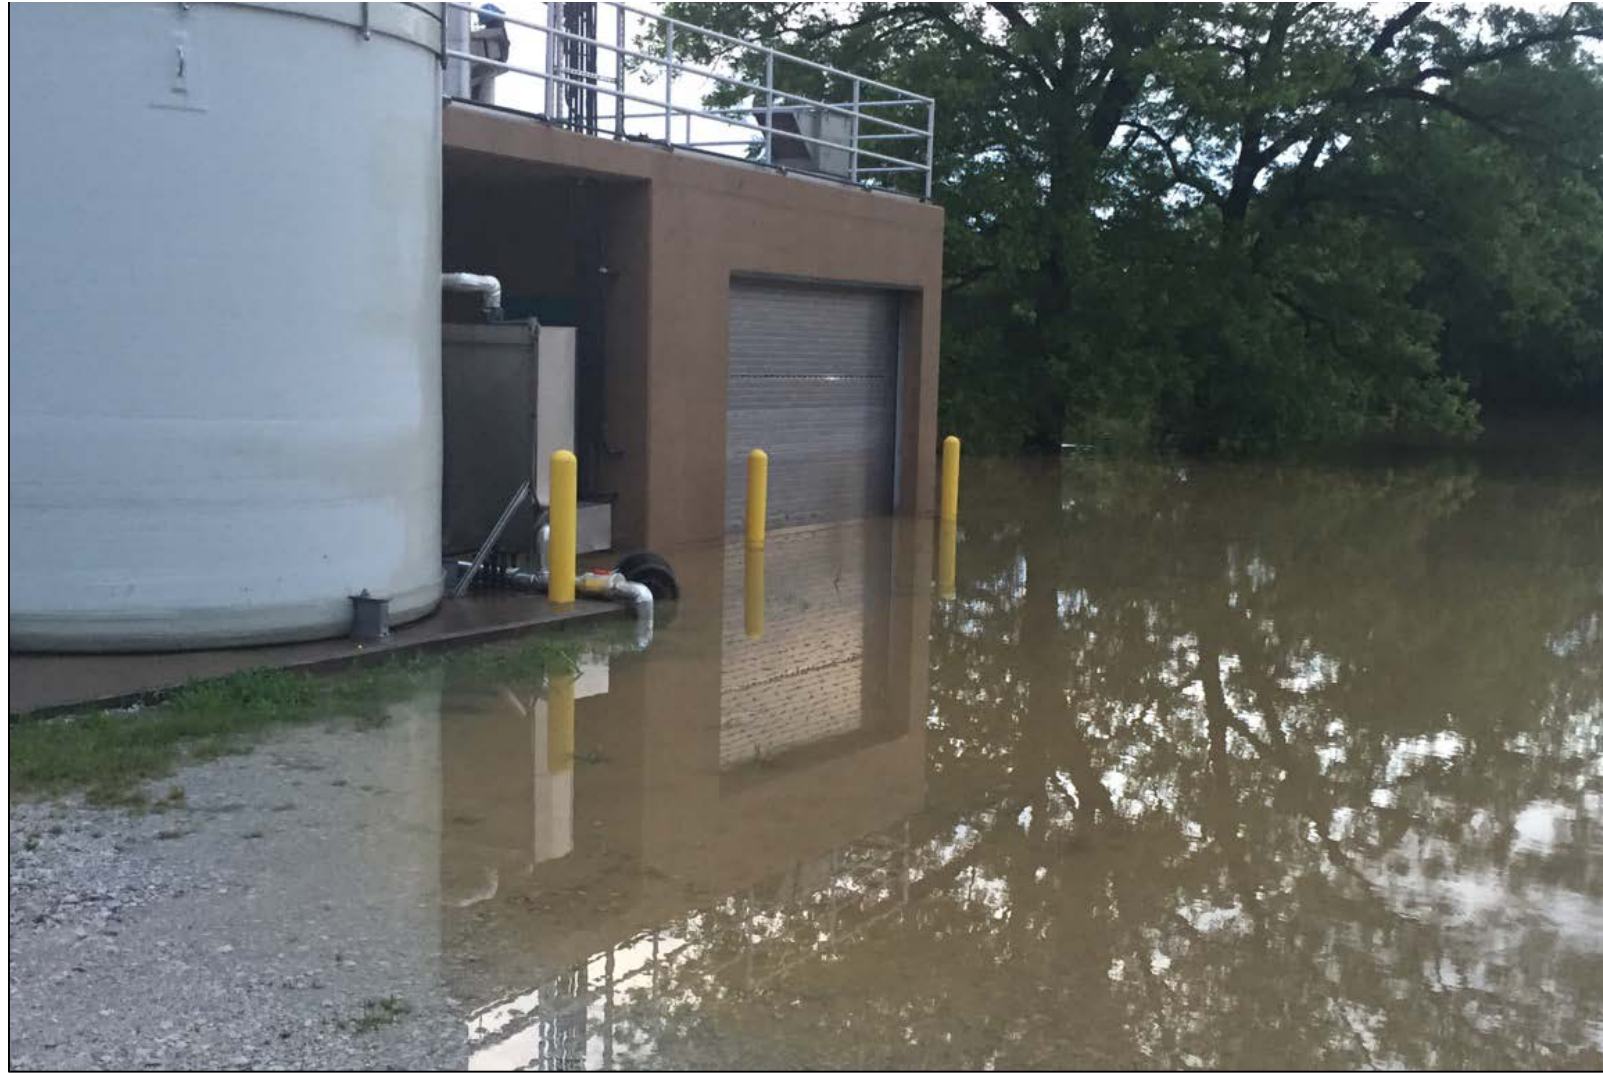
Peninsula Water Reclamation Plant

Flooding around headworks

Grit Building - - flooded

- Flood protection for the Peninsula Plant
- Increase effort by Customer Cities to reduce I / I
- Staffing levels / equipment requirements

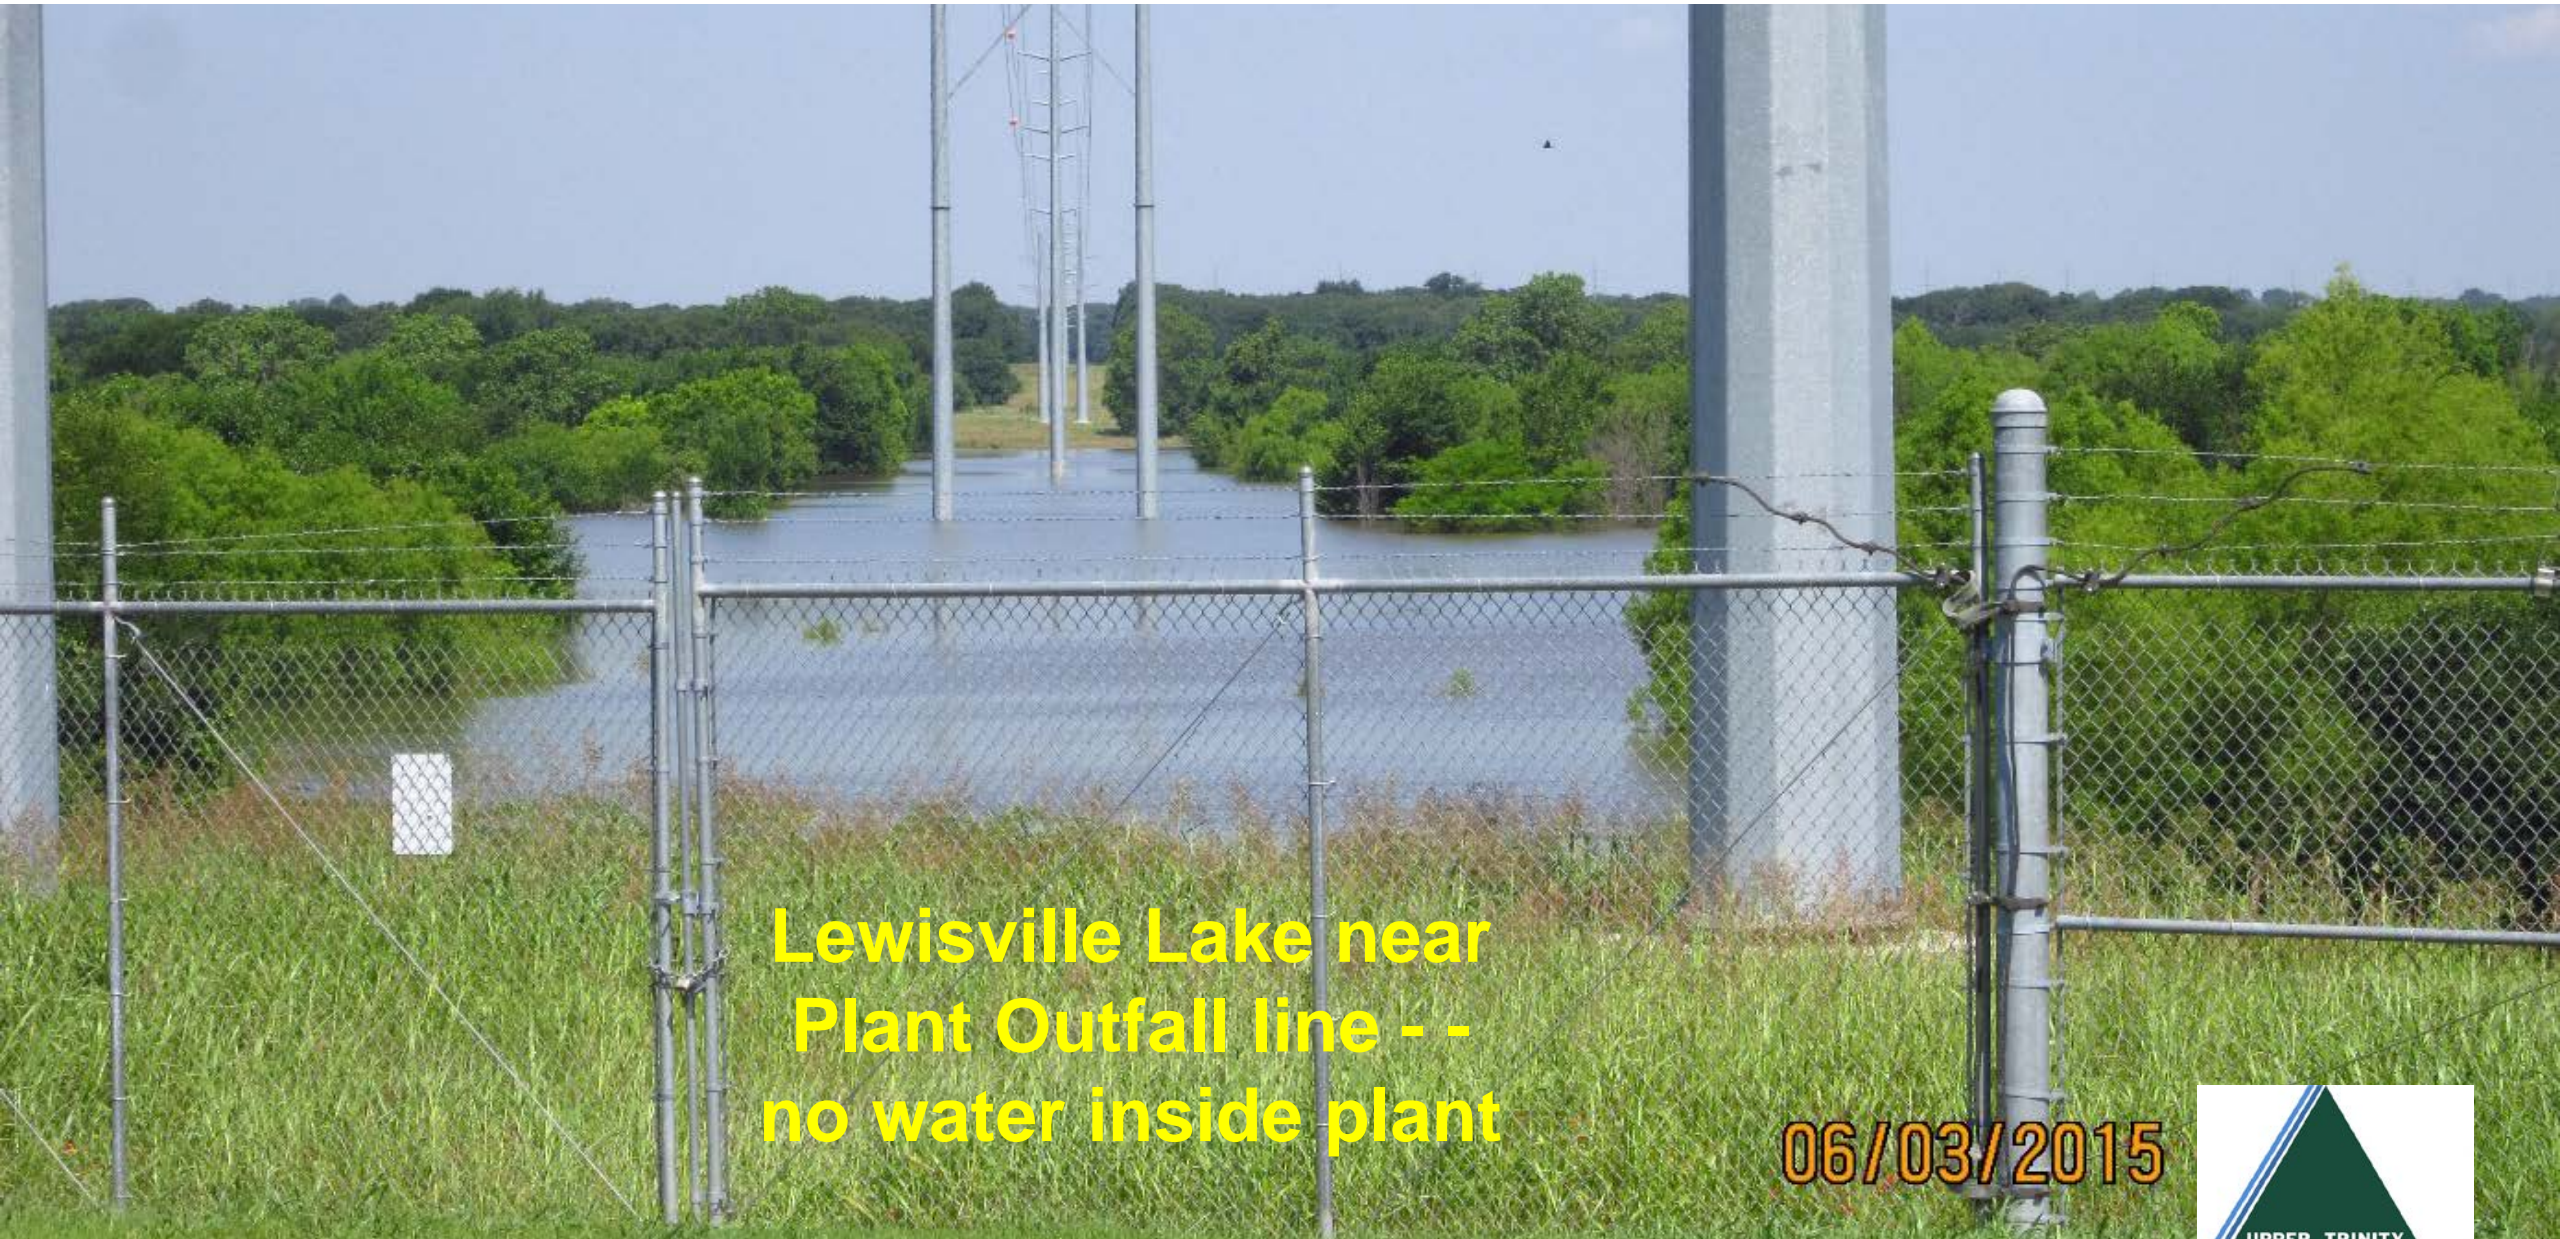
Riverbend Water Reclamation Plant

Lewisville Lake near
Plant Outfall line - -
no water inside plant

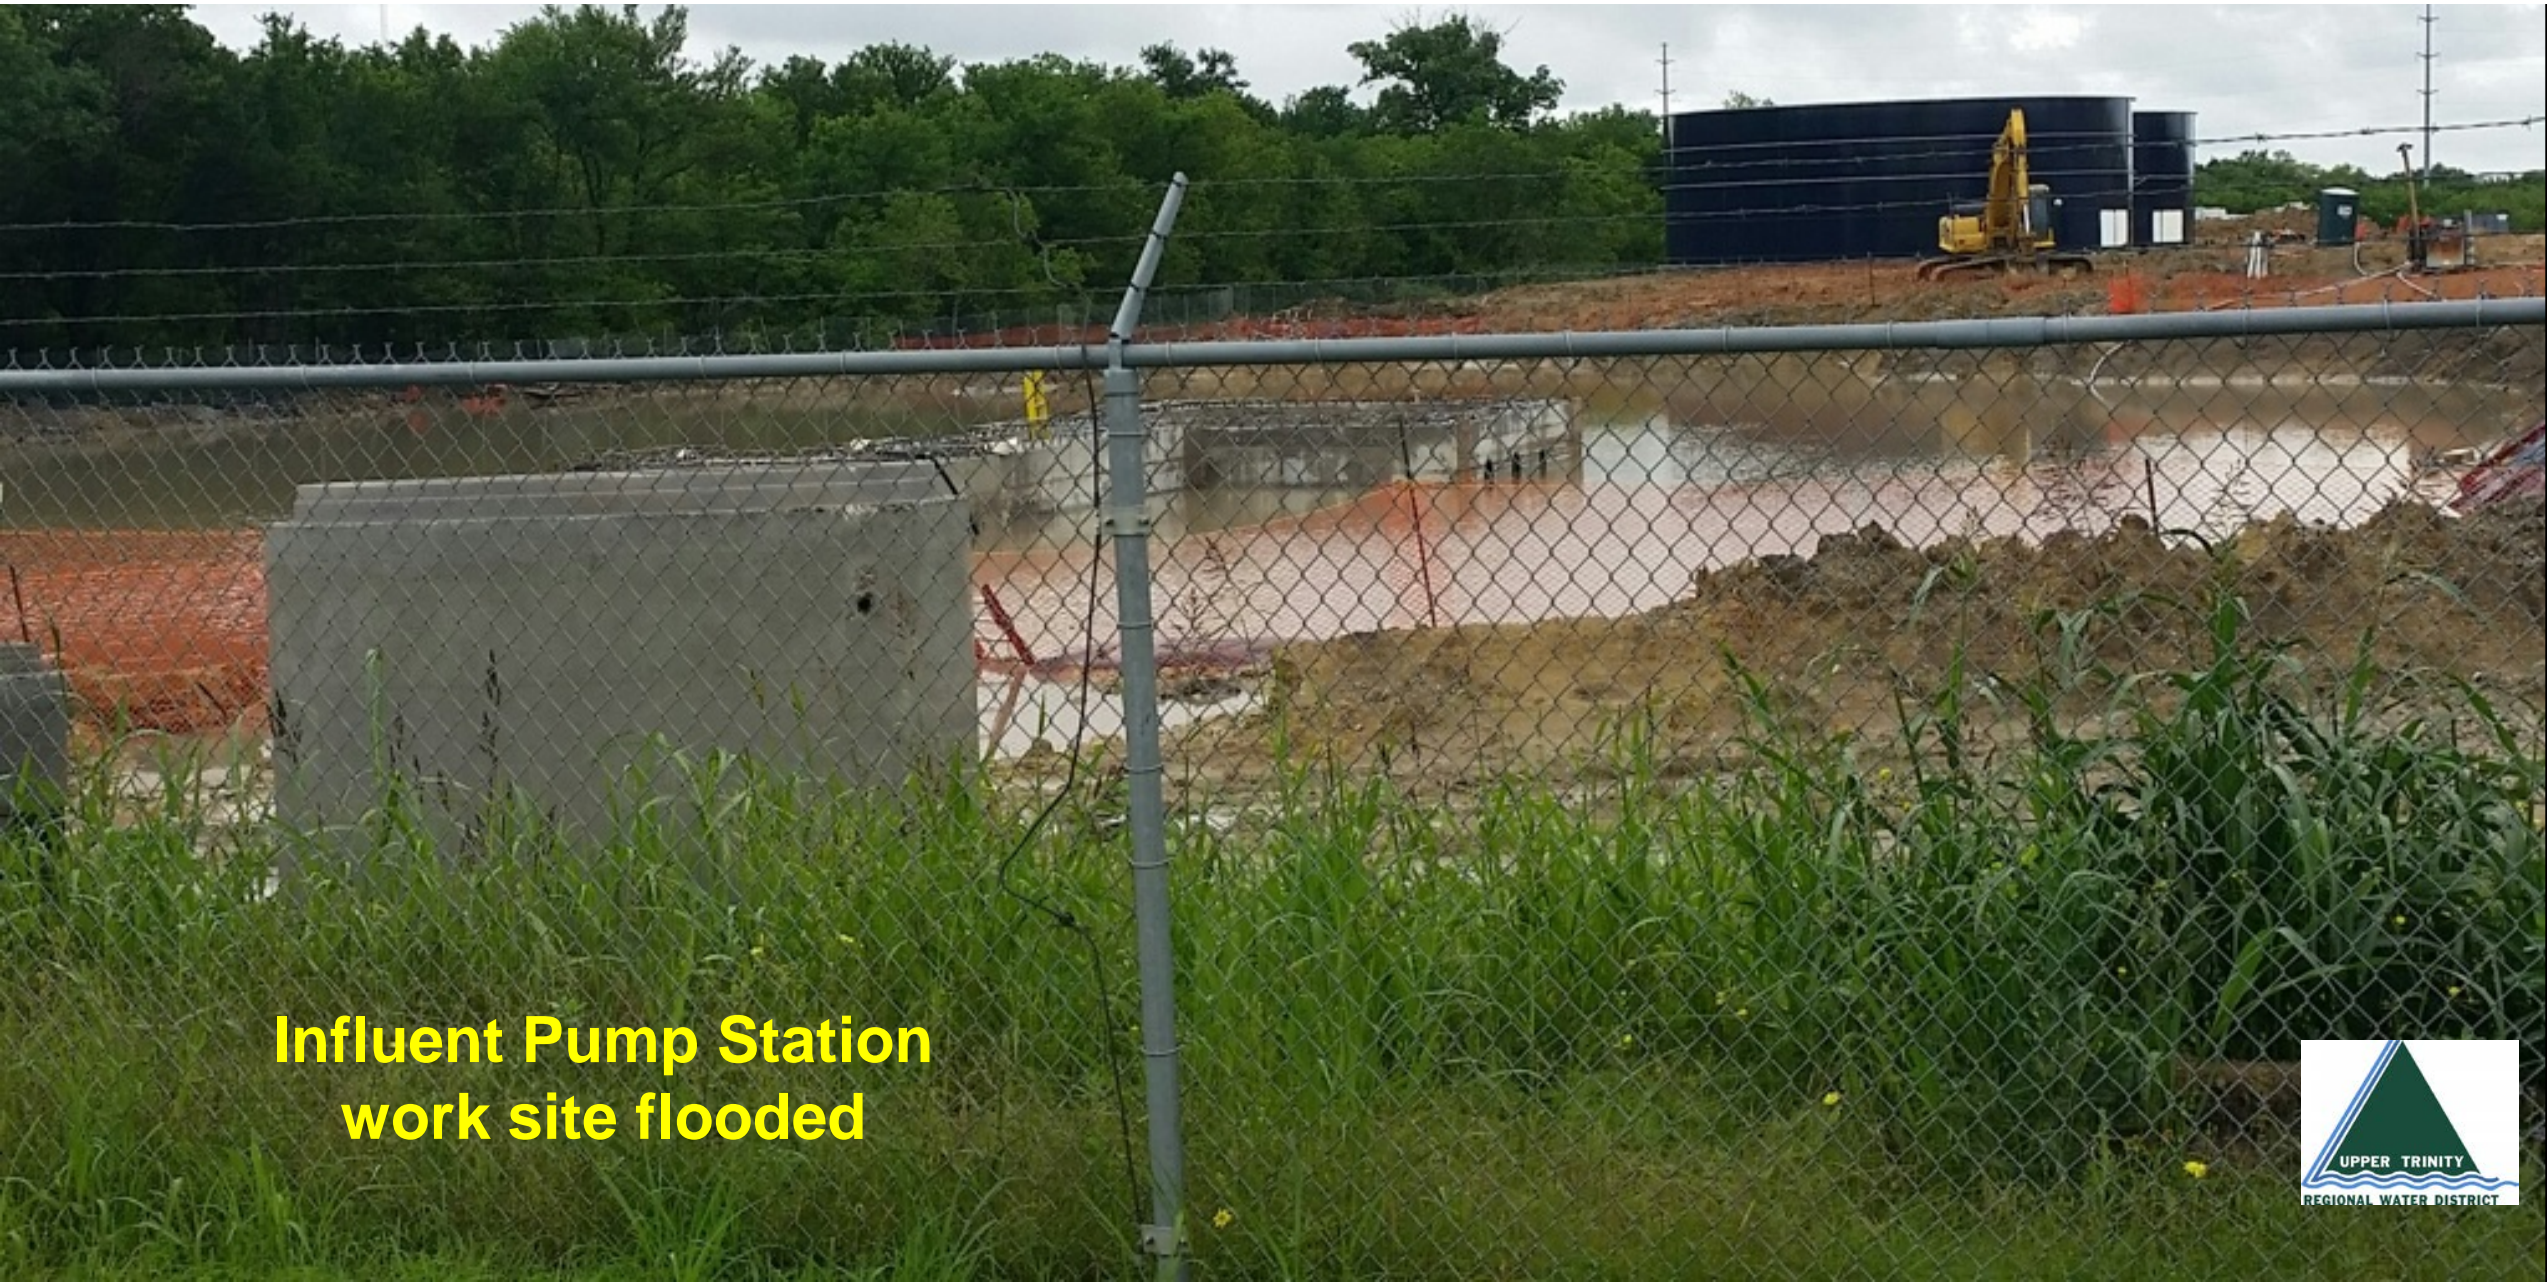
Doe Branch Plant – Construction Site

**Influent Pump Station
work site flooded**

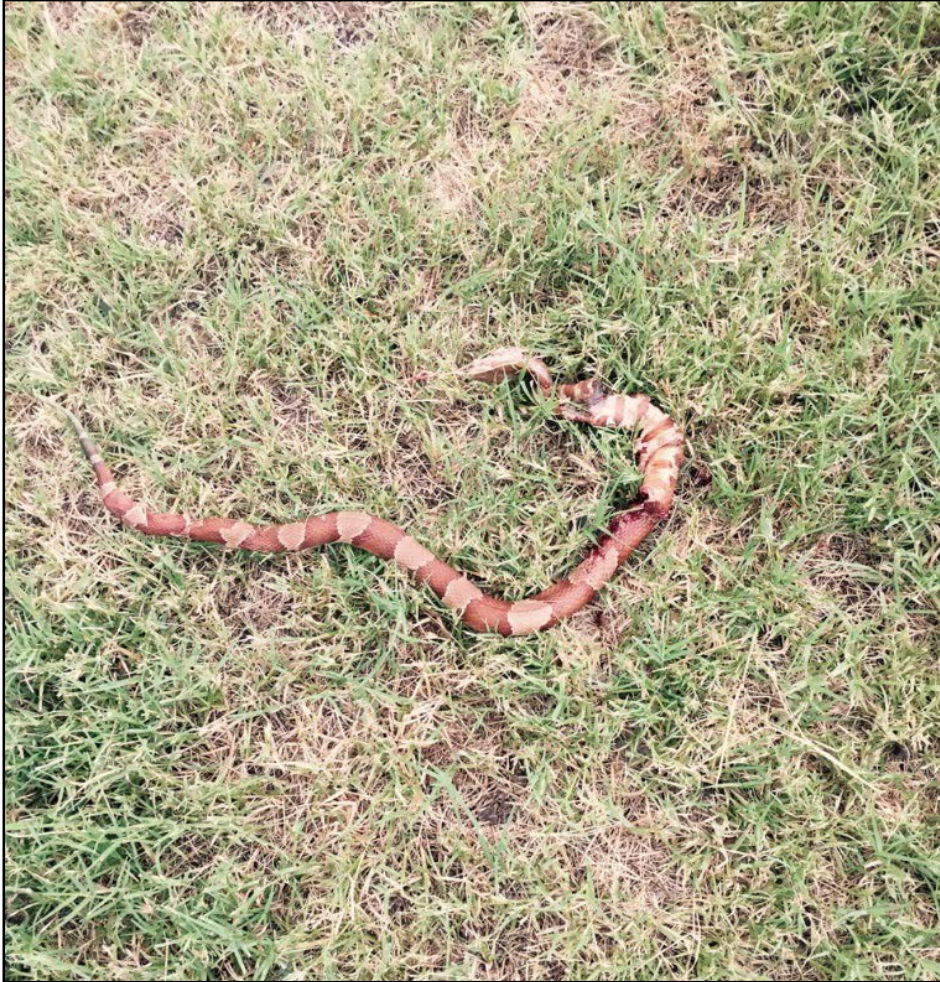
Copperhead found near water meter vault

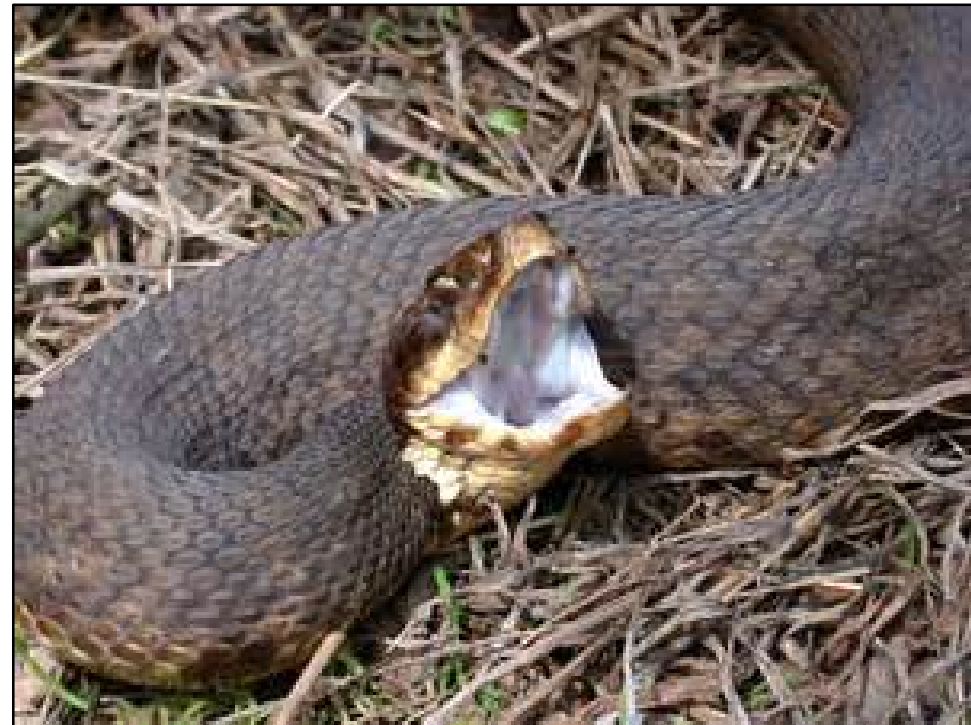
Cottonmouth water moccasins found under equipment at Lakeview Plant
