IDDE Source Tracking

CITY OF DALLAS – LOVE FIELD AIRPORT

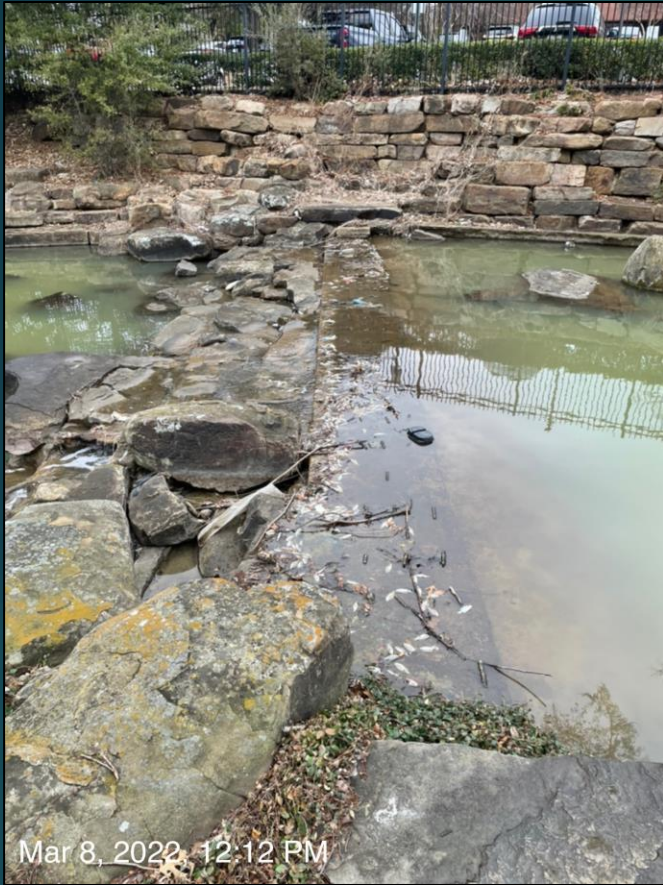
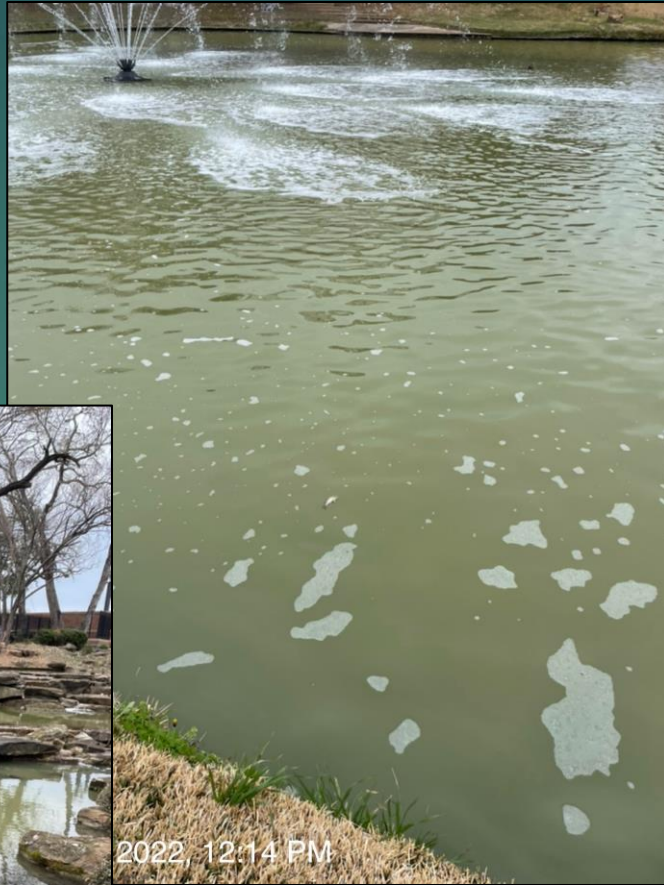
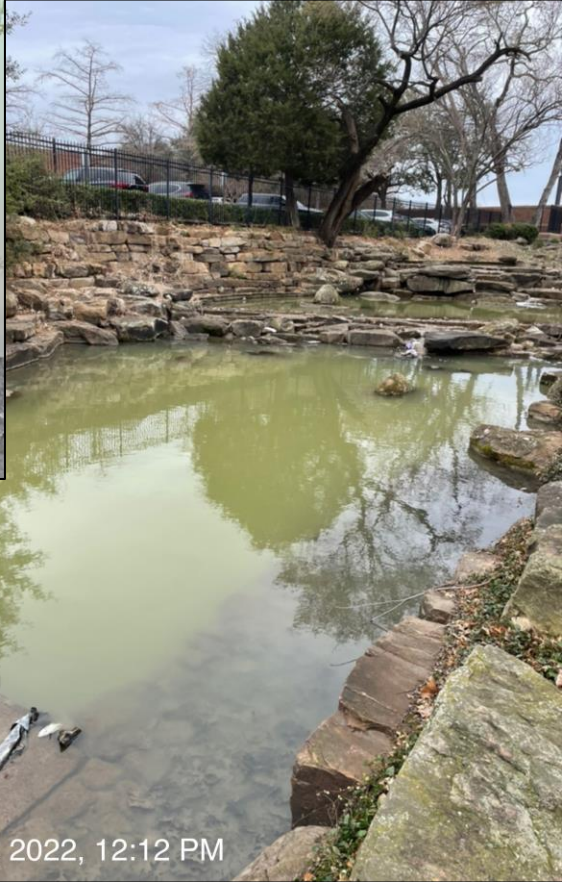
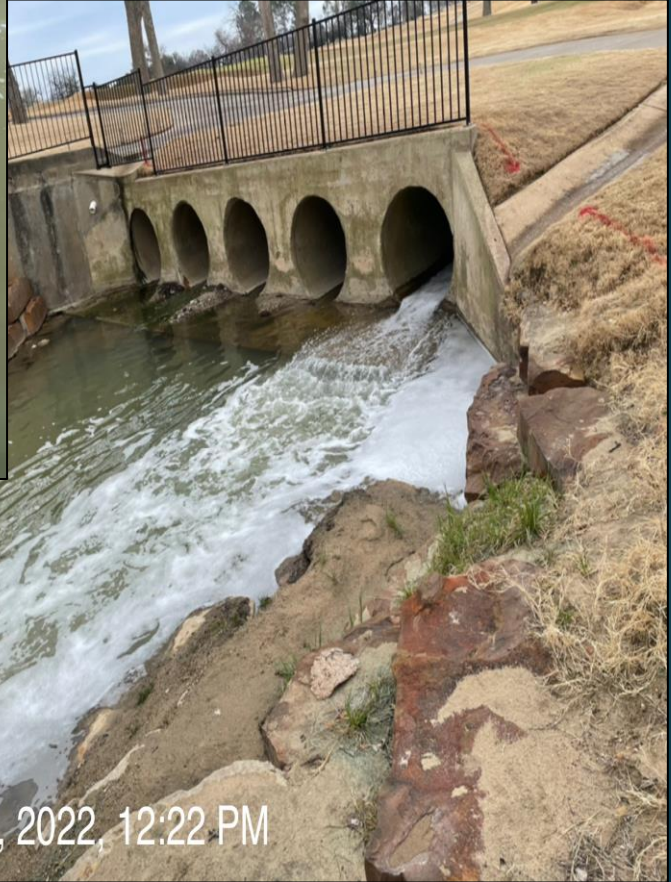
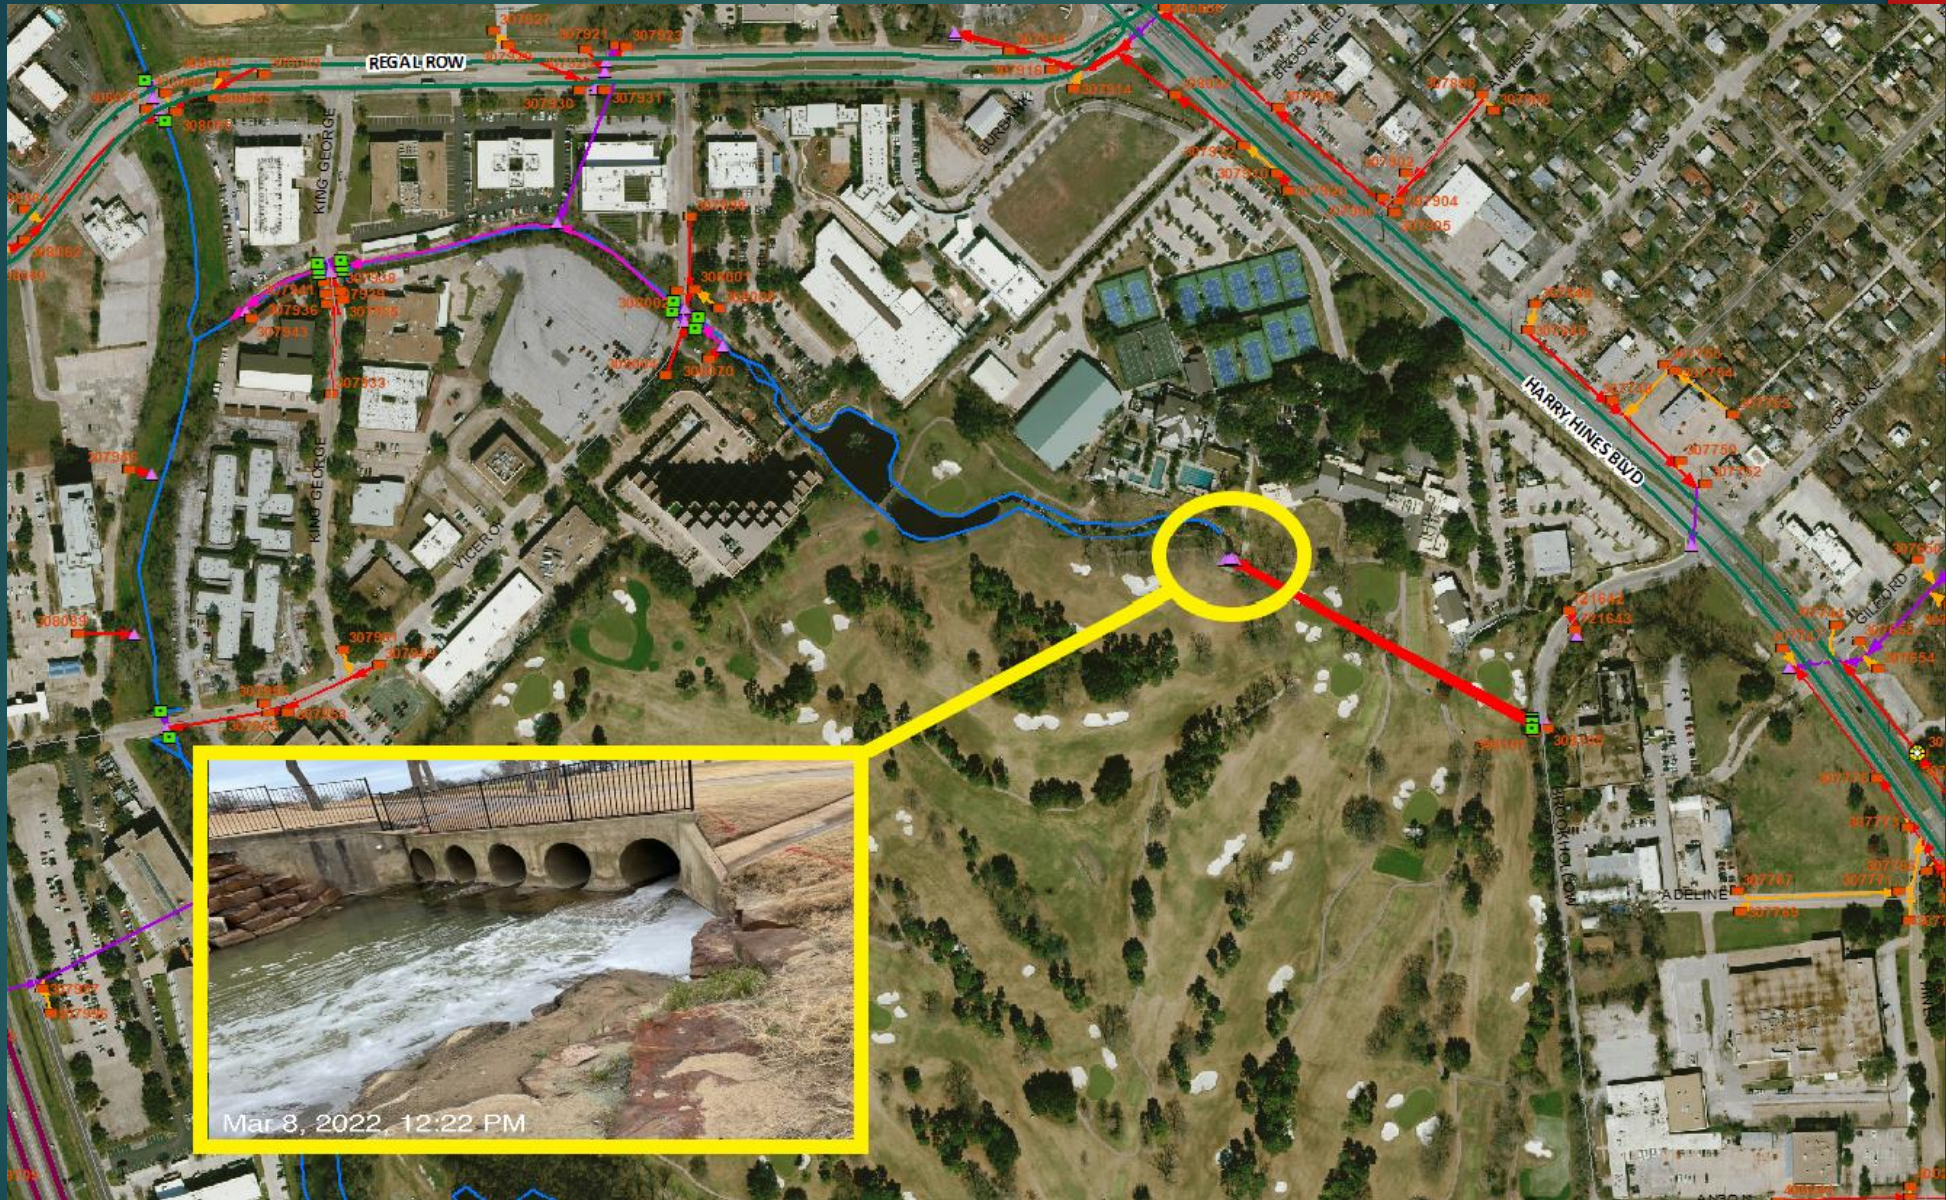
- ▶ The creek channel and pond area near 1600 Viceroy Dr was inspected after arrival. DWU – SWO staff observed 1000+ dead fish (mostly sun fish) along a couple of check dams in the channel.
- ▶ The water in the creek was murky and greenish colored. There was a very distinguishable odor throughout the creek. The odor was likened to vinegar, tomatoes and even play-doh.
- ▶ The cloudy water in the creek was tracked back up into Brook Hollow Golf Course to what was believed to be a series of 5 outfalls.
- ▶ One of the “outfalls” had a heavy flow of rushing water coming from it that was sure to lead us to the source.

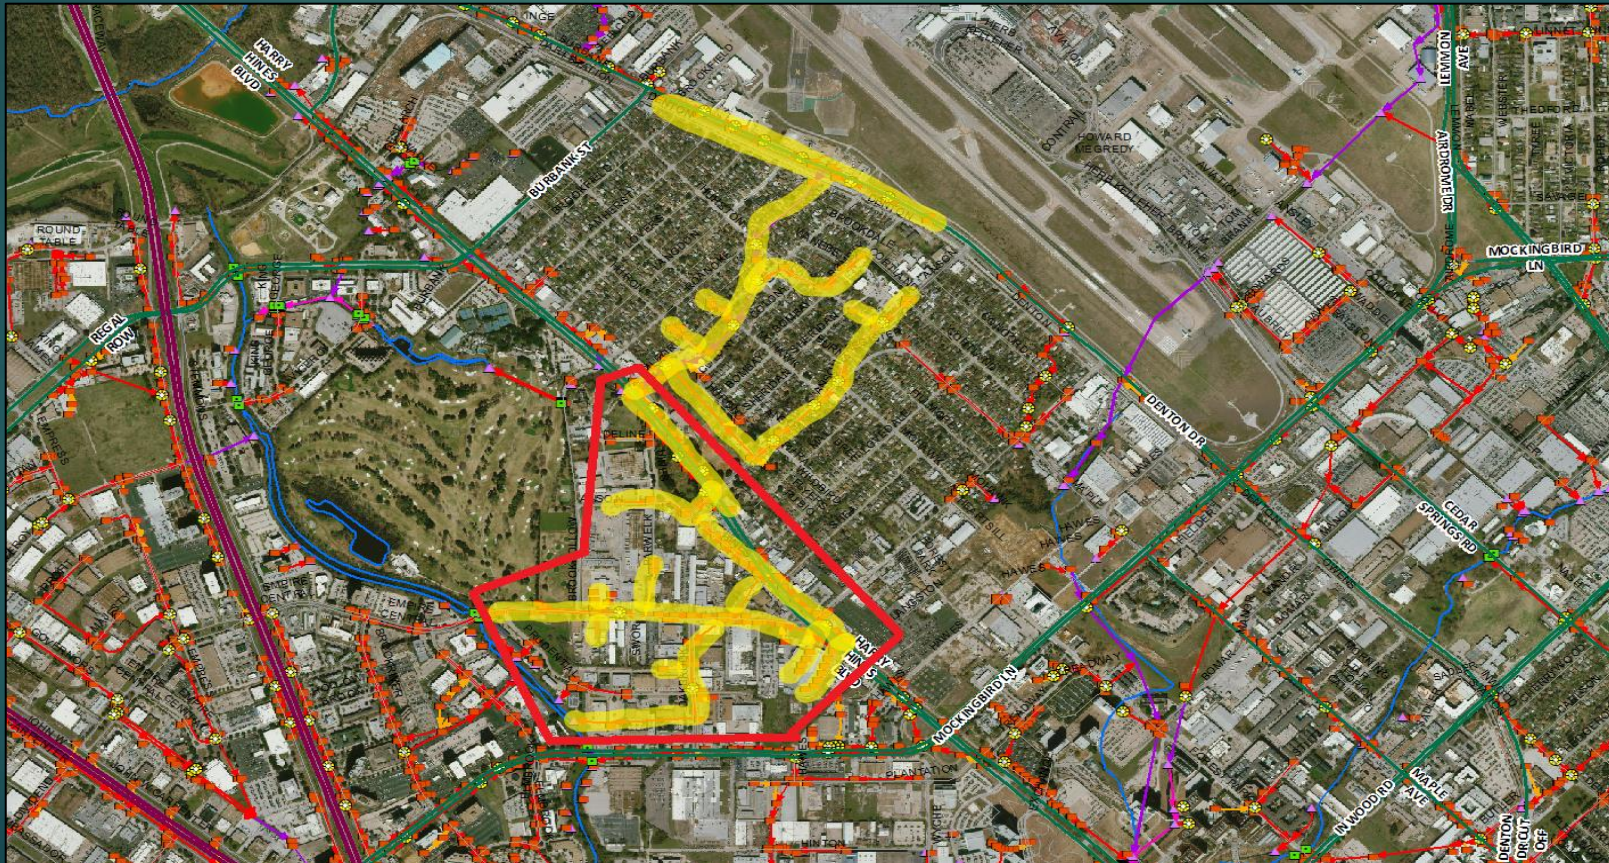
- ▶ The highlighted areas below are affected areas of storm water run off tied to the outfalls in question. The area in red is where the inlets were visually inspected.

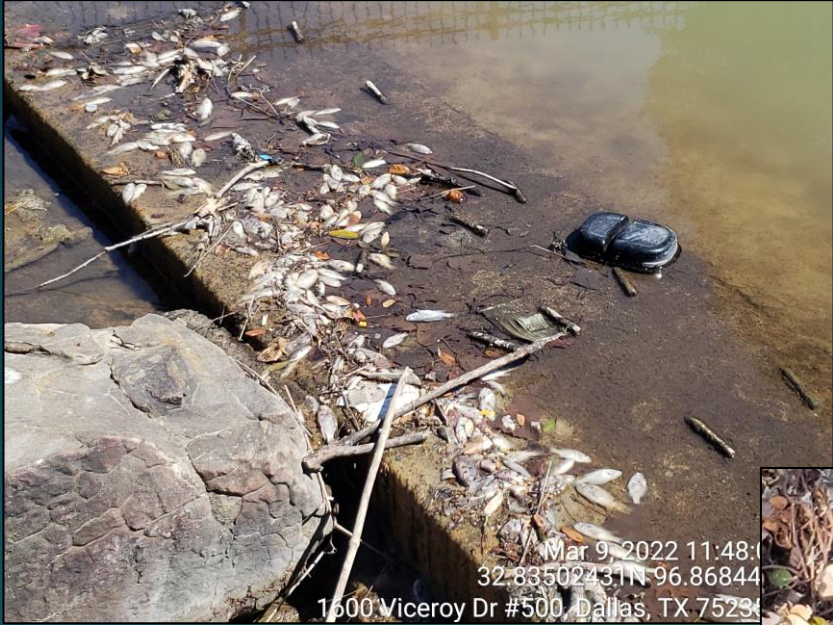
Mar 9, 2022 11:48:00 AM
32.83502431N 96.868441W
1600 Viceroy Dr #500, Dallas, TX 75234, USA

- ▶ While the original team continues tracking investigation, two other teams continue with day 2 sampling and begin fish collection and identification.
- ▶ Team 2 collects field samples from same upstream, downstream and kill site locations for tracking and reference purposes.
- ▶ Team 3 collects 2,370 dead fish, almost all of them sunfish. Most of the fish are picked up along check dams in the channel near 1600 Viceroy Dr.

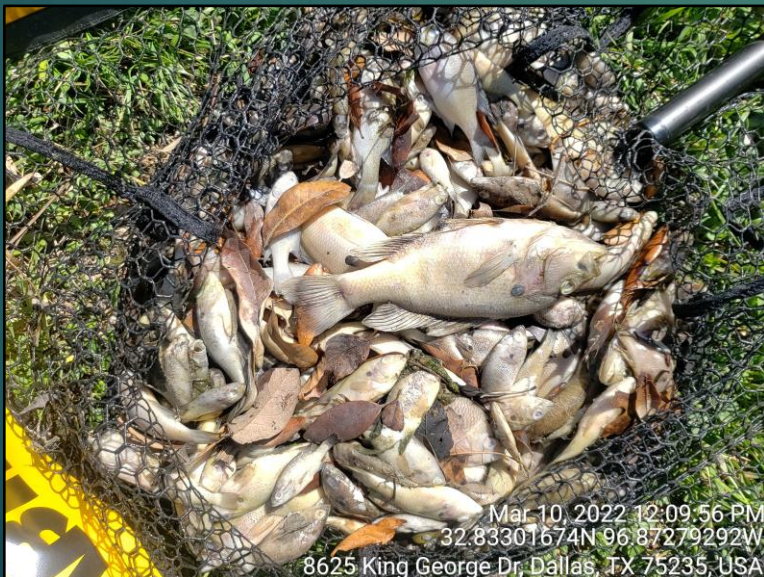
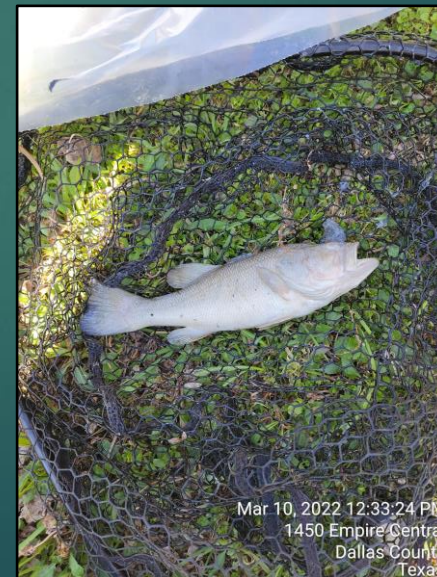
- ▶ Teams 2 and 3 continue day 3 field sampling from all three locations and fish collection and identification.
- ▶ Dead fish were collected from the kill site at 1600 Viceroy Dr all the way downstream to Mockingbird Ln.
- ▶ 1150 more dead fish (mostly sunfish) were collected on day 3.

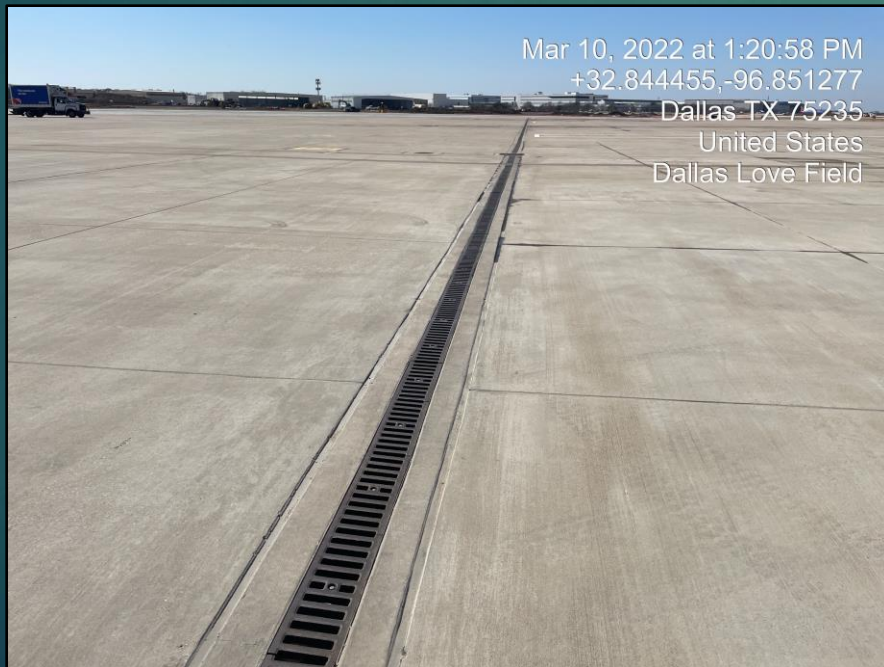
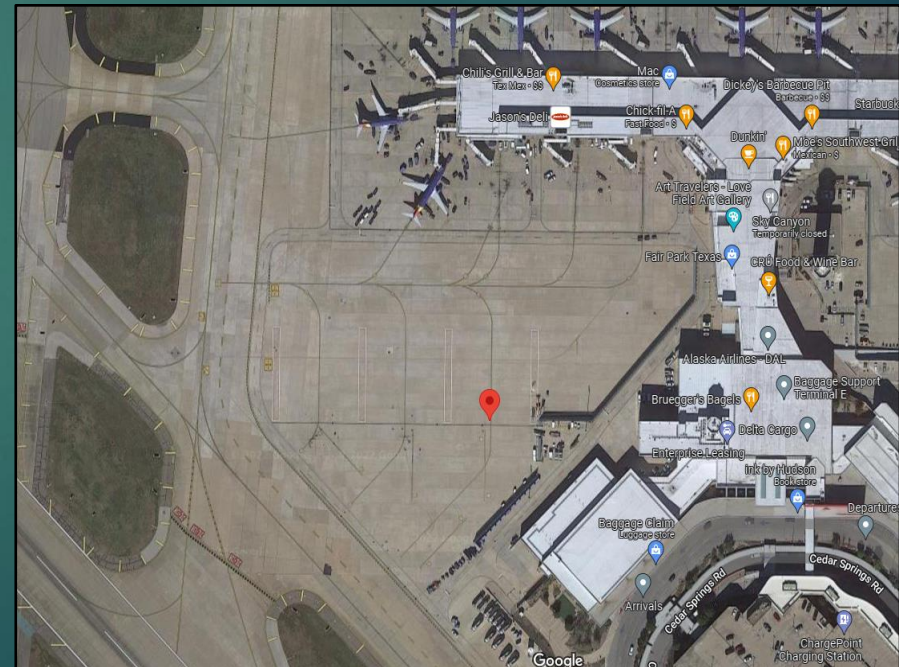
- ▶ WQ Team 1 along with OEQS was escorted to the Southwest Airlines main De-icing pad and the same distinct odor that had been present throughout the creek was also present within their grate inlets.

- ▶ WQ team 2 returned to outfall 16 at love field airport to collect samples for the following parameters to be tested at a NELAP certified lab... Propylene Glycol, Propylene Acetate, TPH BTEX and E.coli.
- ▶ Test results later showed elevated levels of Propylene Glycol (chemical used in de-icing materials) for sampling performed on 3/11 and 3/28 (160 and 117 mg/L). It was noted that two rain events occurred between those two sampling dates.
- ▶ Biochemical Oxygen Demand was tested for at the outfall on 3/11 and at the kill site on 3/8 and both locations showed elevated levels of BOD which is common amongst PG degradation.

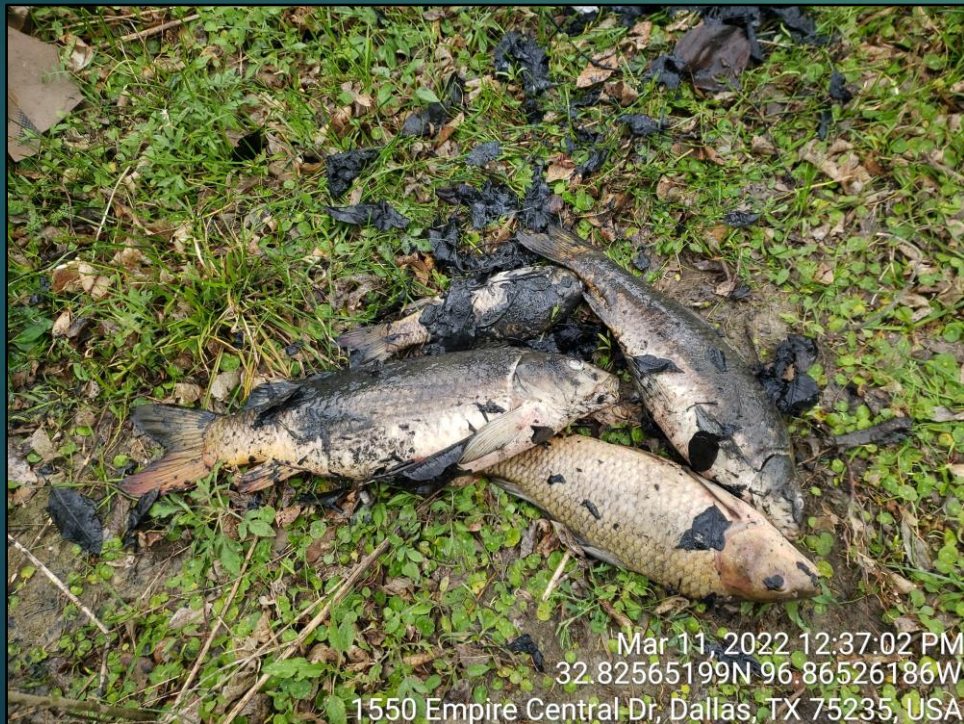
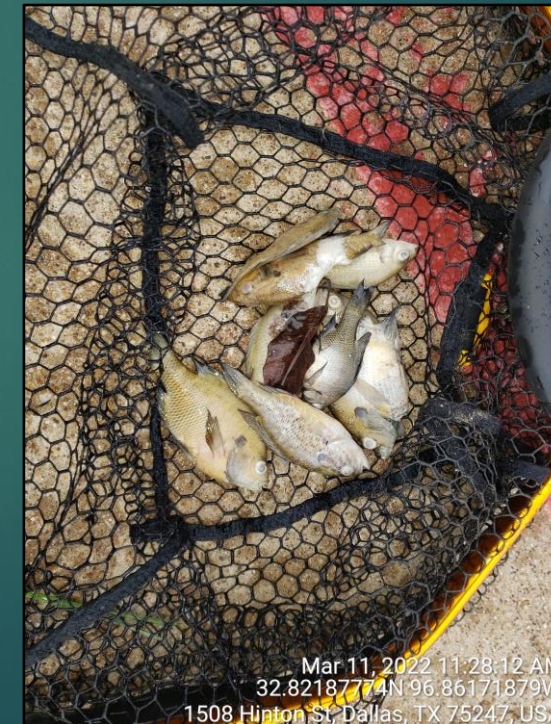
- ▶ WQ Team 3 collected 160 more dead fish most of which were sun fish.
- ▶ A total of 3,610 dead fish were collected over a three-day span.
