IDDE Source Tracking

CITY OF DALLAS – CASE STUDY

HILTON ANATOLE HOTEL, 1428 WYCLIFF AVE

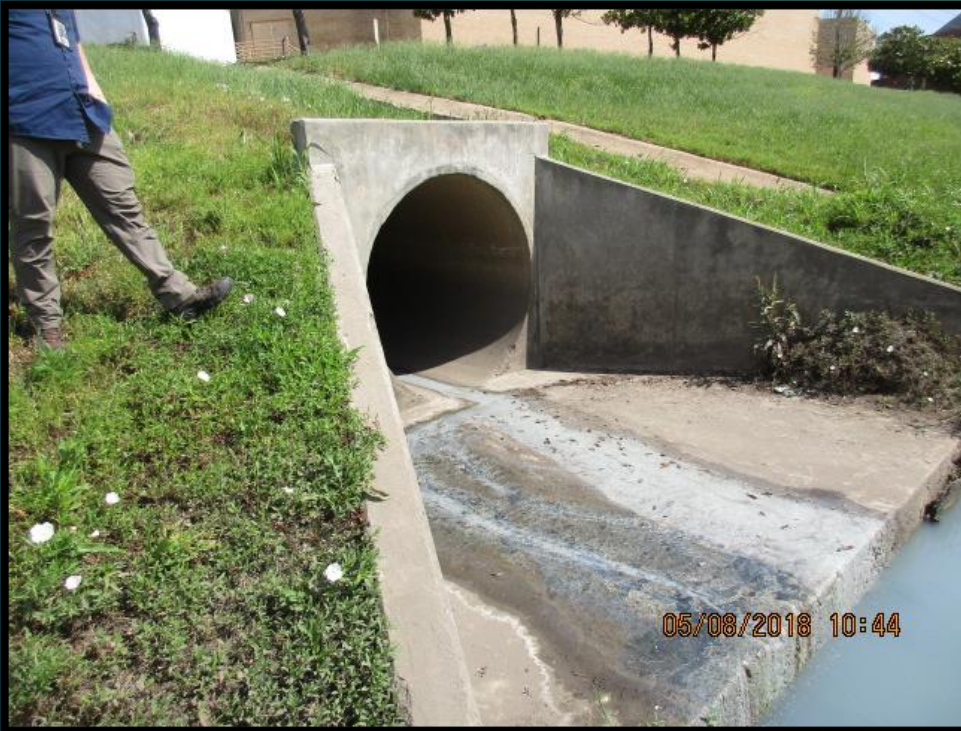
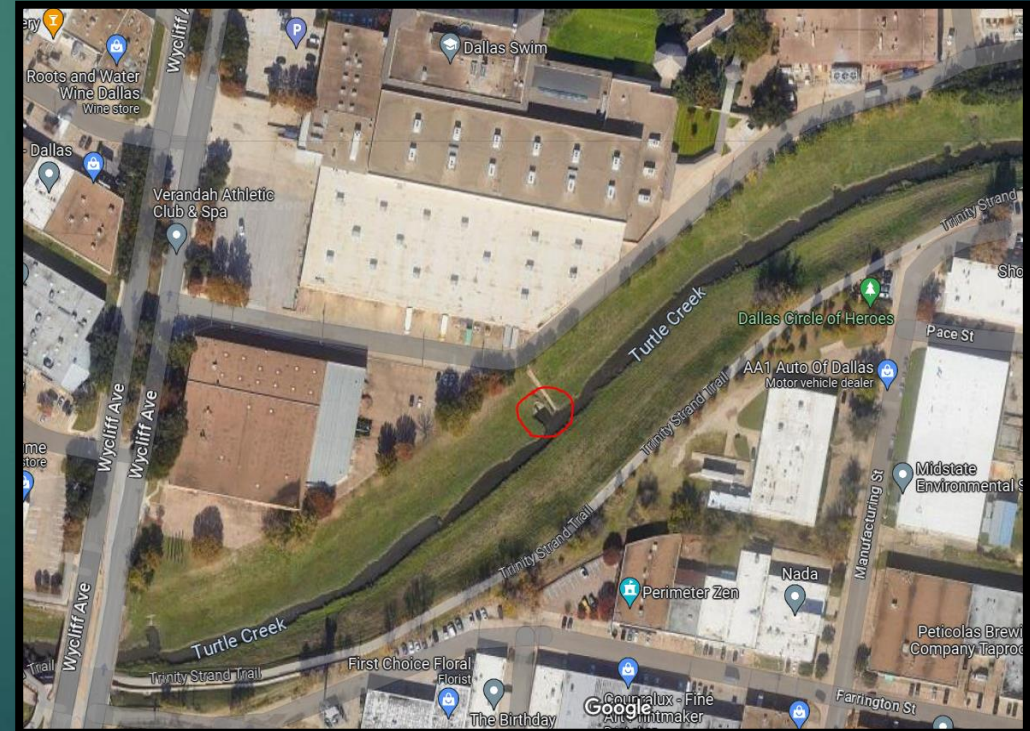
- ▶ On May 8th 2018, while performing dry weather screening, City of Dallas personnel observed white colored water discharging from an outfall along Turtle Creek behind 1300 Wycliff Ave.

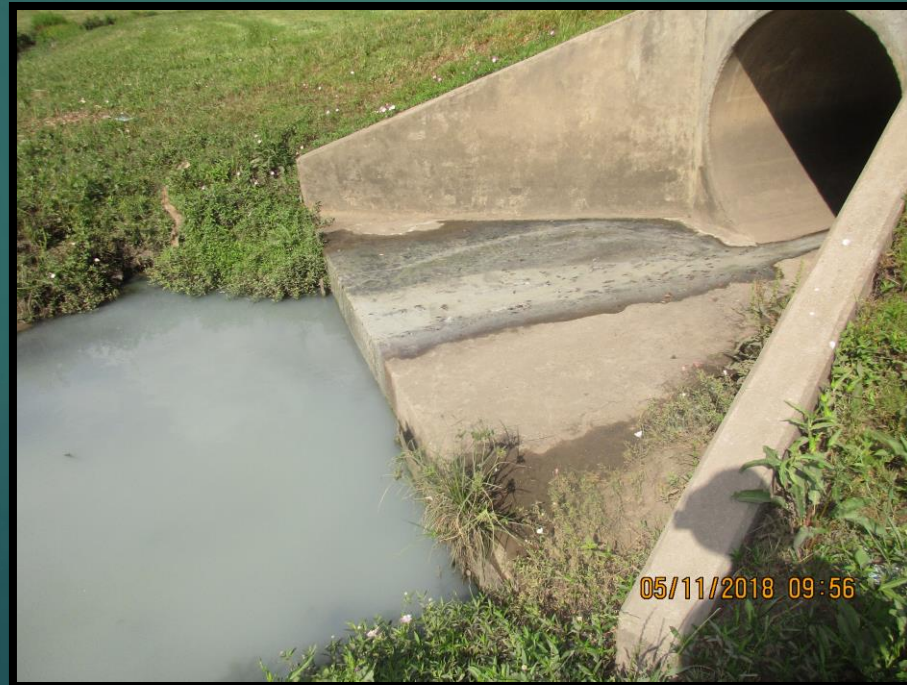
- ▶ DWU Waste Water division is contacted to come out and inspect the city of Dallas Wastewater lines for any possible infiltration into stormwater lines.
- ▶ The outfall is observed and still discharging a light flow of raw sewage.

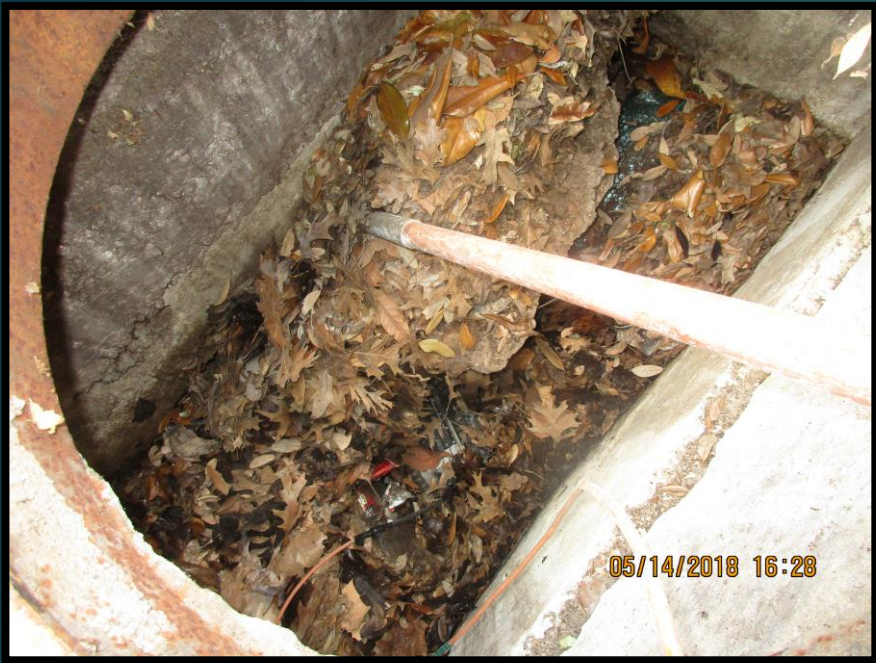
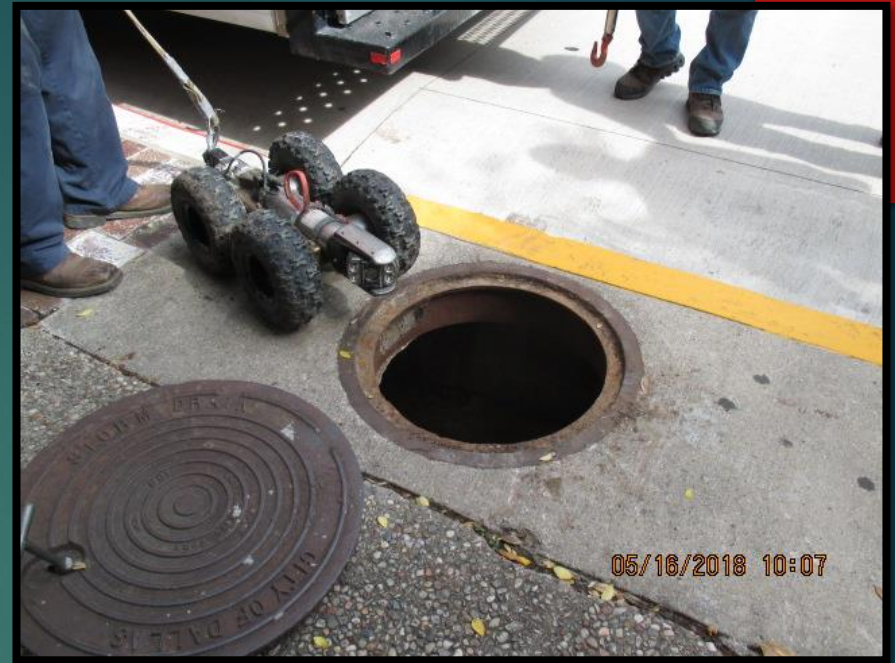
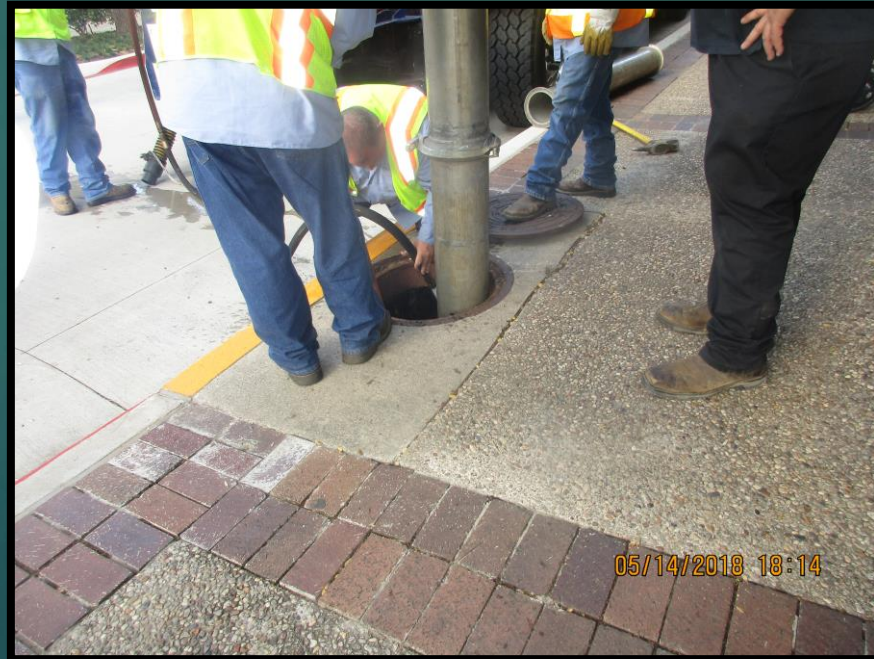
- ▶ CCTV from DWU and TWM attempted to camera 42" storm drain line but were encountering issues getting camera into line form inlet boxes.
- ▶ Hotel staff shared blueprints of plumbing with Stormwater staff but they were not conclusive.
- ▶ Grease traps in the front parking lot were dye tested for possible infiltration but no dye was observed in the storm drain line.
- ▶ CCTV noticed food particles in 42" line so all kitchens and break rooms were dye tested on the first floor of the hotel but the dye showed up on the grease traps and not in the storm drain.

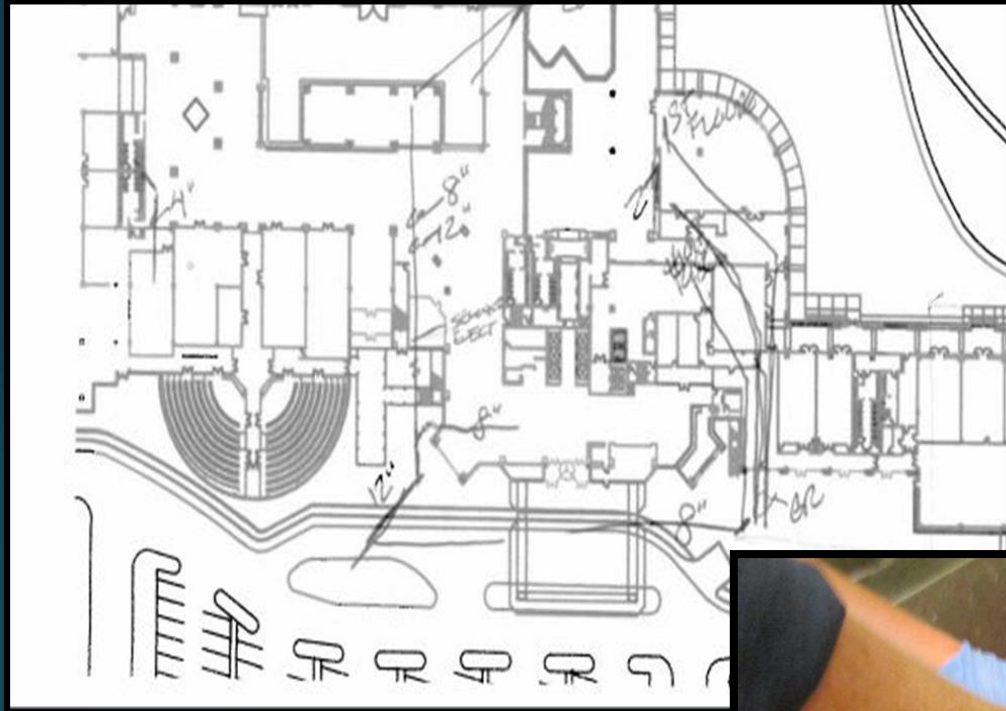
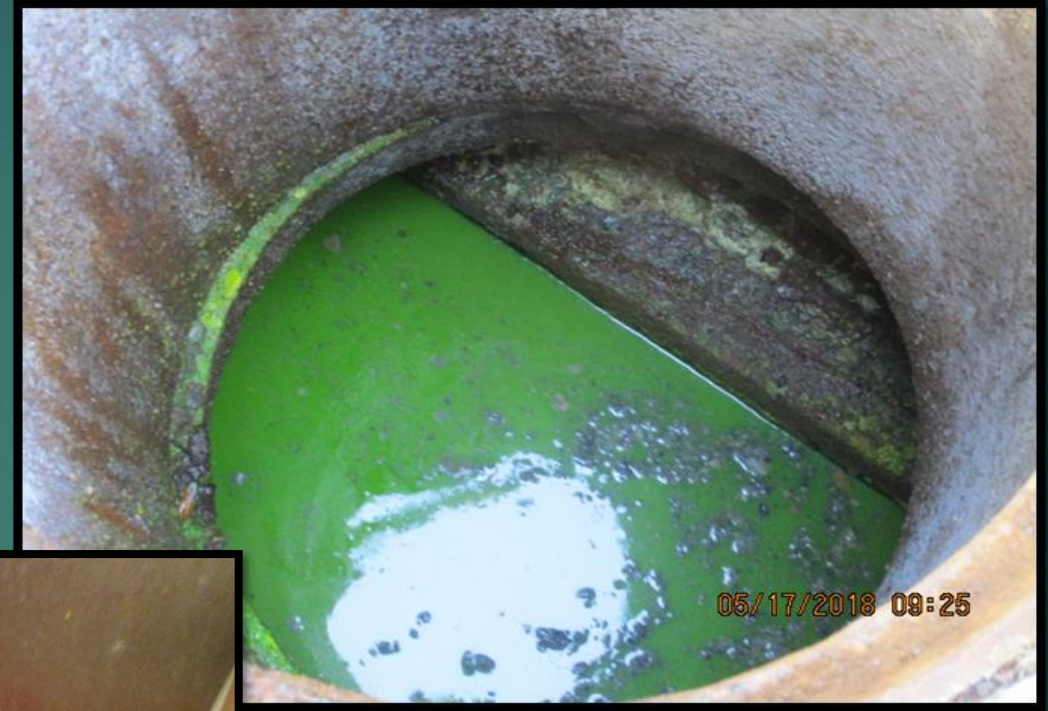
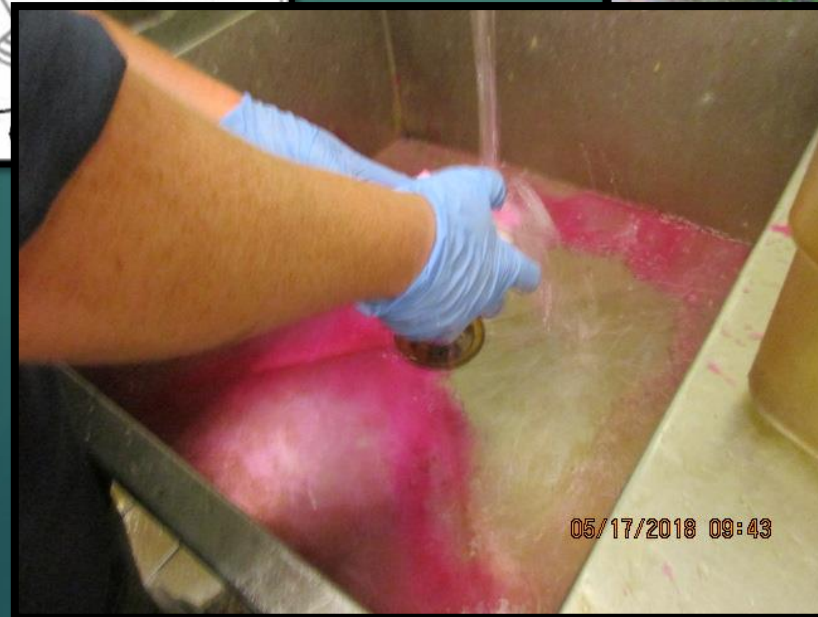
- ▶ Investigation continued with CCTV able to camera the 42" line from the opposite direction observing that there was a heavier presence of white colored sewage at an area near another set of grease traps.
- ▶ Dye testing was performed on the grease traps, but no dye ever showed up in the storm drain.
- ▶ Another set of plumbing blueprints were provided by hotel staff.
- ▶ There was a kitchen inside the building near where the heavier sewage was noted by CCTV, but dye testing was performed on all sinks and drainpipes and no signs of dye tests were found in storm drain line.

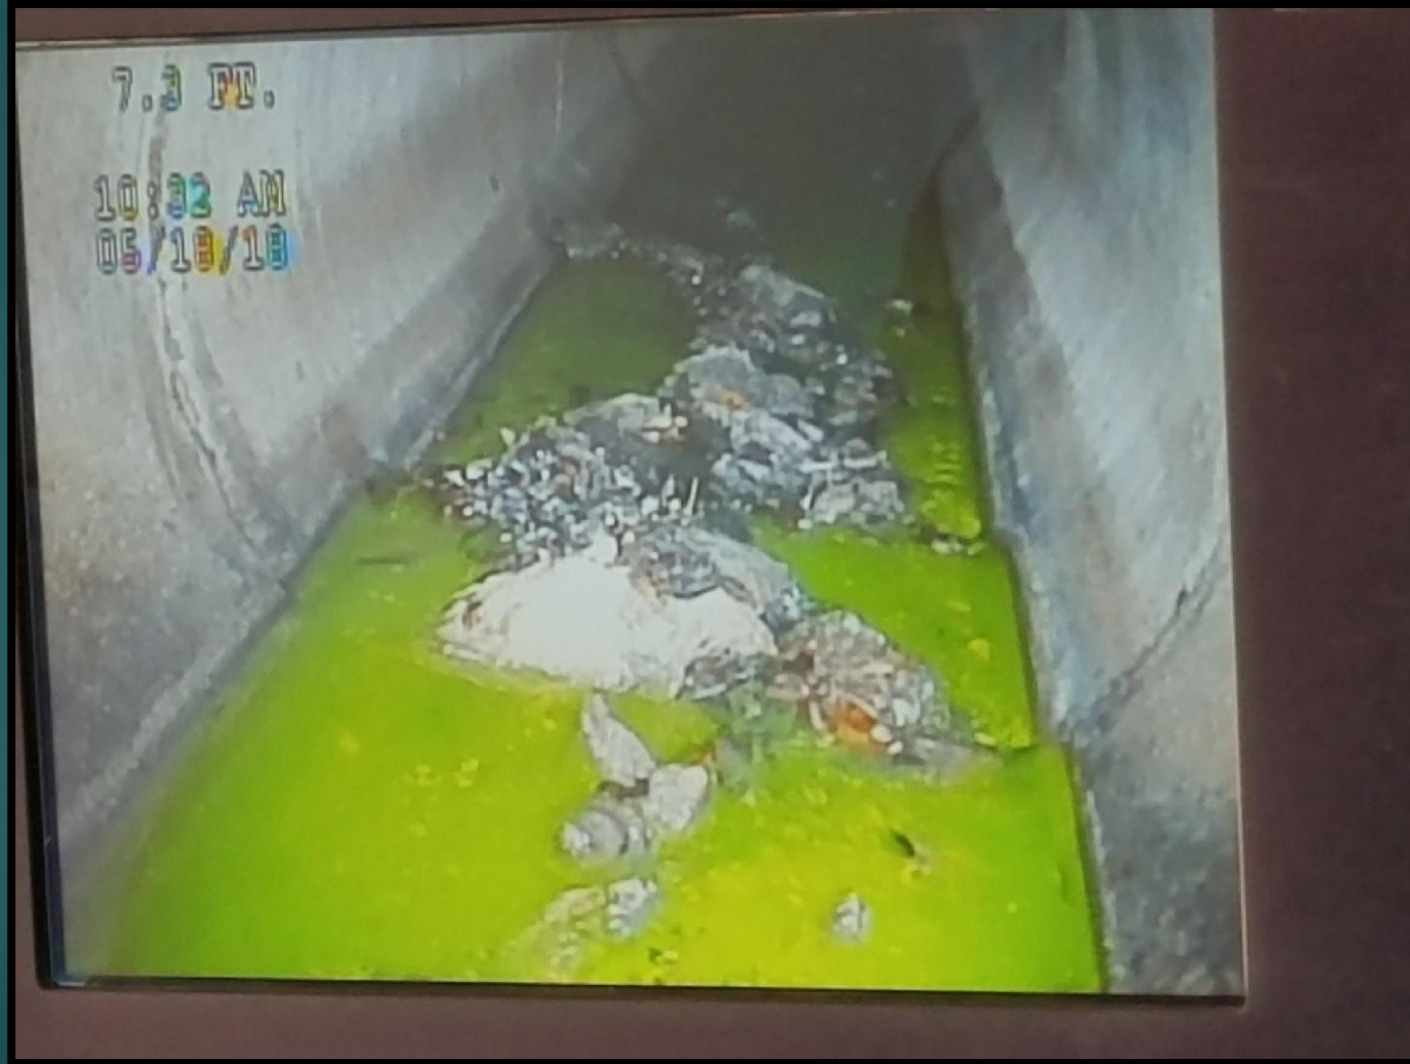
- ▶ Further investigation led Stormwater to perform dye testing inside a small kitchen located on the 27th floor of the hotel.
- ▶ CCTV observes dye entering the storm drain. Dye was observed in one of the cleanouts next to the building as well.
- ▶ Hotel staff was informed of the findings and issued an NOV for the illicit discharge
