# Road Safety Audit Center Street and Cooper Street Arlington, TX

DECEMBER 2024

Facilitated by: Amelia (Millie) Hayes, P.E., PTOE, RSP<sub>21</sub>  
FHWA Texas Division

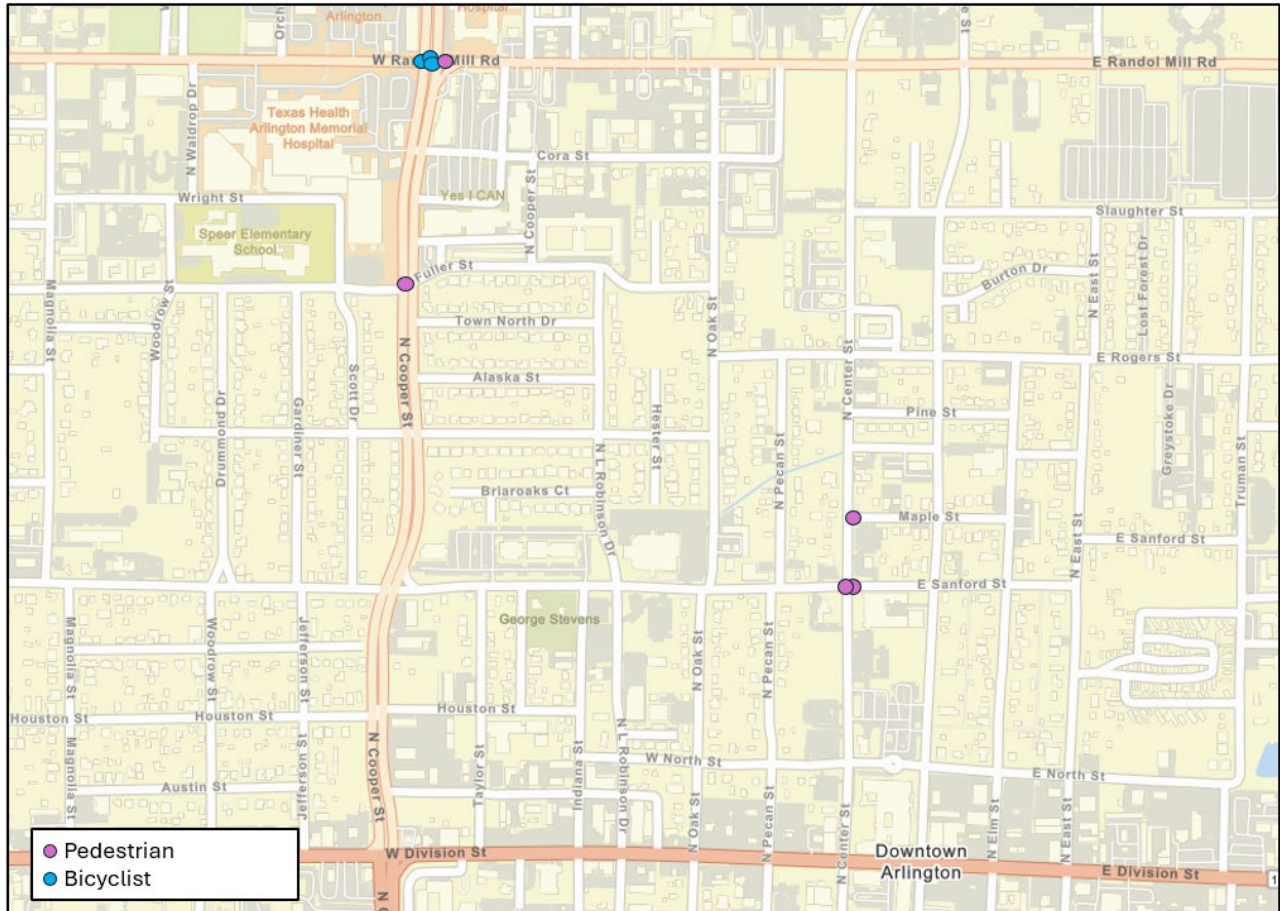
Figure 5: Pedestrian and Bicyclist crash map of the corridor. (Source: TxDOT Crash Record Information System, 2013 - 2022)

As shown in the map above, pedestrian crashes are overrepresented at Cooper/Randol Mill and bicycle crashes are overrepresented on Cooper Street. In the kickoff meeting and in subsequent interviews, the RSA Team heard feedback that driver speeding was prevalent in both Cooper and Center Street corridors, and that drivers often did not yield to pedestrians even in marked crosswalks within active school zones. The RSA Team also heard feedback that bicyclists often avoid Center and Cooper Streets corridors when possible due to safety and comfort concerns, but the location of certain destinations (e.g. grocery stores and other retail near Cooper/Randol Mill) often required some travel on Cooper Street.

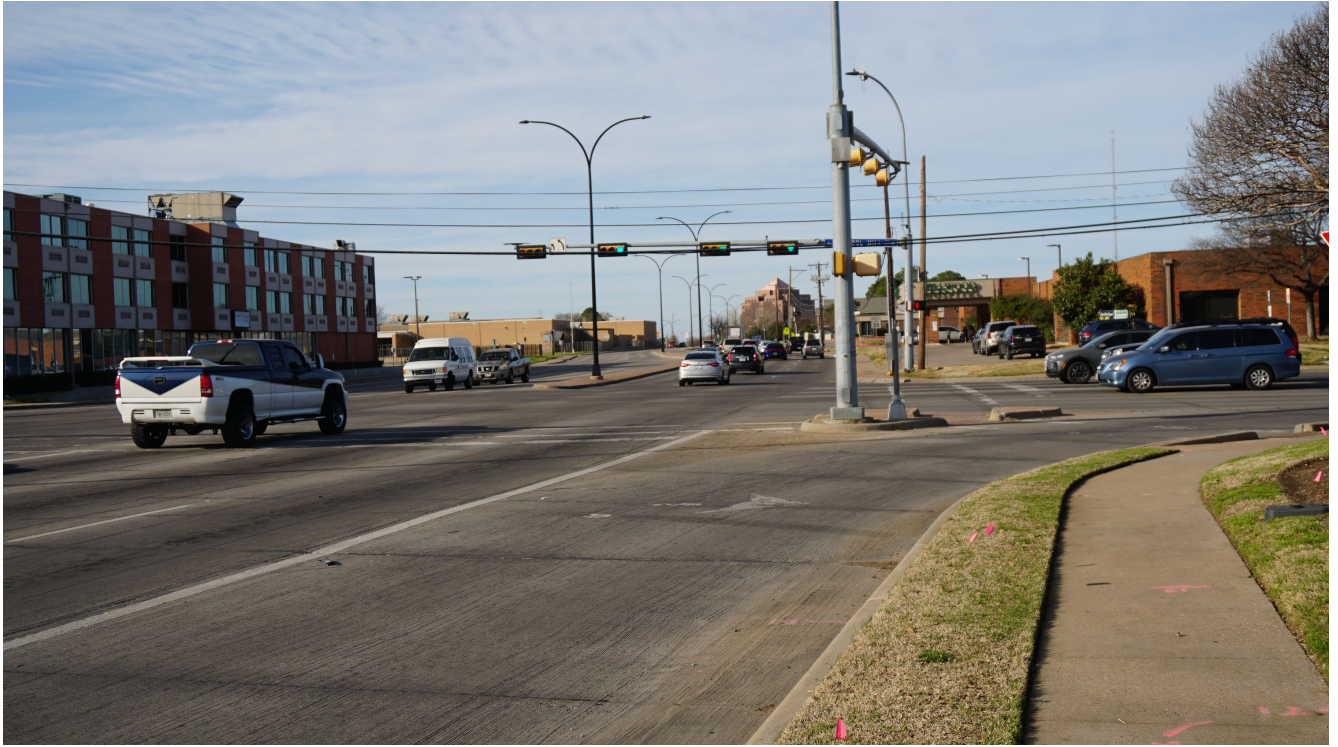
*Figure 6: Design of right-turn islands like this one (southeast corner of Center Street and Randol Mill Road) allow for high-speed turns with reduced yielding to pedestrians*

- Consider crosswalk improvements at intersections. The City should consider the following improvements for pedestrian expectancy and accessibility.
    - Consider TxDOT's new standard for right-turn islands. At some intersections, drivers turning right turned at high speeds. Due to the high speeds and longer crossing length in these locations, the RSA Team observed pedestrians having difficulties in crossing. During future improvement projects, the City could also consider [TxDOT's new standard](#) for right-turn islands, which tightens the right-turn and provides improved visibility for crossing pedestrians. The new standard also features hatching and pavement markings for passenger vehicle paths, while overall curb return allows for truck off-tracking. Timeline: Long-term.

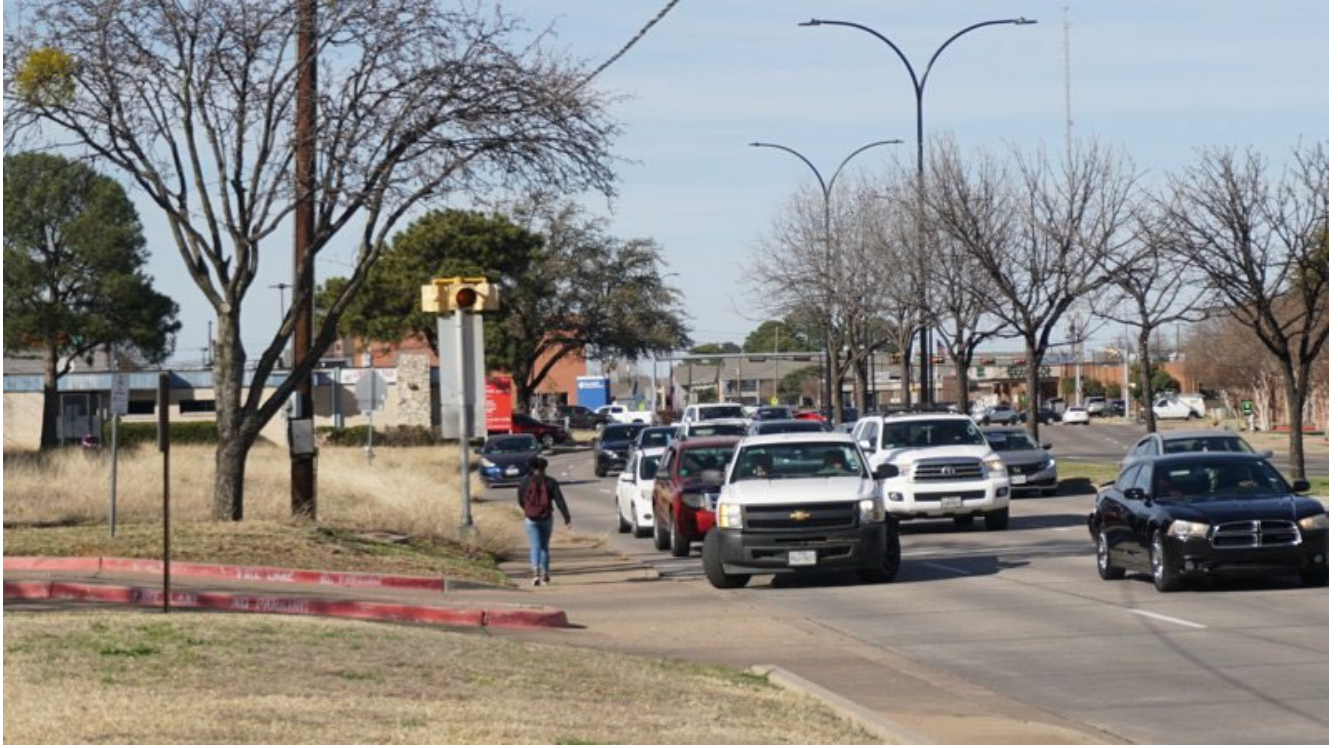
*Figure 10: Driveway design resembling intersection at Cooper/Fuller*

- Consider redesign of sidewalks across driveways to encourage driver yielding to pedestrians. Throughout the corridor, the sidewalks ramp down to street level at driveways. This creates a “rollercoaster effect” for pedestrians. The design prioritizes vehicle movement and allows for turns at high speeds, which decreases likelihood of drivers yielding to pedestrians. Timeline: Long-term.

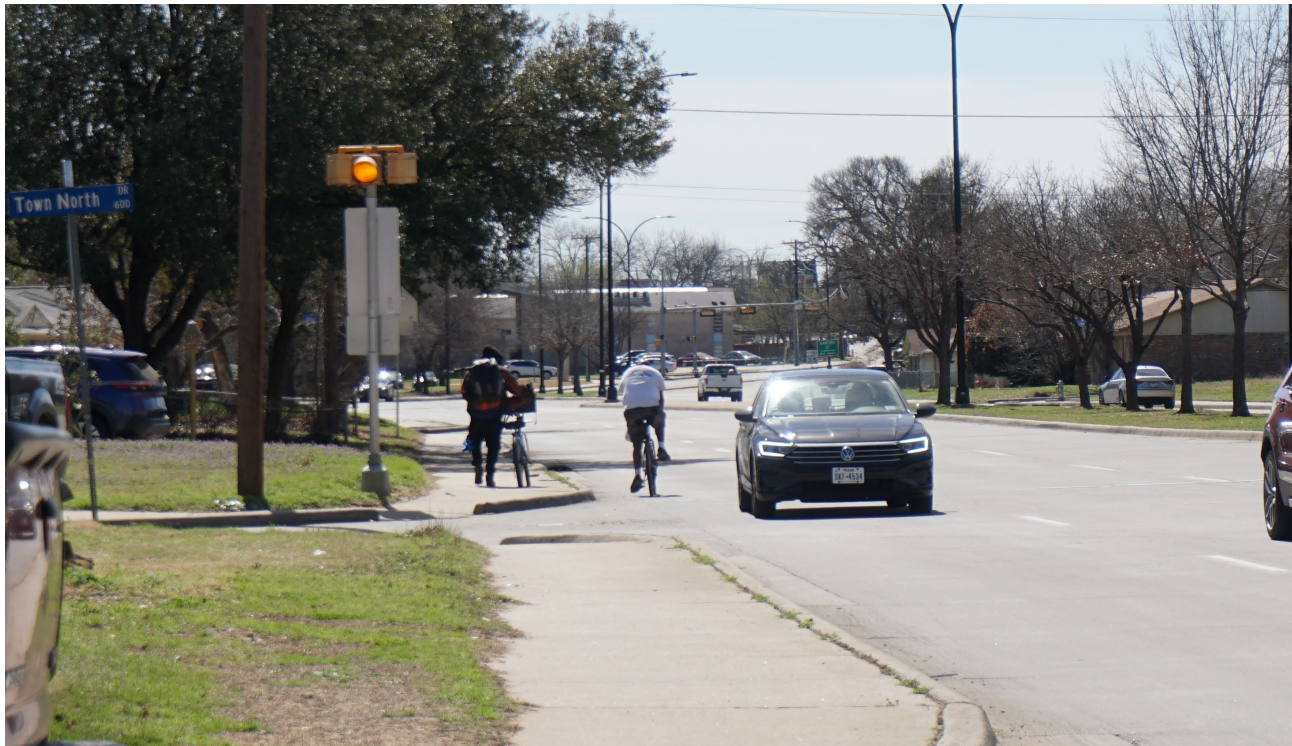
- **Observation:** Many bicycle users were observed throughout the corridor, with usage ranging from taking a lane or riding on the sidewalk. Nearly all bicyclists chose to use the sidewalk except when needing to pass other cyclists or pedestrians.

*Figure 13: With other users on the sidewalk, pedestrians and cyclists trying to pass didn't have enough space to do so on the sidewalk and often passed in this manner*

**Recommendation:** Determine preferred bicycle accommodation. Consider changes to cross-section that include a high quality separated bike facility per FHWA’s [Bikeway Selection Guide](#). As discussed in the General Recommendations, at a network level, the City must decide which streets are needed to give more priority to people walking and biking (and thus slower speeds) and those where motor vehicles may have more priority (where investments in separating walking and biking from the roadway may be required).
