City of Arlington
Water Utilities Department

Rethinking Renewal Prioritization

CONCRETE WATER MAIN CONDITION ASSESSMENT PROGRAM

LARGE DIAMETER SANITARY SEWER CONDITION ASSESSMENT PROGRAM

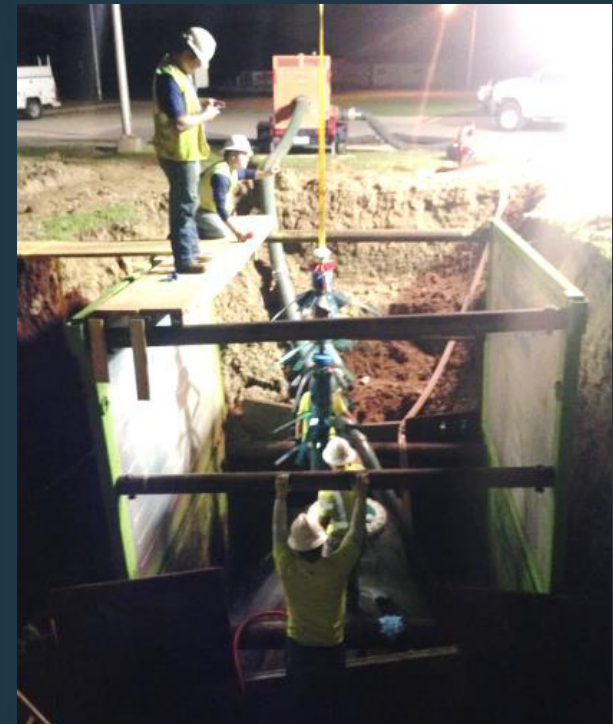
Green Oaks Water Transmission Main 2016 Condition Assessment

- 2.6 miles, 42", 48" & 54", Prestressed Concrete Cylinder Pipe (C301), 1982
- Estimated Replacement Cost \$10,500,000
- Assessment Cost \$286,500

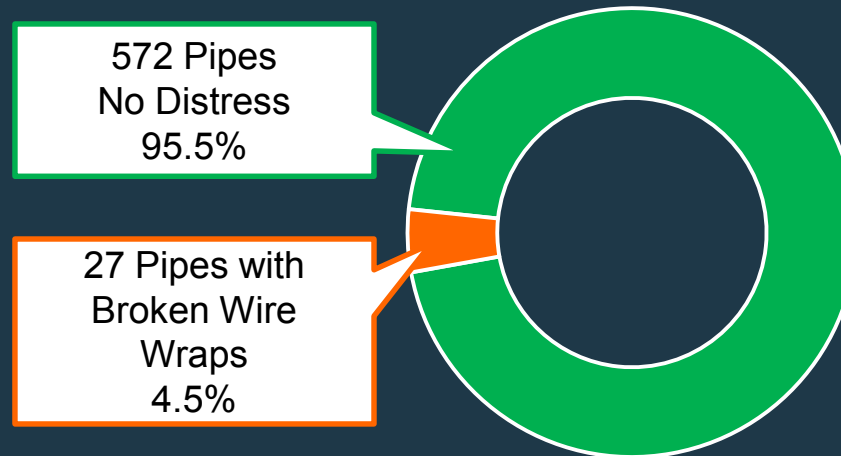
Green Oaks Water Transmission Main 2016 Condition Assessment

- Assessment Results
 - 599 pipe segments
 - 27 segments with wire breaks (4.5%)
 - 6 segments with 25+ wire breaks (1.0%)
 - Cost avoidance of \$7,000,000

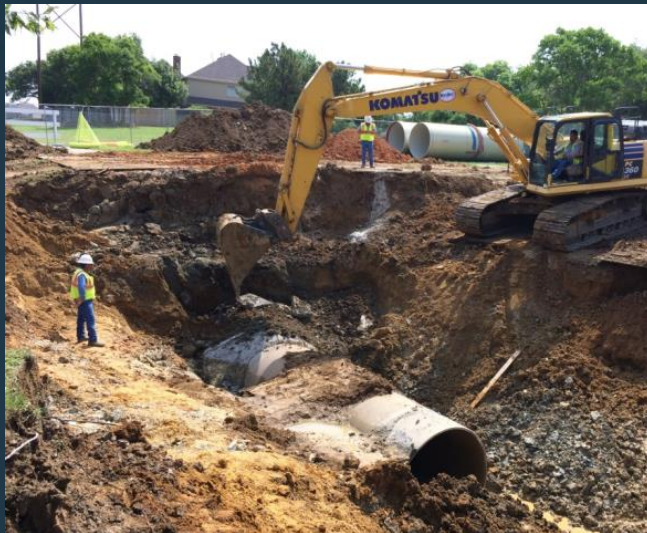
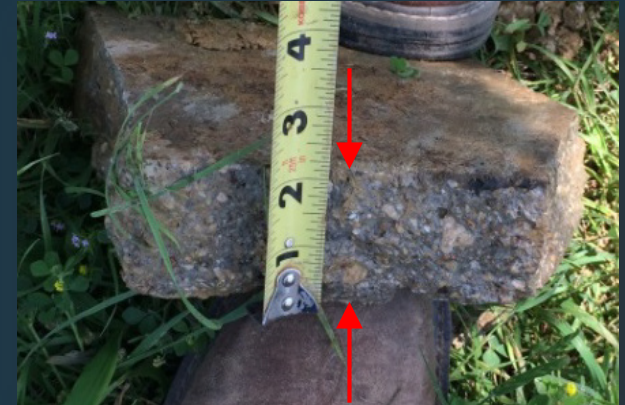
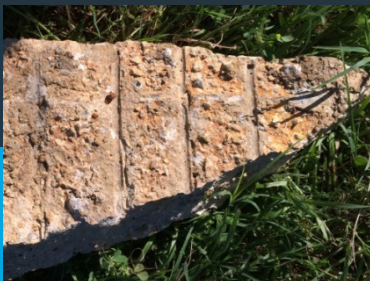
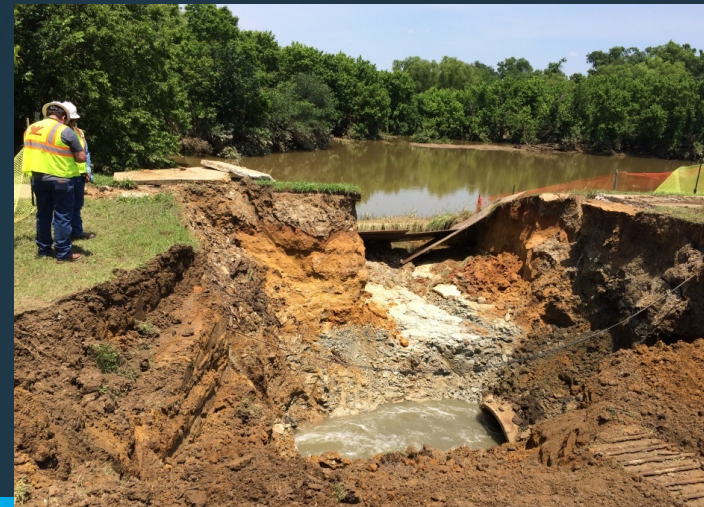
66-Inch Sanitary Sewer Failure

- Installed in 1983
- 66-inch RCP Sanitary Sewer
- Repair Cost \$138,000

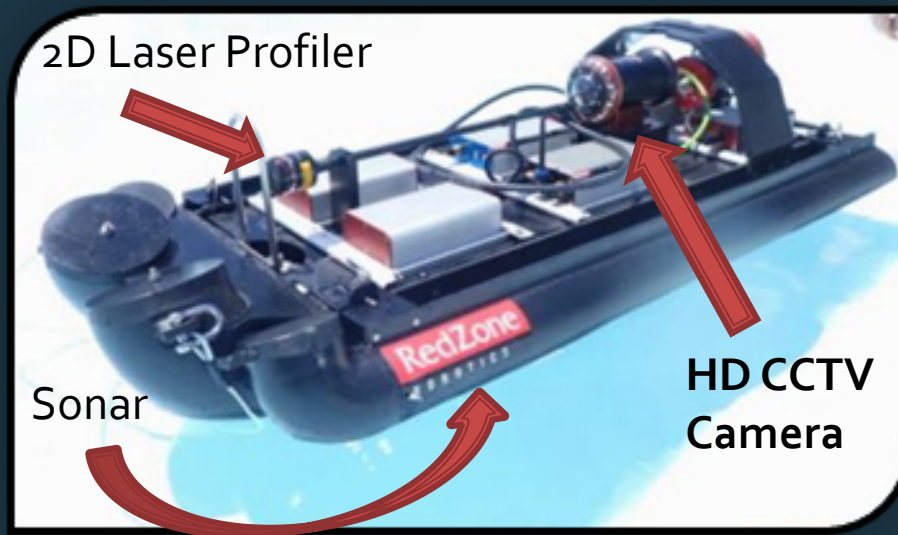
Inspection Equipment

- Multi-Sensor Inspection Platform
- HD CCTV Camera
- Laser Ring Profiler
- Sonar

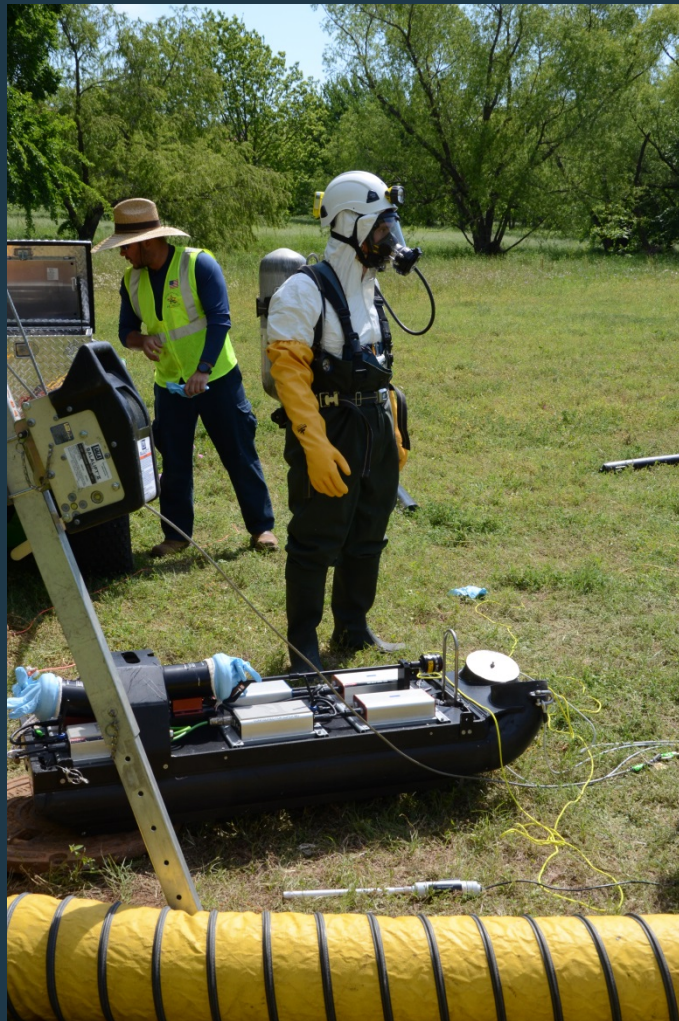
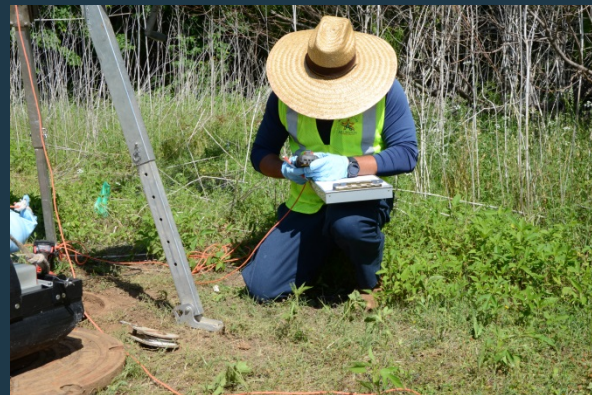
Inspection Process

- Manhole Dangers...
 - Too Much H₂S
 - Presence of Flammable Gases
 - Lack of Oxygen
 - Presence of Carbon Monoxide
 - Heavy Flow

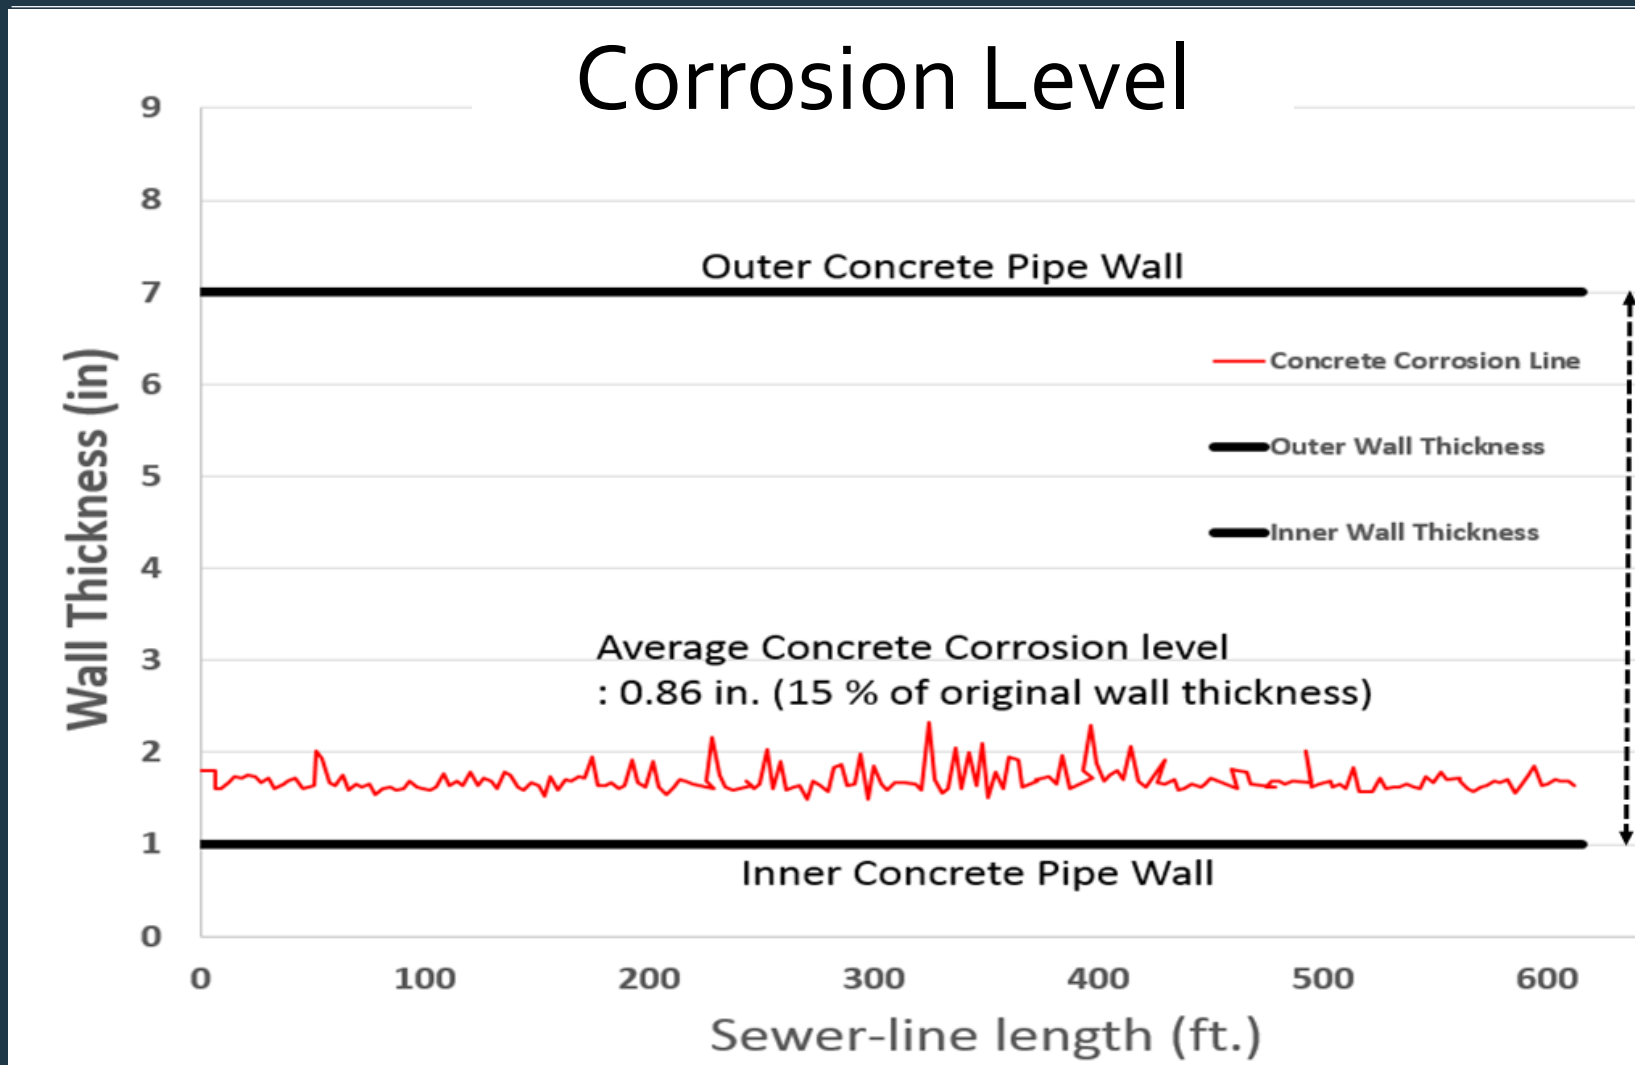
Corrosion Level

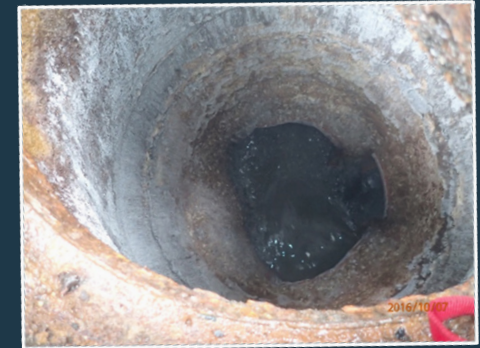
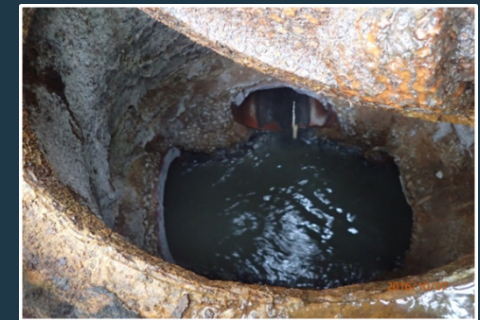
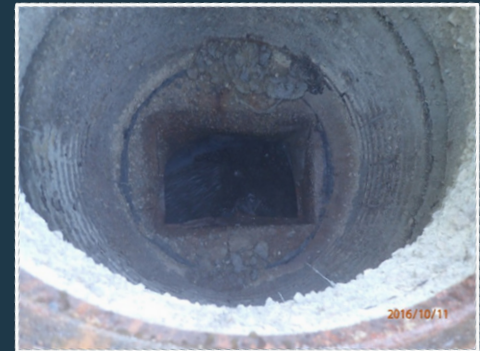
Manhole Corrosion Protection Needs Assessment

- Measure multiple liquid & gas phase parameters and manhole corrosion rates
- Determine conditions requiring corrosion protection
- Cost-benefit analysis of available corrosion protection options
- Recommend pipe slopes to reduce H₂S generation & H₂S release

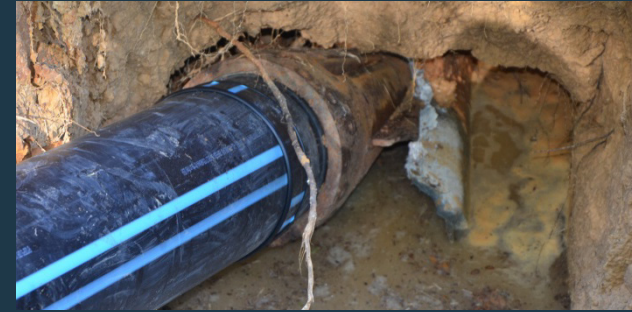
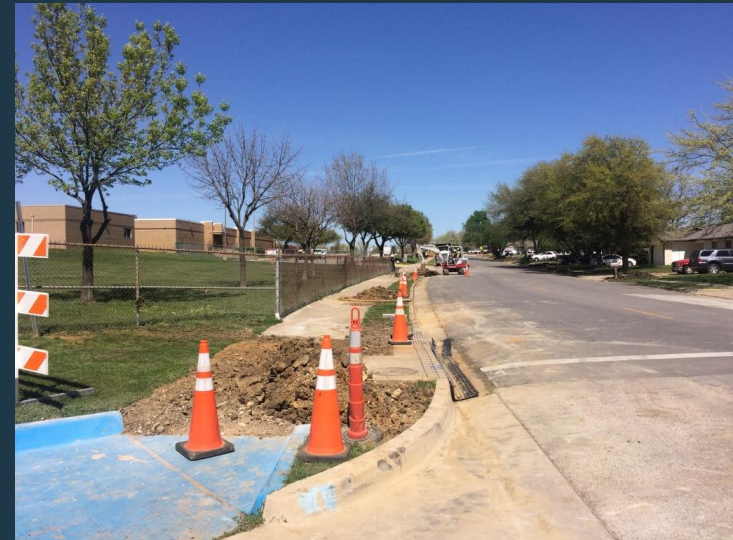
Trenchless water main replacement

- Pipe-bursting replaces break-prone mains with HDPE pipes. Fused pipes are jointless and have zero allowance for water loss.
- Shorter project duration, less impact on residents
- 35 % less expensive than traditional open cut methods
- 13,125-feet of pipe bursting projects in 2016
- In April 2017, AWU operations crews began learning pipe-bursting process. Demonstration project saved the city \$125,000 replacing 800 feet of water main.

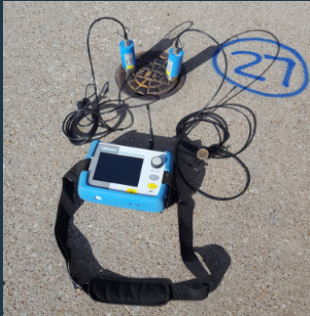
- Full time proactive leak detection program since 2014. Uses advanced sensors and software to determine where underground main leaks are before crews start digging.

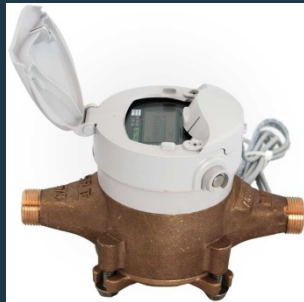
- 47,000 AMI meters installed (30,000 with in-house labor)
- \$14 million equipment upgrade at two treatment plants. Replacing ozone generators and installing advanced control systems will make the plants more efficient and less costly to run.
