Road Safety Audit W Spring Valley Road Richardson, TX

NOVEMBER 23, 2022

Facilitated by: Amelia (Millie) Hayes, P.E., PTOE, RSP₂₁
FHWA Texas Division

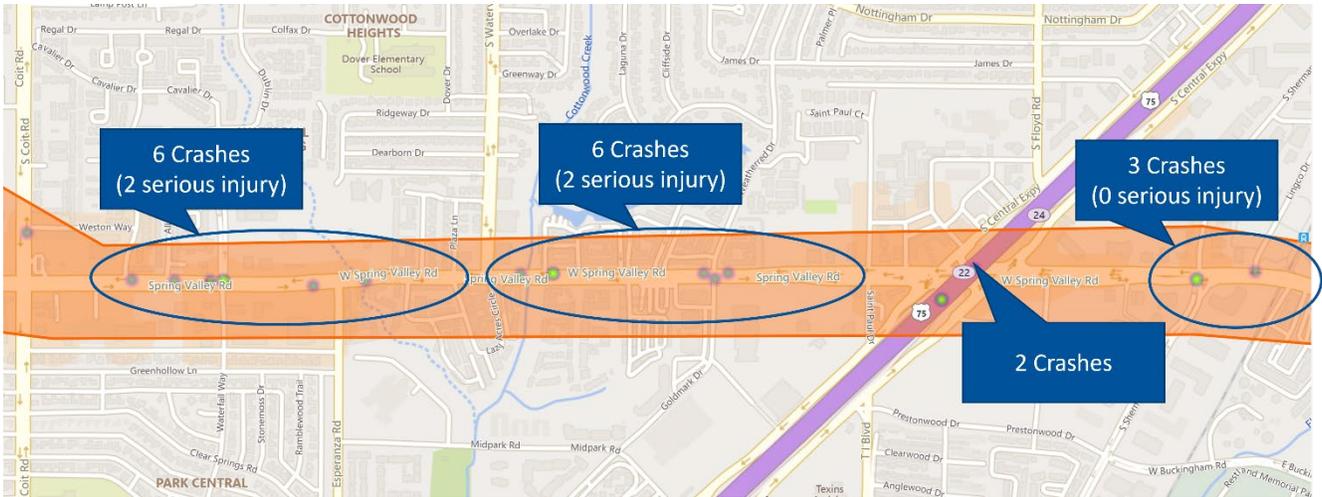
Figure 3: Pedestrian and Bicyclist crash map of the corridor. (Source: TxDOT Crash Record Information System, 2018-Sept 2022)

As shown in the map above, pedestrian crashes are overrepresented west of US 75. Most of the crashes are classified as non-intersection related. In the kickoff meeting and in subsequent interviews, the RSA Team heard feedback that many pedestrians and bicyclists cross away from marked crosswalks, particularly on the east and west ends of the Spring corridor. On the east end, pedestrians were observed crossing W Spring Valley from Central Trail underneath the DART rail overpass instead of using the intended diverted path crossing at the Business Parkway/E Spring Valley intersection. On the west end, pedestrians were observed crossing between the multifamily residential buildings and the retail establishments, typically between the two midblock crosswalks installed near that location.

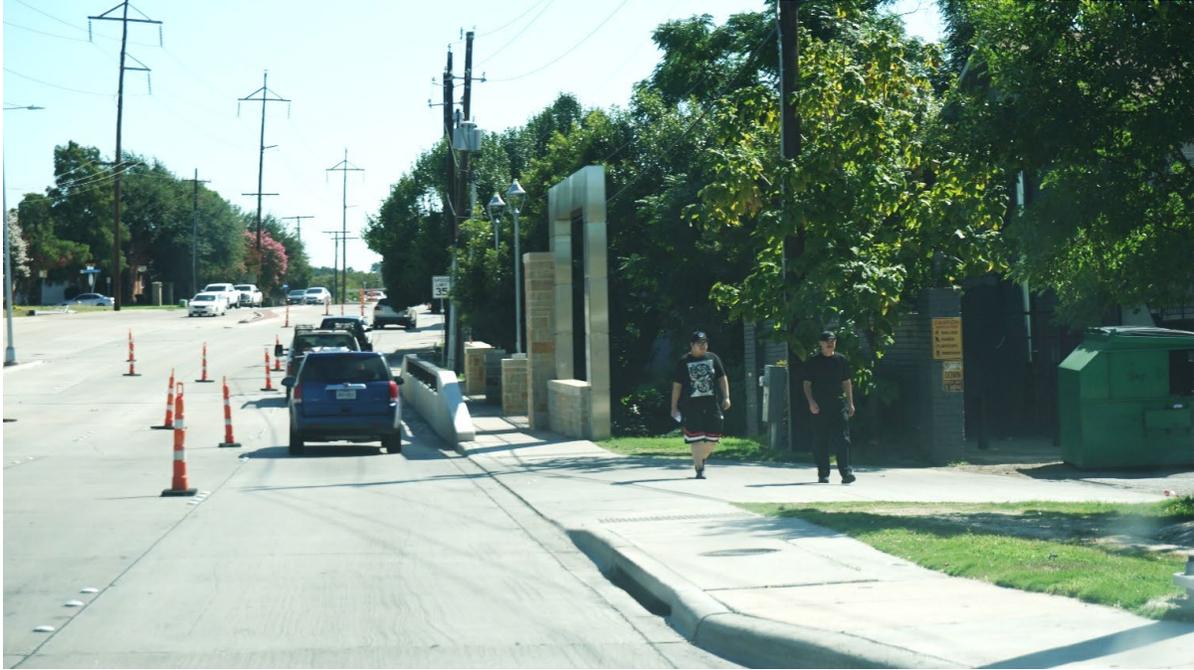
During our field reviews, the RSA Team also observed pedestrians and bicyclists tending to avoid being on the sidewalk adjacent to the vehicle lane whenever possible. Pedestrians especially tended to walk through parking lots or grass of vacant lots, using the back-of-curb sidewalk only when they didn't have those other options.

Figure 4: Pedestrians avoiding back-of-curb sidewalk when possible

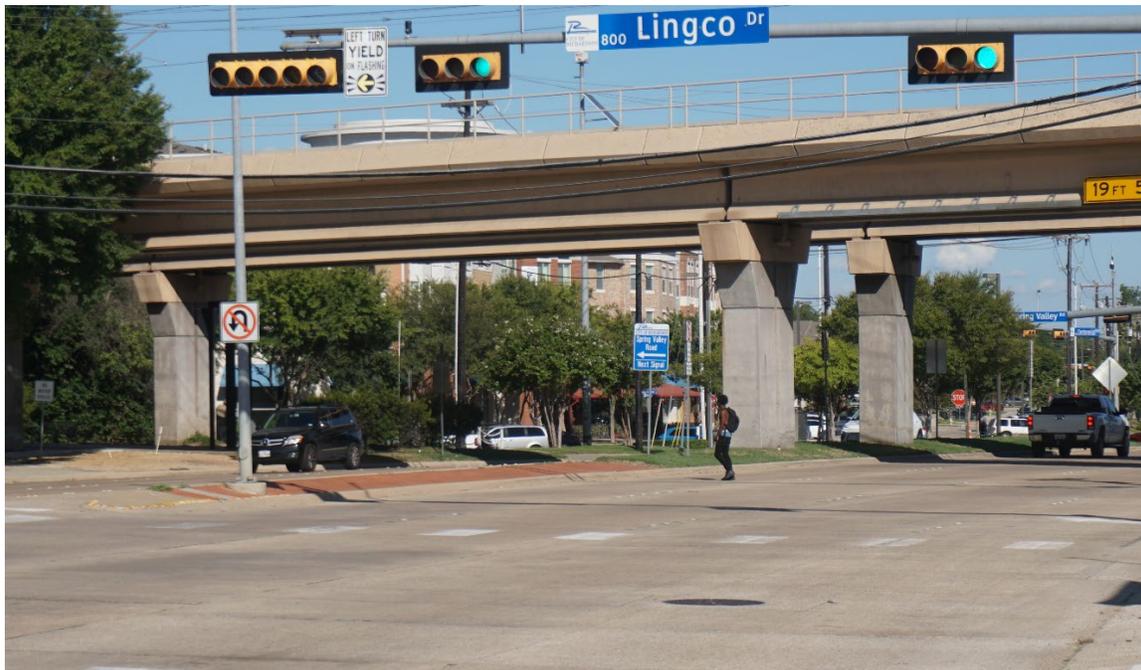
Figure 5: Some marked crosswalks were not within natural or expected paths

Figure 5 is one of several examples of a pedestrian crossing in the natural or expected path, with this crossing movement occurring where the northbound Central Trail had just ended.

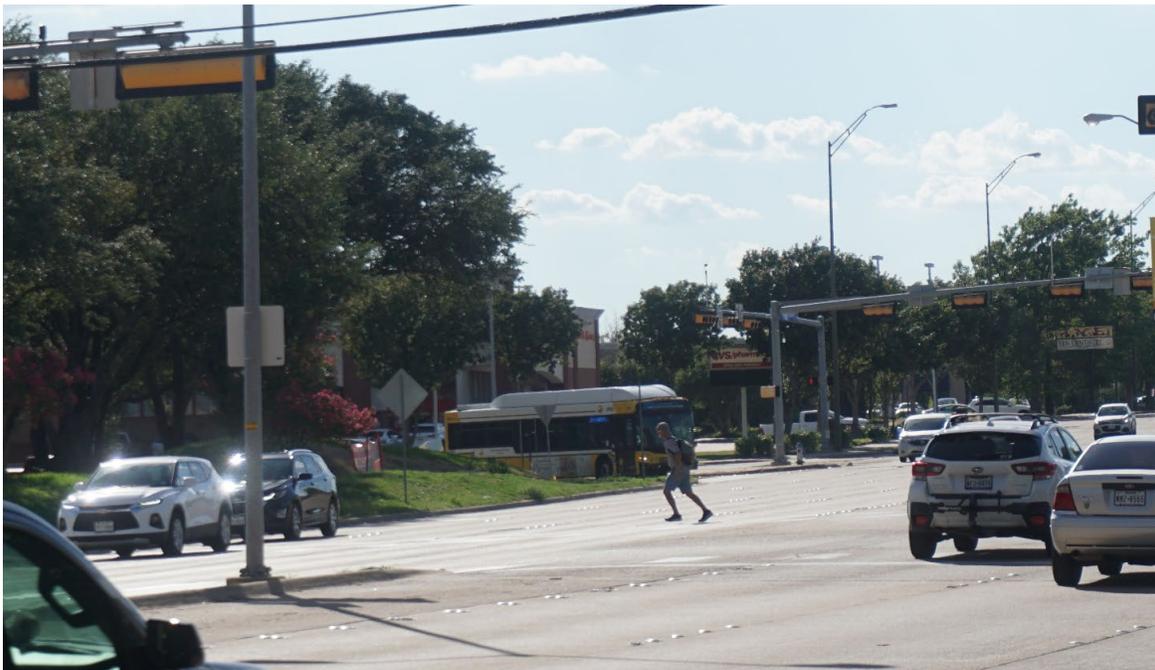
During our field reviews, the RSA Team observed very little yielding to pedestrians or bicyclists by drivers. This observation was consistent for crossing movements within marked crosswalks and outside of crosswalks alike.

Figure 6: Few gaps in traffic, lack of drivers yielding, and long cycle lengths result in few pedestrians crossing at marked crosswalks

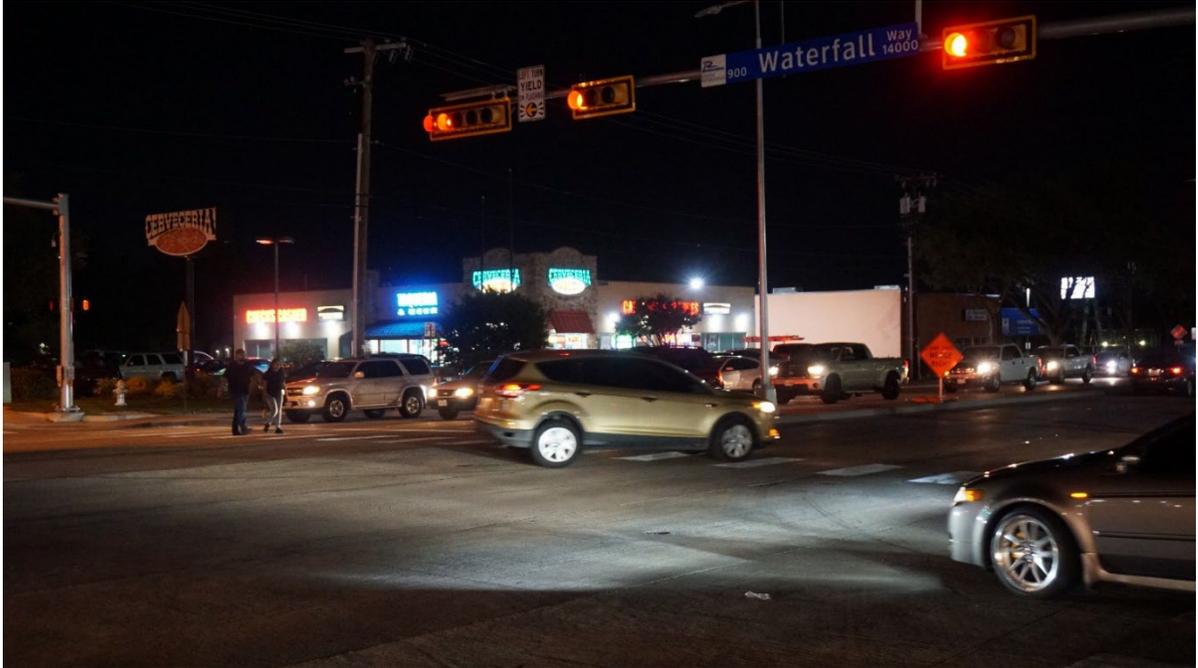
- Consider protected turn phasing. Permissive turns allow for more conflicts between pedestrians and opposing traffic, and adds to pedestrians feeling less safe. The City should analyze intersections to consider protected turn phasing to prevent conflicts between pedestrians and vehicles. The City could also consider protected-only turns in certain times of day, or on demand when a pedestrian pushbutton has been activated. Protected turn phasing and pedestrian phase recall should be considered at each leg of an intersection to balance safety and convenience for pedestrians alongside potential impacts to vehicular traffic. Figure 7 shows a common observation from the RSA Team filed visits: when pedestrians do choose to cross at signalized intersections within the corridor, the lack of adequate gaps made it difficult to cross. Timeline: Short-term.

Figure 7: Lack of gaps for pedestrians at signalized intersections

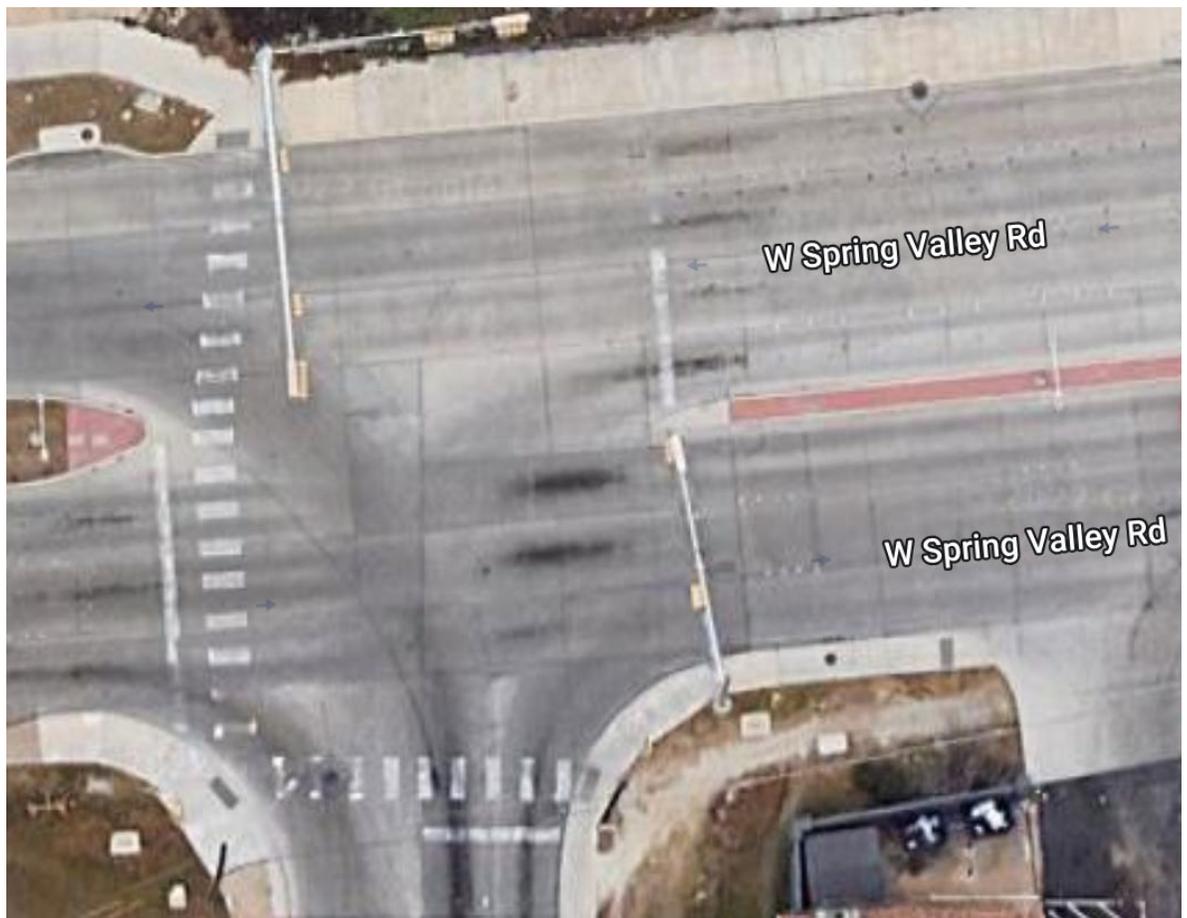
Figure 8: Change in crosswalk direction delineated only with pavement marking at Esperanza Road (Google)

At some locations, there were misaligned crosswalks and ramps, including a change in direction crossing the median in multiple locations. Changes in direction delineated only in paint are not ADA compliant. Timeline: Short-term, otherwise medium-term if median changes are needed.

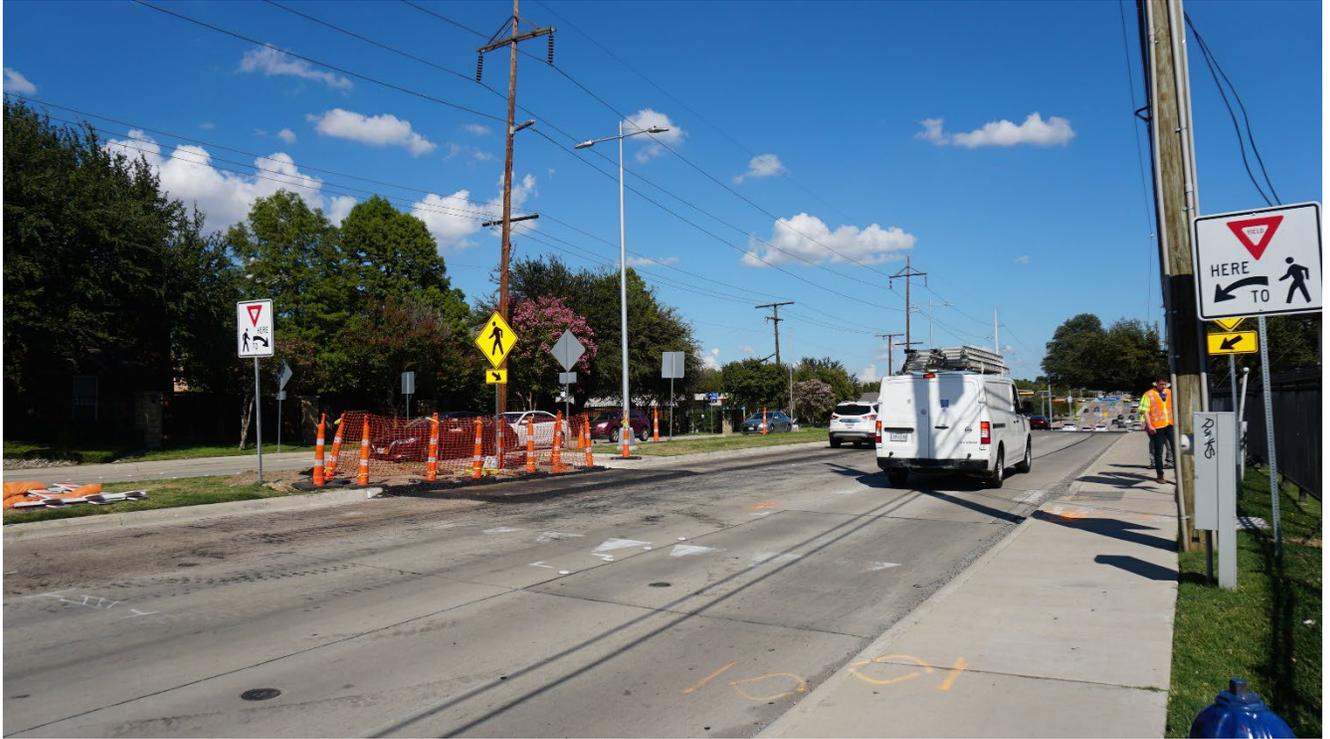
- Consider standards for accessible detour paths for sidewalk closures. The RSA Team observed sidewalk closure and midblock crossing closure with no accessible path and no advance warning.

Figure 9: Closure of midblock crossing with no warning or accessible detour path

The RSA Team observed people trying to get around, including one user with a mobility assistance device which made it much more of a challenge. The City should investigate who is responsible for the construction work at these locations. The City should have standards for accessible detour paths for sidewalk closures. Sidewalk closures should be at least as accessible as they were prior to construction. Timeline: Short-term to provide continuous and accessible walking path, and medium-term for updating City standards for sidewalk closures.

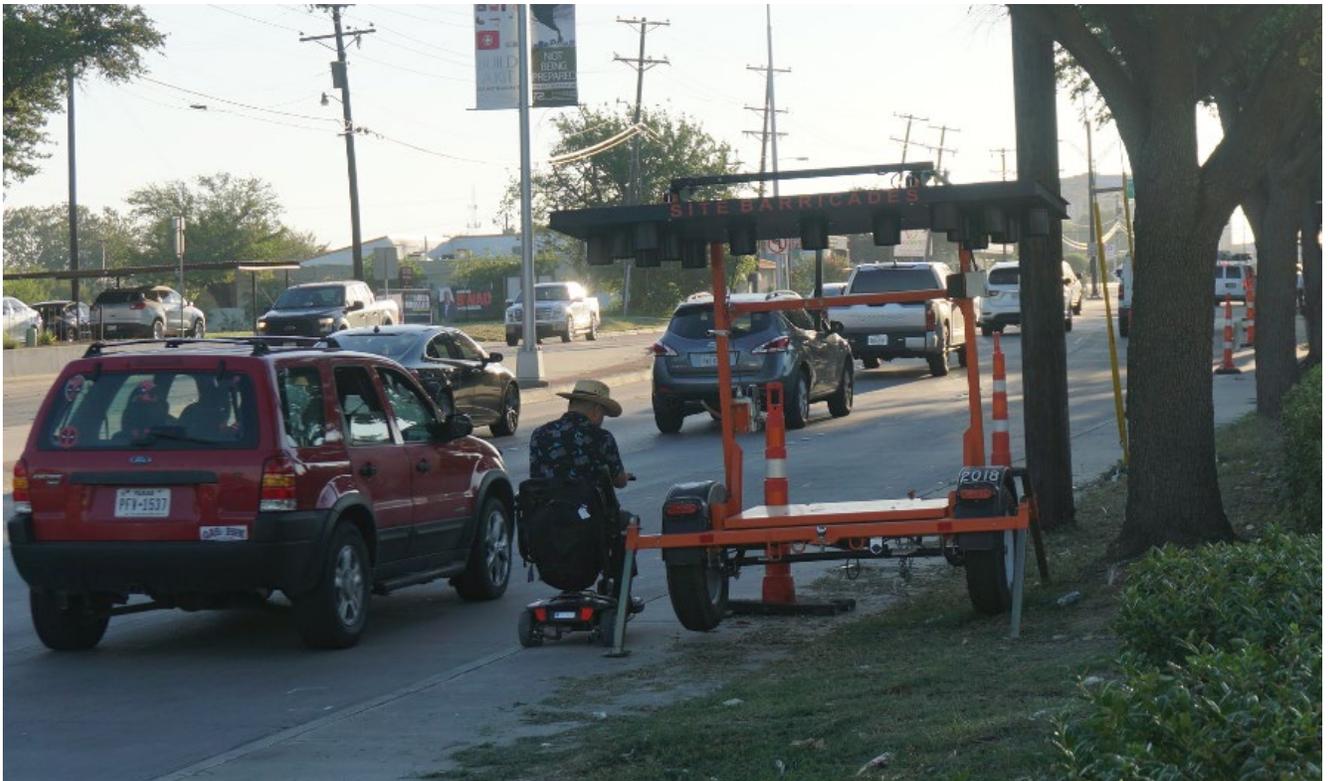
Figure 10: Closure of sidewalk with no warning or accessible detour path, located immediately adjacent to bus shelter

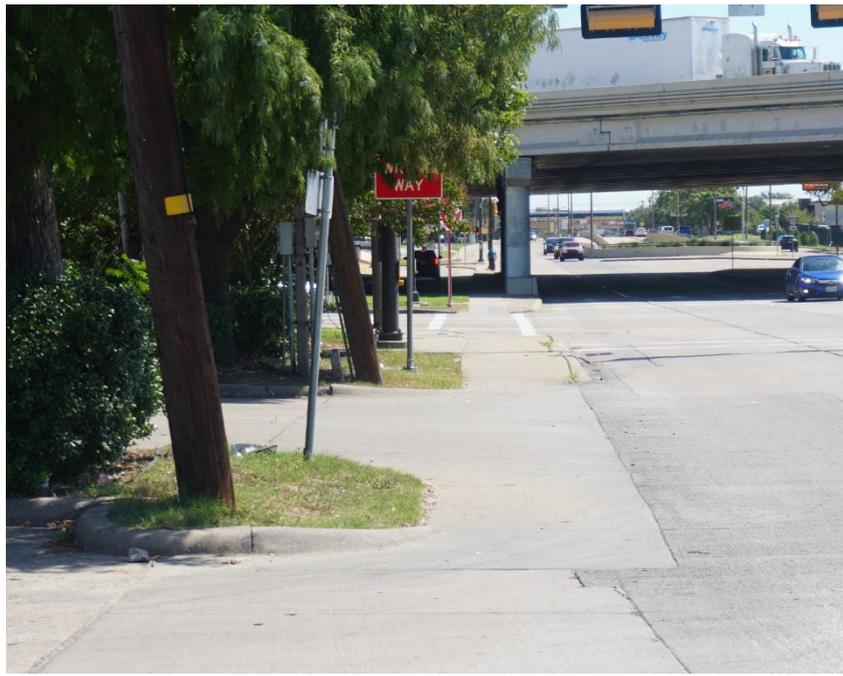
- Consider redesign of sidewalks across driveways to encourage driver yielding to pedestrians. Throughout the corridor, the sidewalks ramp down to street level at driveways. This creates a “rollercoaster effect” for pedestrians. The design prioritizes vehicle movement and allows for turns at high speeds, which decreases likelihood of drivers yielding to pedestrians.

Figure 11: Ambiguous pavement area

In some locations near US 75, as shown in Figure 11, there were extended lengths where there is no curb separating the sidewalk from motorists. Timeline: Medium- to long-term.

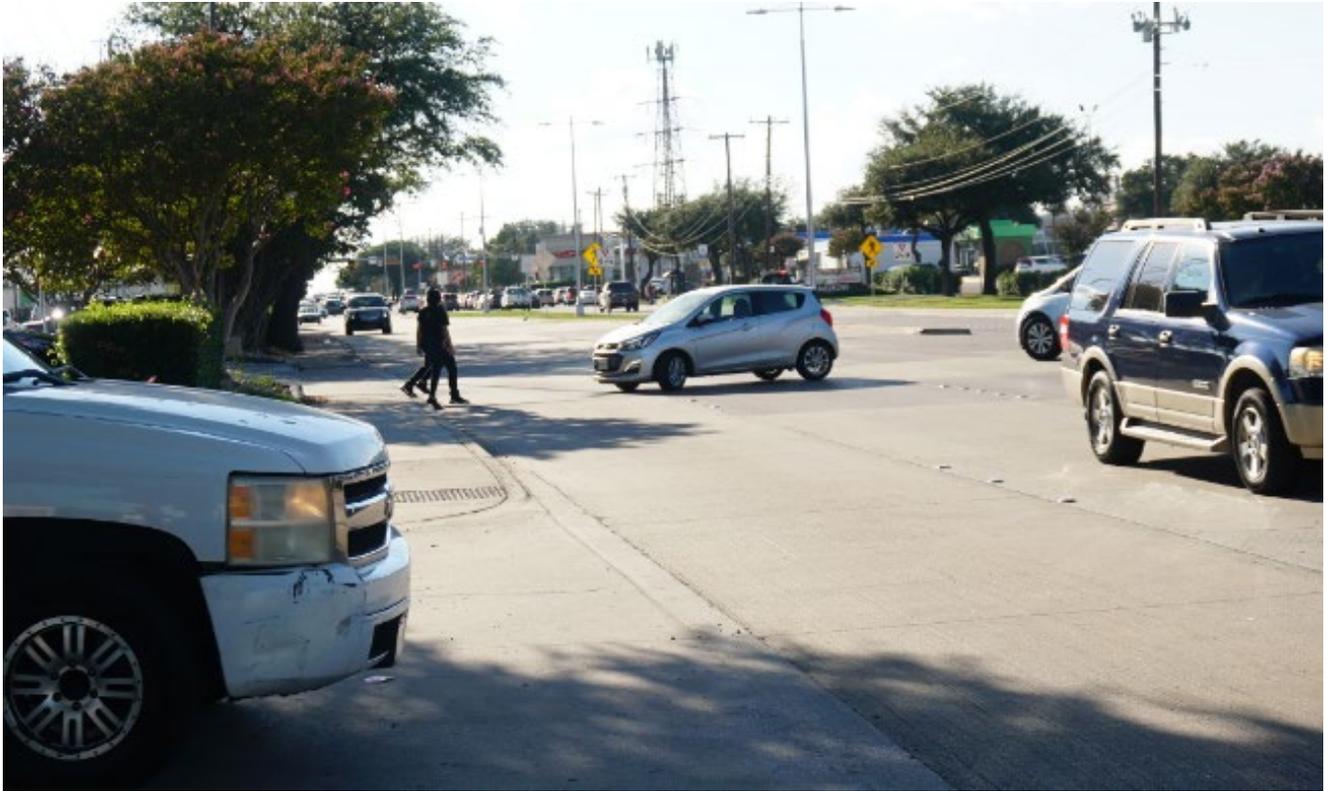
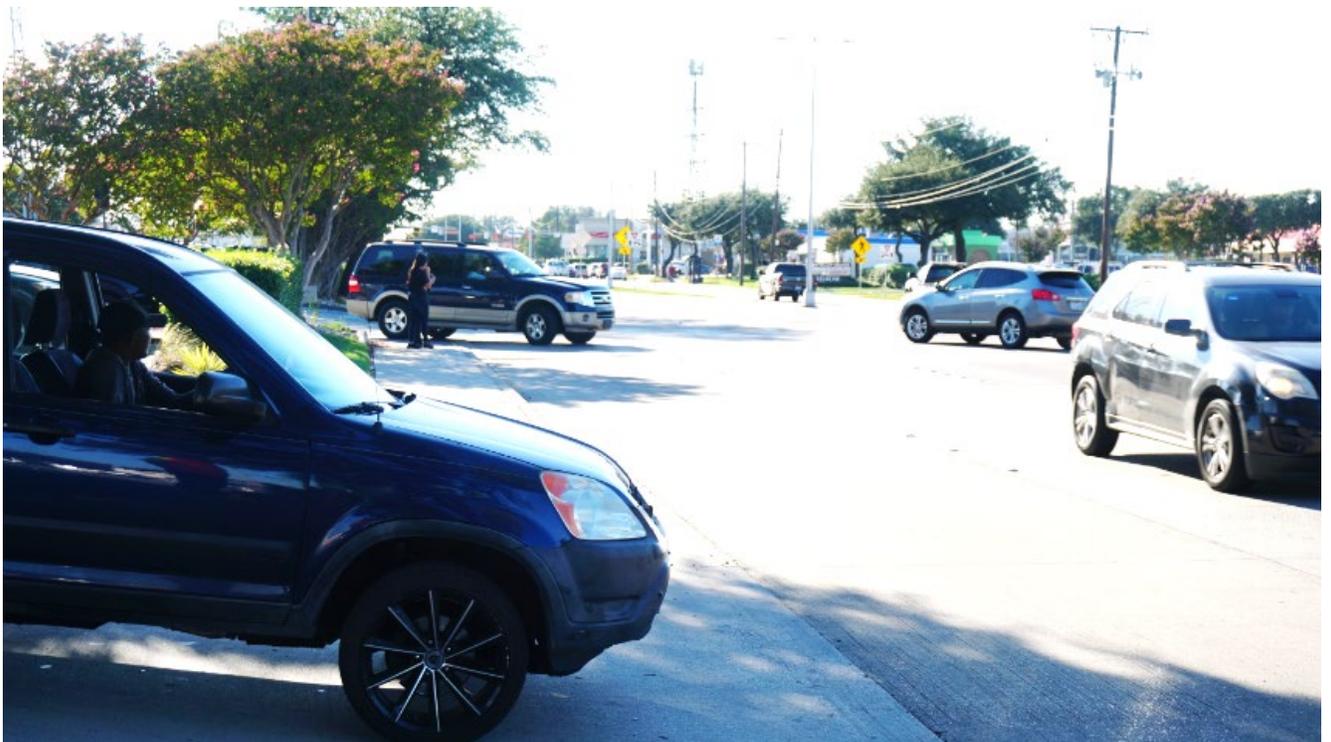
- **Observation:** Significant conflicts were observed at the driveway of Fiesta/Regency Drive. Conflicts were observed between pedestrians, bicyclists, drivers making left-turns into Fiesta, drivers making left-turns from Regency onto eastbound Spring Valley, and drivers making right-turns onto eastbound Spring Valley. Conflicts were especially prevalent during peak periods, particularly PM peak.

Figure 14: Conflicts at Fiesta/Regency Drive

Figure 15: Conflicts at Fiesta/Regency Drive

Recommendation: Consider driveway configuration changes (limit left turns or close driveway), consolidating midblock crosswalks with Pedestrian Hybrid Beacon (PHB), or consider signal if warrants are met. Timeline: Medium- to long-term.

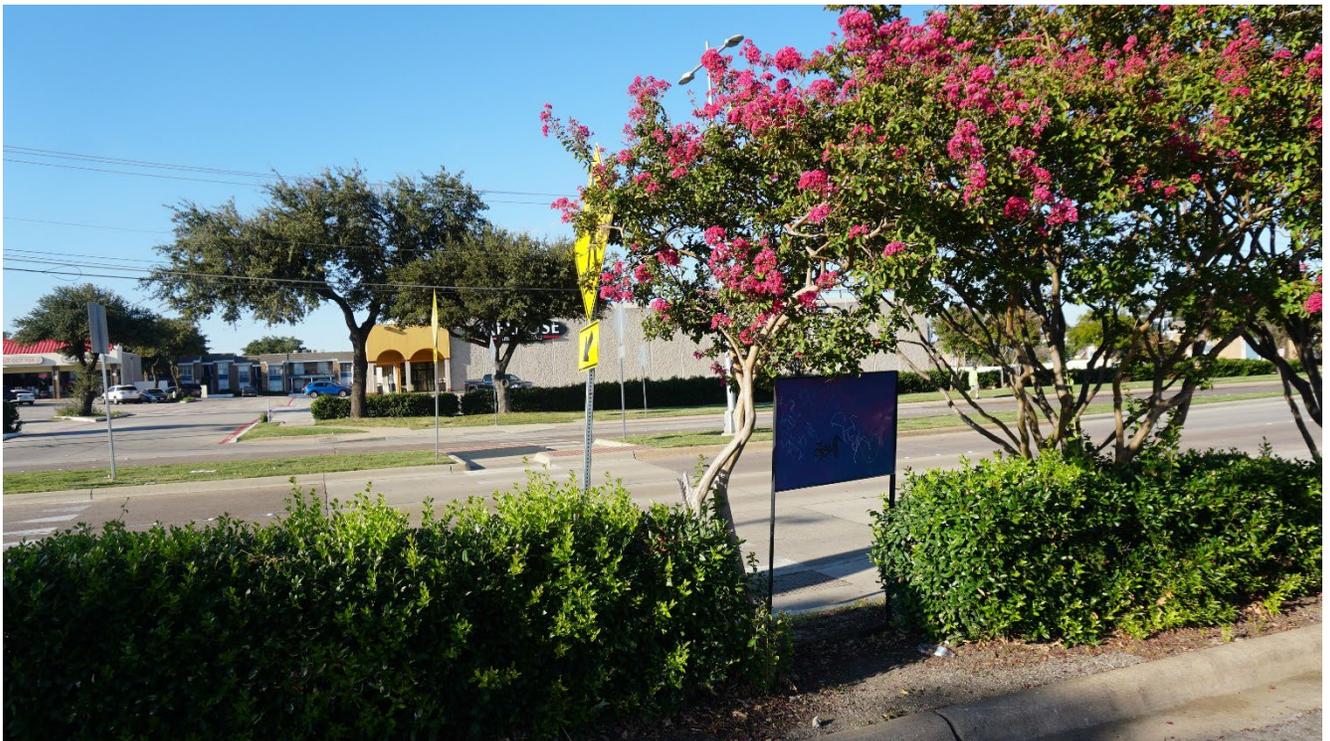
- **Observation:** There is a need for improved pedestrian connections between sidewalk facilities and the commercial developments. Pedestrian and bicyclists who travel to the commercial buildings using the sidewalk have no way of entering the parking lots except by using the vehicular driveways, which creates conflicts. The RSA Team observed this throughout the corridor but it was especially prevalent in this location.

Figure 16: Pedestrian path from western midblock crosswalk/sidewalk into Fiesta is blocked

Figure 16 shows the western midblock crosswalk into Fiesta as blocked by sign and shrubs. The RSA Team interview with Fiesta indicated that they were unsure of the reason for the blockage. **Recommendation:** The City should coordinate with businesses to improve connections to the sidewalks. Timeline: Medium-term.

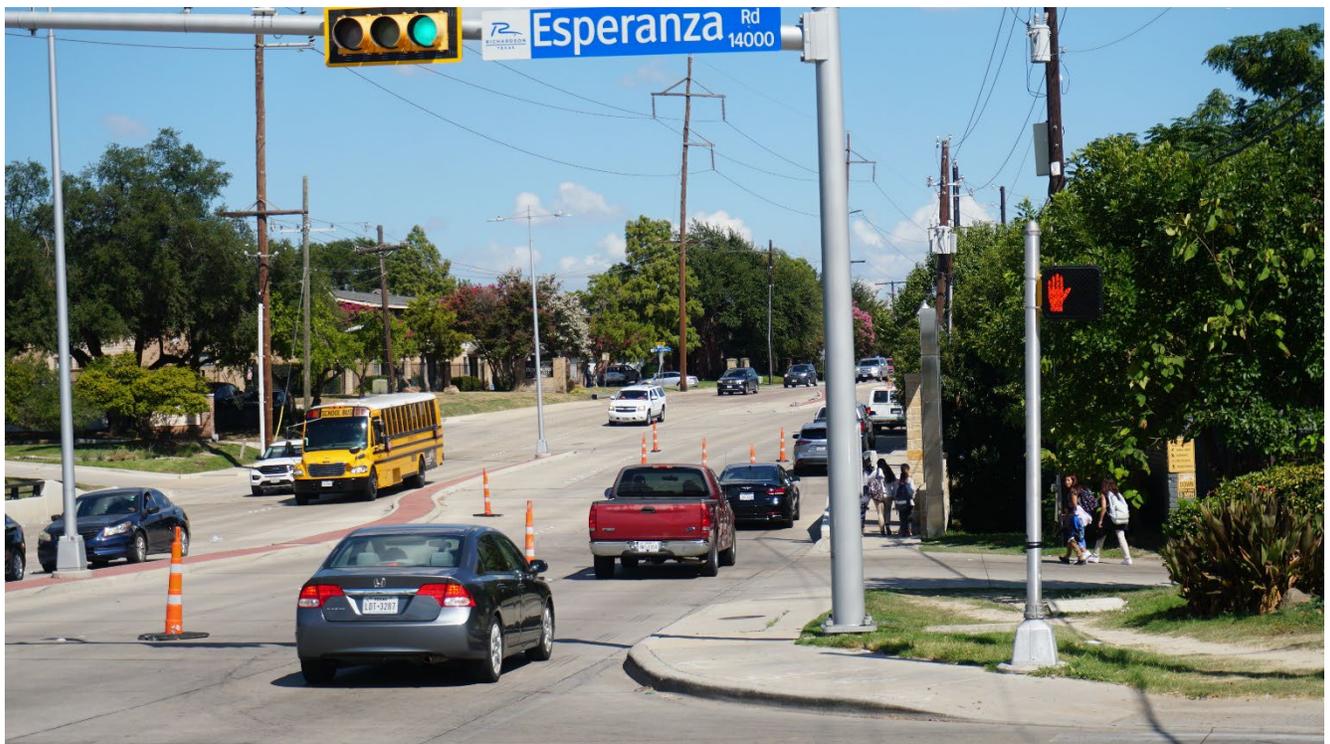
- **Observation:** Marked crosswalks were not provided for all movements. The east side of the intersection had no marked crosswalk, and the RSA Team observed people crossing in this location. Pedestrians, especially in a city near a school, have a reasonable expectation for traditional intersections with marked crosswalks across all legs. Removing a crosswalk because of vehicle conflicts should be the last resort that has been unable to be corrected through other countermeasures. **Recommendation:** Install marked crosswalk with associated ramps, pedestrian signal heads, and pushbuttons. Timeline: Medium-term.
- **Observation:** Traffic circulation around Carolyn Bukhair Elementary could be improved. Most students chose to walk through apartment parking lot instead of using the sidewalk along Esperanza Road.

Figure 17: Walking path of students to Spring Valley Road

Cottonwood Creek Trail junction. City of Dallas school flashers were not operational. **Recommendation:** Consider coordinating with City of Dallas on school traffic circulation, including school flashers and possible marked crosswalk on the north side of the school property. Timeline: Short- to medium-term.

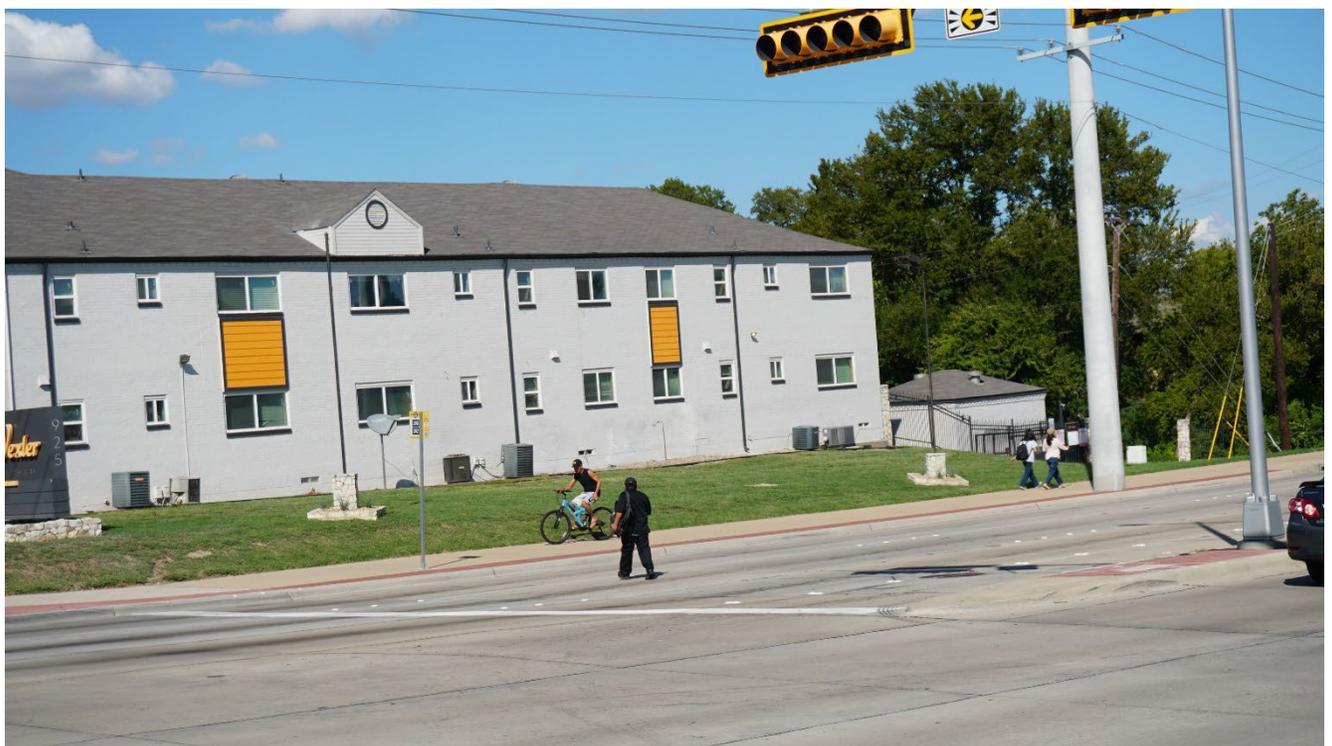
- **Observation:** Marked crosswalks were not provided for all movements. The east side of the intersection had no marked crosswalk, and the RSA Team observed people crossing in this location, particularly those traveling to eastbound and westbound bus stops.

Figure 18: Desired marked crosswalk location

Recommendation: Install marked crosswalk with associated ramps, pedestrian signal heads, and pushbuttons. Timeline: Medium-term.

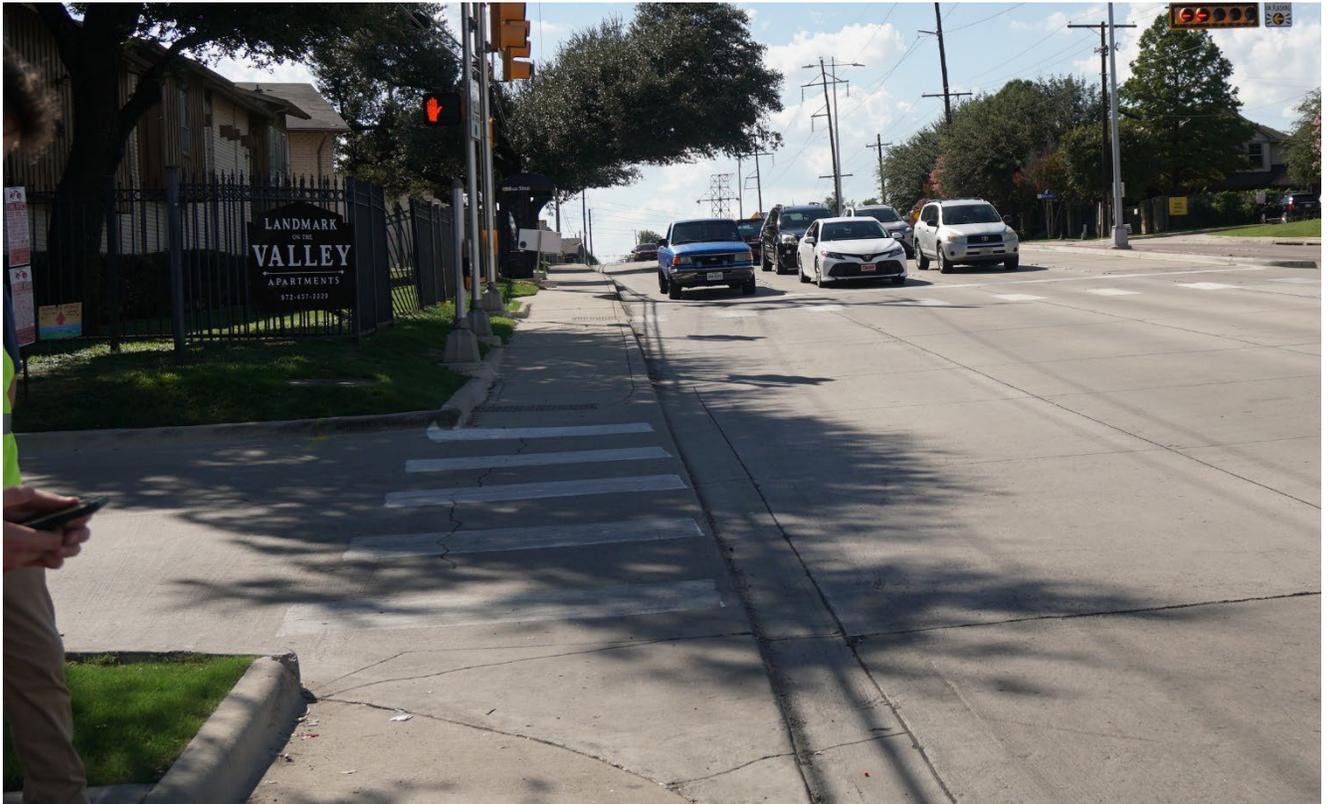
- **Observation:** The south leg of intersection (across apartment driveway) is short and few pedestrians were observed waiting for a WALK indication.

Figure 19: Pedestrian signal head across driveway rests in DON'T WALK indication

Recommendation: This location resembles a driveway yet has a pedestrian signal head that rests in DON'T WALK indication and would benefit from pedestrian recall. Timeline: Short-term.

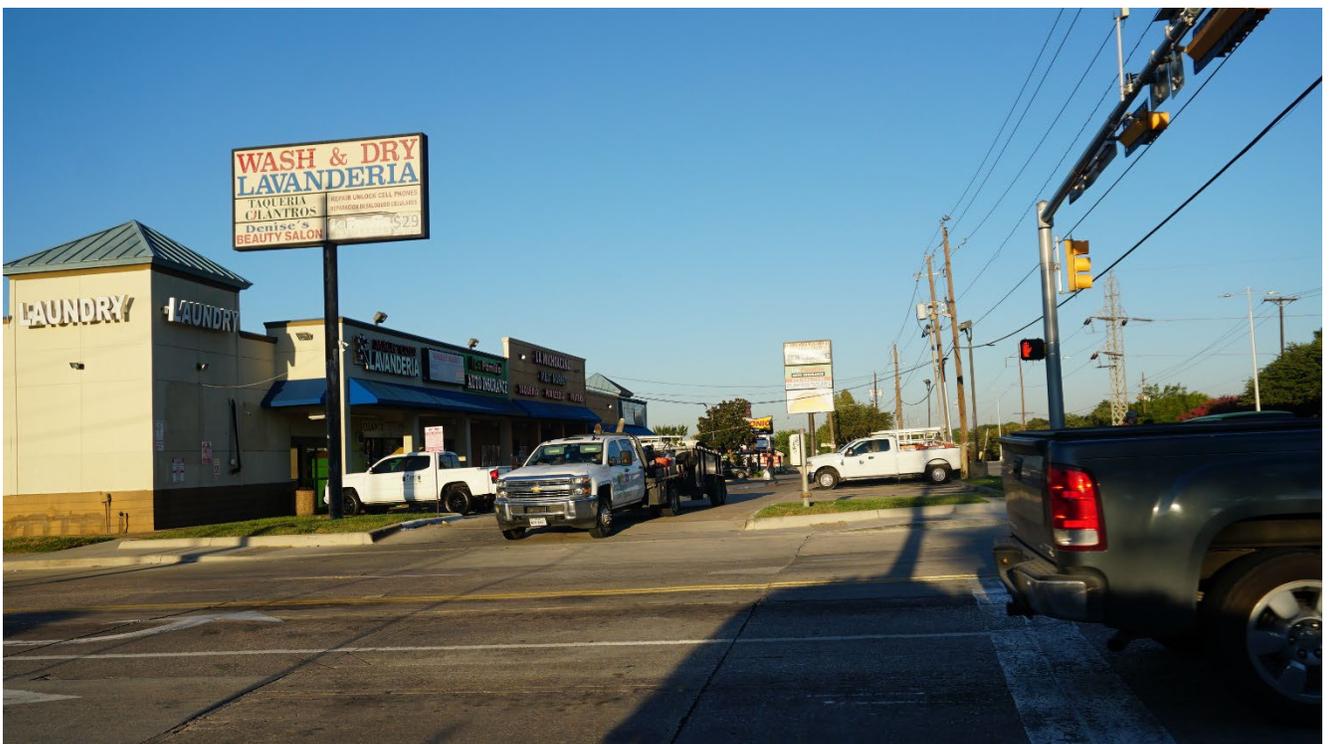
- **Observation:** There is a dual left-turn lane for the movement for westbound Spring Valley Road to southbound Goldmark Drive. The dual left-turn seemed unnecessary during the various times of our field reviews. Large trucks tended to use both lanes, which caused conflicts. **Recommendation:** Consider reconfiguring lane assignments to remove the dual left-turn. If the dual left-turn is still warranted, consider adding an Intersection Lane Control sign. Timeline: Short-term.
- **Observation:** The RSA Team observed multiple conflicts of drivers entering and exiting the commercial development on the southwest quadrant of the intersection onto Goldmark Drive.

Figure 20: Conflicts at Goldmark Drive

Recommendation: Consider coordinating with the City of Dallas to work with the commercial development to potentially close the driveway. Timeline: Medium-term.

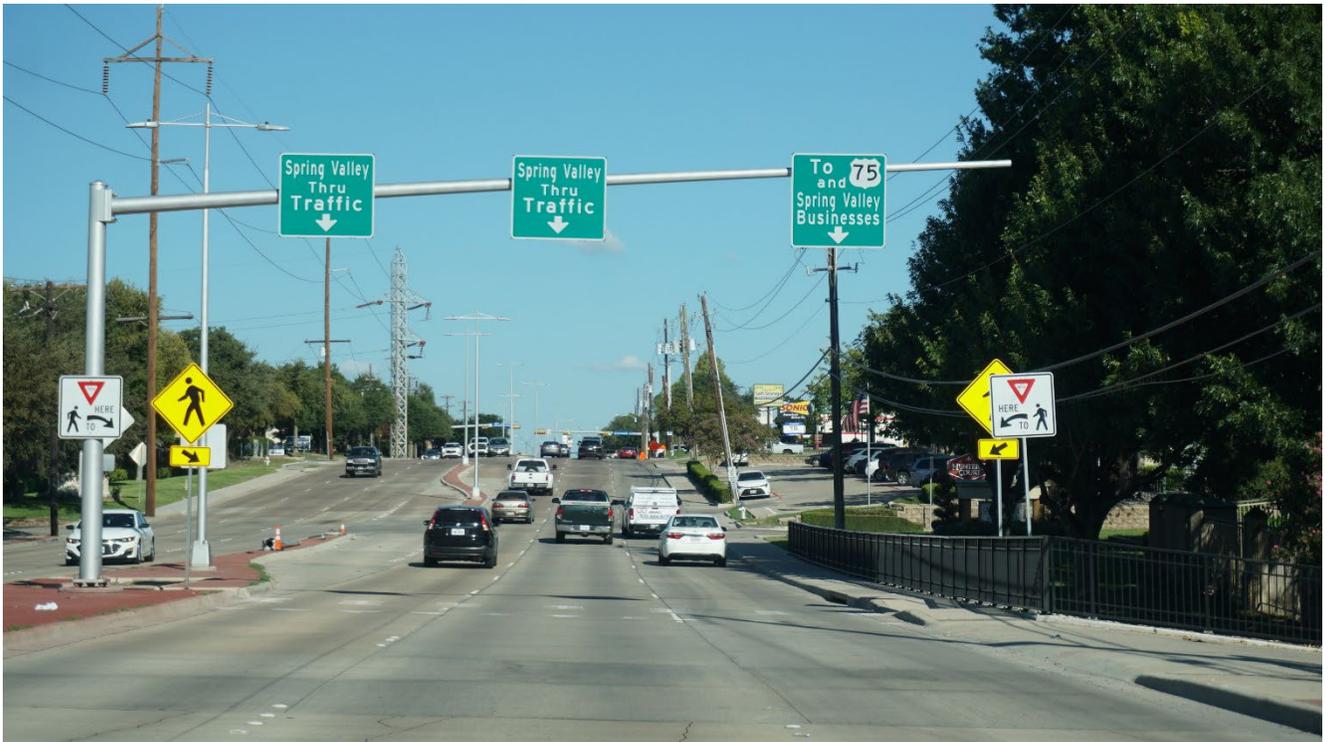
- **Observation:** The tunnel overhead approach signage is outdated, with smaller typeface. The RSA Team observed some last-moment weaving maneuvers that suggest more clear and understandable wording may be needed, and/or location adjustments may be helpful.

Figure 21: Eastbound overhead sign structure

Recommendation: Redesign tunnel approach signs to current freeway guide signing principles. In all of the overhead signs, there were individual signs for each lane; consolidation of the legend and lane arrows could accommodate larger typeface and would allow for less pieces of information for drivers to read and comprehend. Signage lighting should be considered since nighttime visibility was a challenge. The location of the first eastbound overhead sign structure might be reconsidered as it competes with the nearby midblock crosswalk for

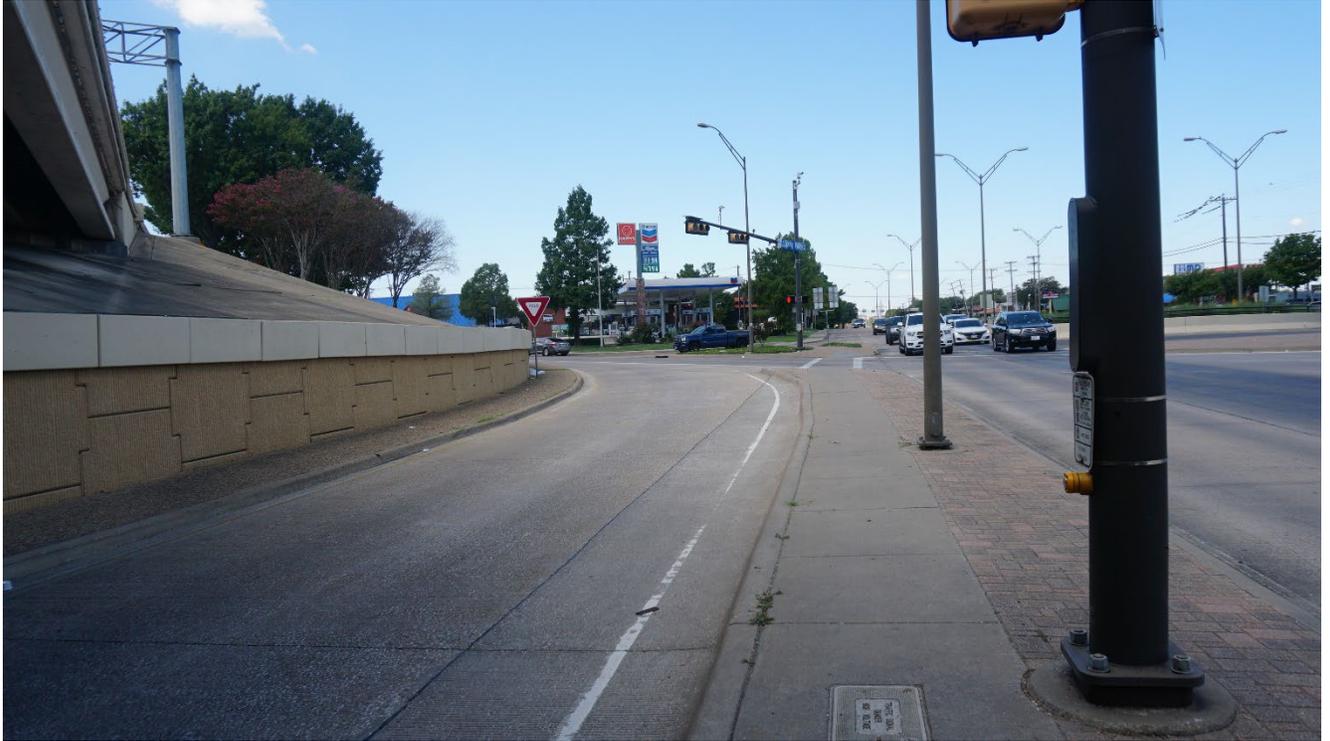
- **Observation:** The RSA Team observed several pedestrian accessibility issues. Pedestrian head locations were not in direct view when crossing Spring Valley. Two pushbuttons locations were located very far away from the curb ramps. Errant rebar was observed protruding from a curb on the northeast side of the intersection. There were misaligned crosswalks crossing Spring Valley Road. Some pedestrian signal heads were missing some LED bulbs.

Figure 22: Some pushbuttons located far from curb ramps

Recommendation: The City should improve pedestrian accessibility in this location by relocating pedestrian signal heads and pushbuttons, removing obstructions, and straightening crosswalks. Timeline: Short-term for rebar issue. Medium- to long-term for all others.

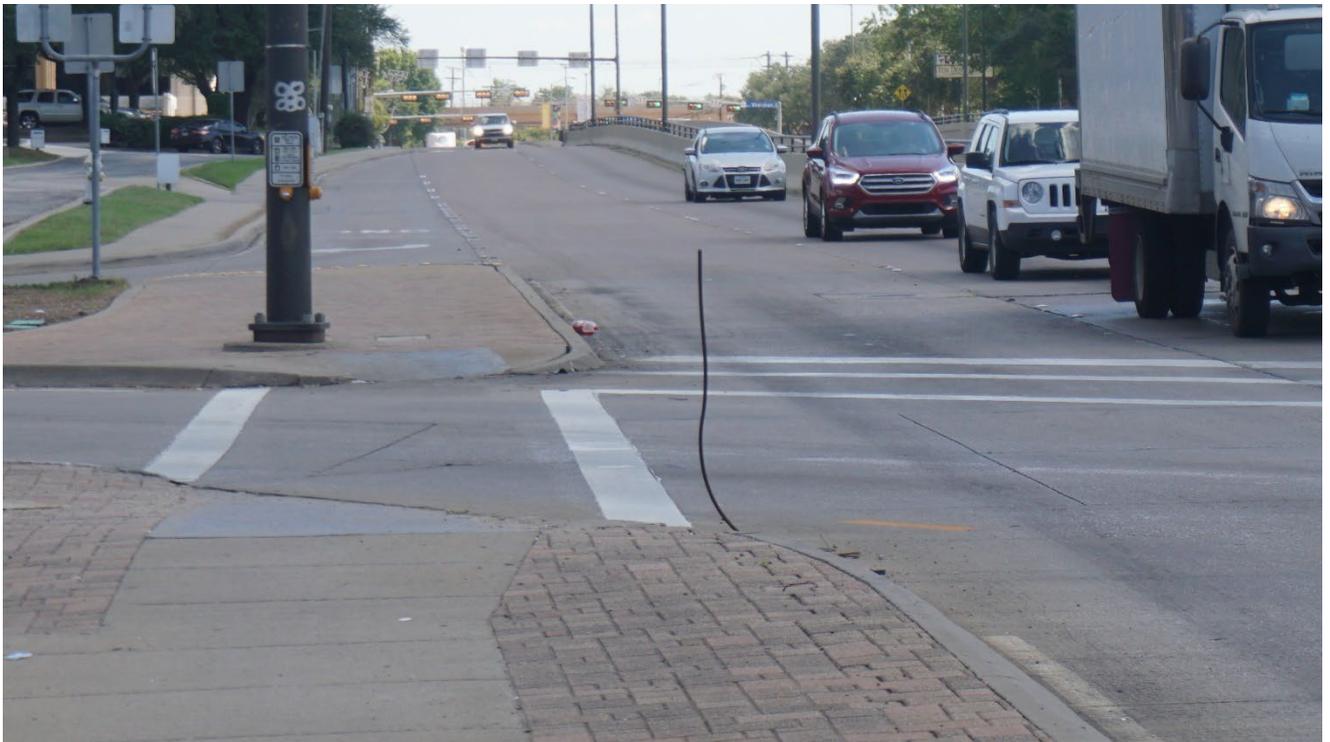
Figure 23: Rebar obstruction on sidewalk/curb

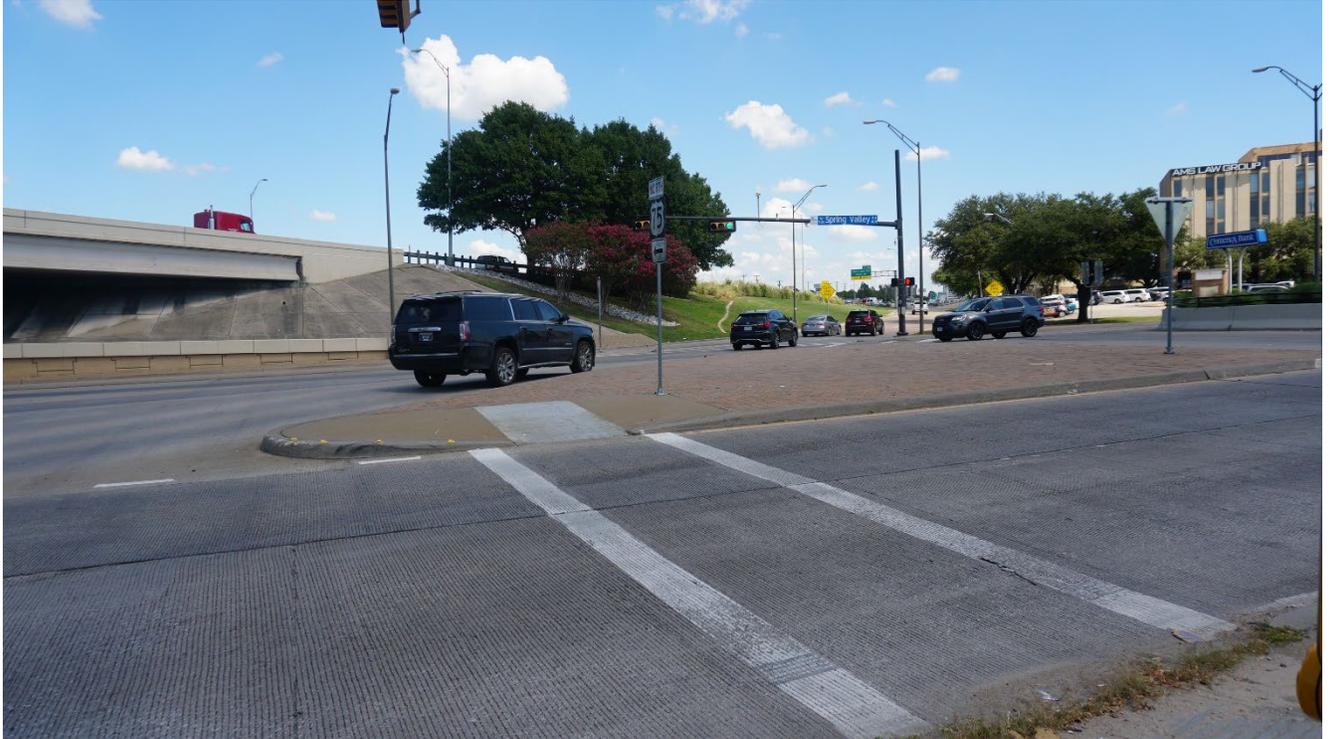
Figure 24: Crosswalks were misaligned across Spring Valley Road

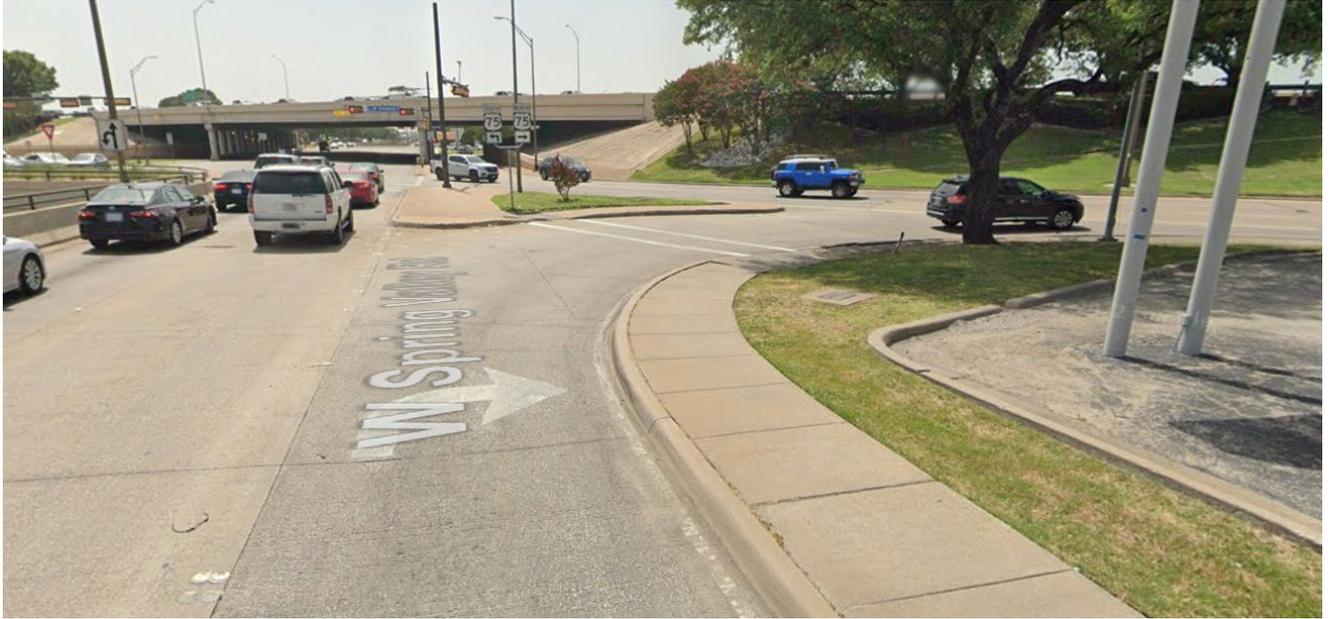
- **Observation:** At northeast and southwest corners, drivers turning right into the frontage road dedicated lanes turned at high speeds. Due to the high speeds and longer crossing length in these locations, the RSA Team observed pedestrians having difficulties in crossing. **Recommendation:** The City should consider raised crosswalks at these locations to slow turning vehicles. Raised crosswalks of even 2 to 3 inches in these locations could help control speed of turning movements and emphasizes the need to yield to people walking. Raised crosswalks have been successfully used in several locations in Austin, and are becoming a more regular treatment for speed management and pedestrian safety across the US

Figure 25: Design of northeast corner allows for high speed turns with reduced yielding to pedestrians
