Road Safety Audit W Spring Valley Road Richardson, TX

NOVEMBER 23, 2022

Facilitated by: Amelia (Millie) Hayes, P.E., PTOE, RSP₂₁
FHWA Texas Division

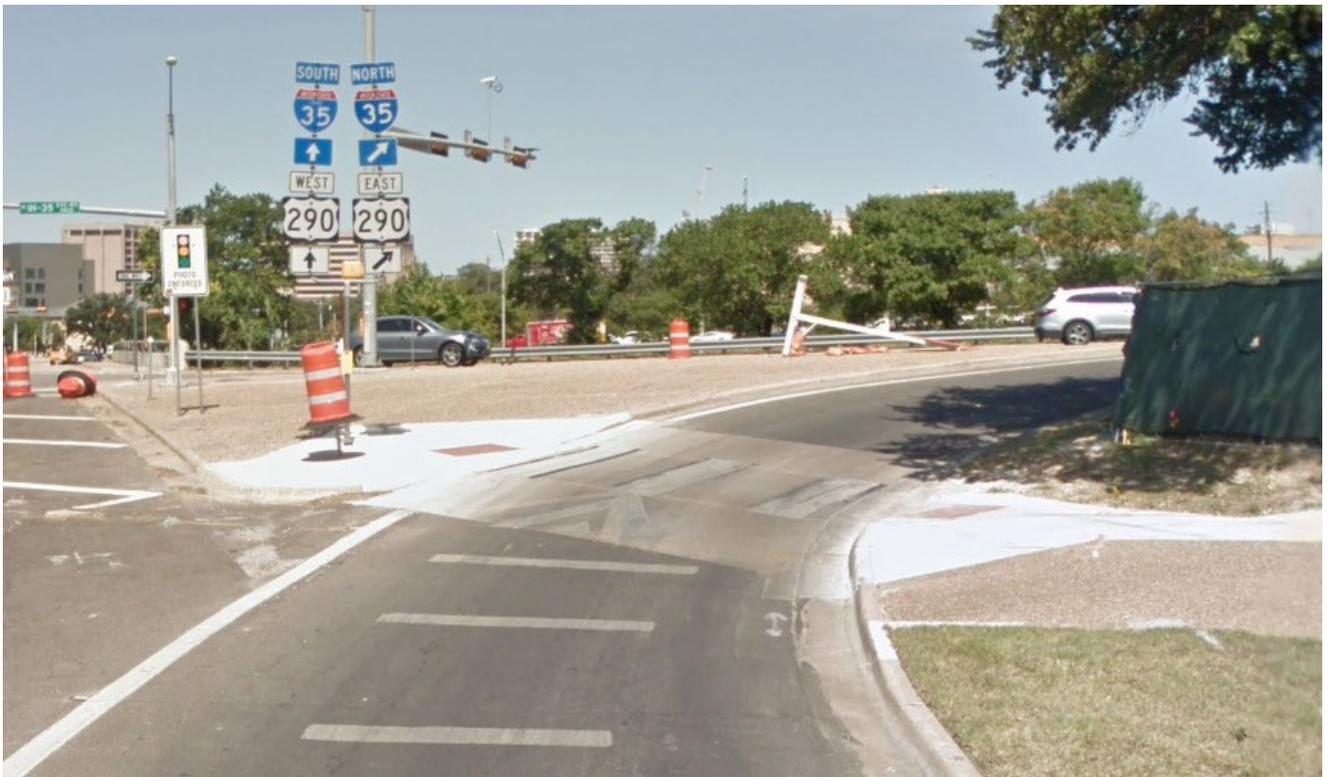
Figure 26: Example of a raised crosswalk on a turn lane joining an Interstate frontage road in Austin, TX ([Google StreetView](#))

During future improvement projects, the City could also consider [TxDOT's new standard](#) for right turn islands, which tightens the right turn and provides improved visibility for crossing pedestrians. The new standard also features

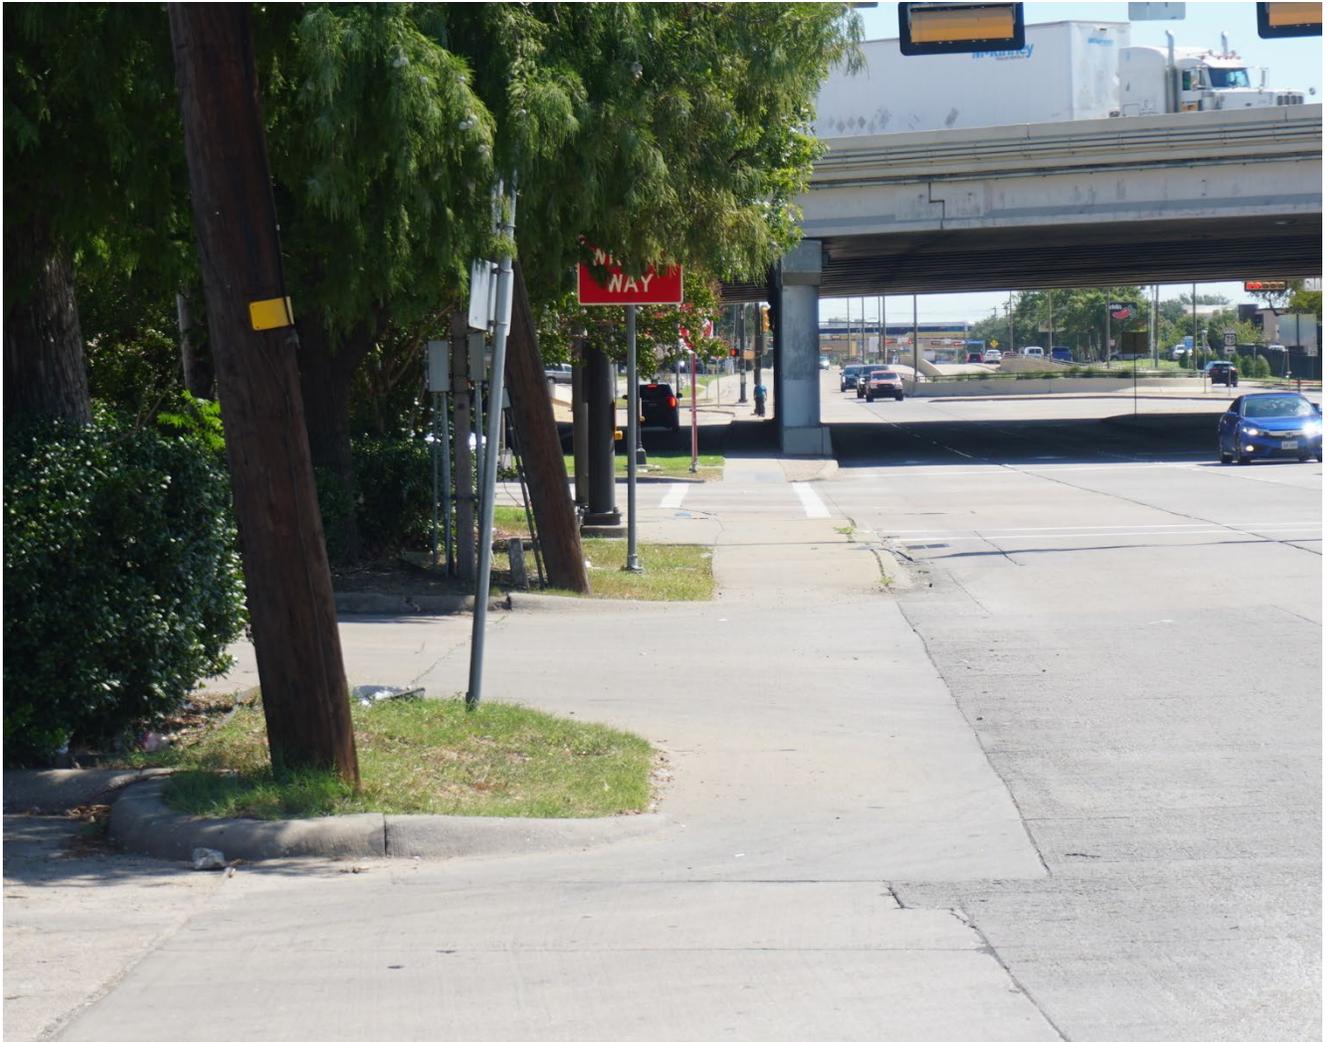
- **Observation:** Sidewalks around several driveways were missing or ambiguous for extended segments.

Figure 28: Missing or ambiguous sidewalk

Recommendation: Sidewalks should be a minimum of six feet wide if directly behind back-of-curb, free of obstructions, and include a curb separation. As discussed in the General Recommendations above, sidewalks across driveways should be designed to encourage driver yielding to pedestrians. Timeline: Medium-term.

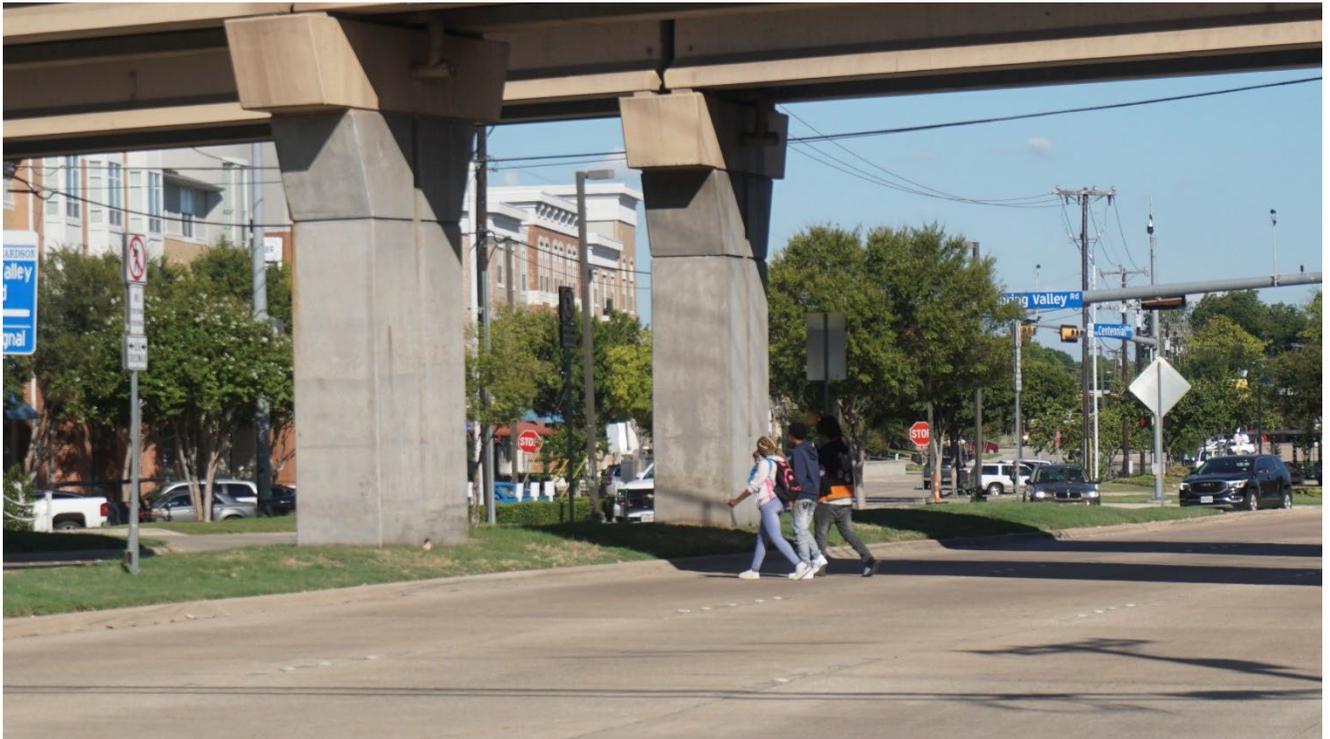
- **Observation:** As discussed in the Primary Concerns section, marked crosswalks were not located in the desired paths of the pedestrian movements. Pedestrians were naturally taking certain paths between origin and destination, and the crosswalks were not within those paths.

Figure 29: Some marked crosswalks were not within natural or expected paths

In Figure 29, the pedestrians are crossing where the northbound Central Trail had just ended. The RSA Team observed most trail users crossing at that location, and the fencing in place did not appear to be an adequate deterrent. Additionally, signs to route trail users across Spring Valley Road are ambiguous. Central Trail maps show Business Parkway to be the preferred routing. The RSA

Recommendation: Clarify trail continuity and routing. To the maximum extent possible, the preferred routing should continue to have pavement width and markings similar to the trail to feel cohesive to the users. The preferred routing should be clearly indicated on guide signs, whether Business Parkway on the east side or Lingco Drive on the west side. The City should remove the PEDESTRIANS AND BICYCLES PROHIBITED signs on both the north and south sides of Spring Valley Drive, and should keep and maintain the median signs currently in place. The City should also consider adding fencing to the median to further reduce midblock crossings in this location.

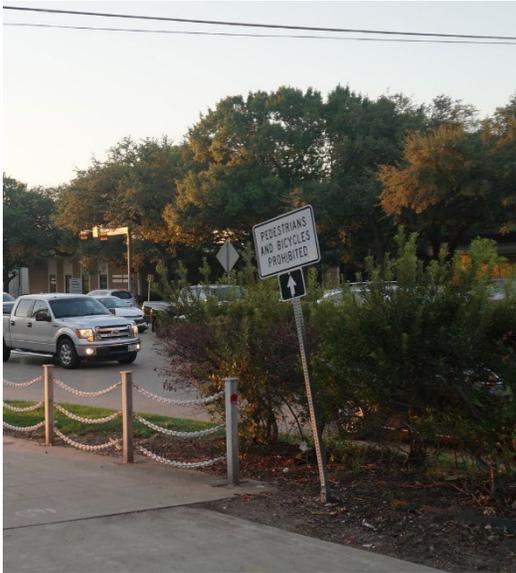
Figure 30: Prohibited movement sign

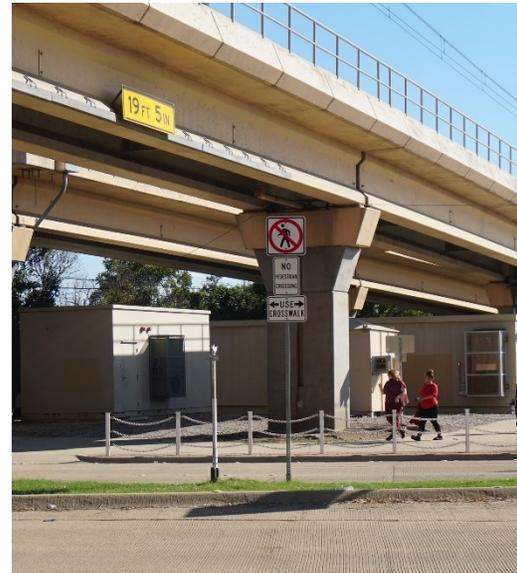
Figure 31: Signs do not indicate preferred routing
