Illicit Discharge Detection and Elimination Roundtable

IDDE Source Tracking

CITY OF DALLAS – LOVE FIELD AIRPORT

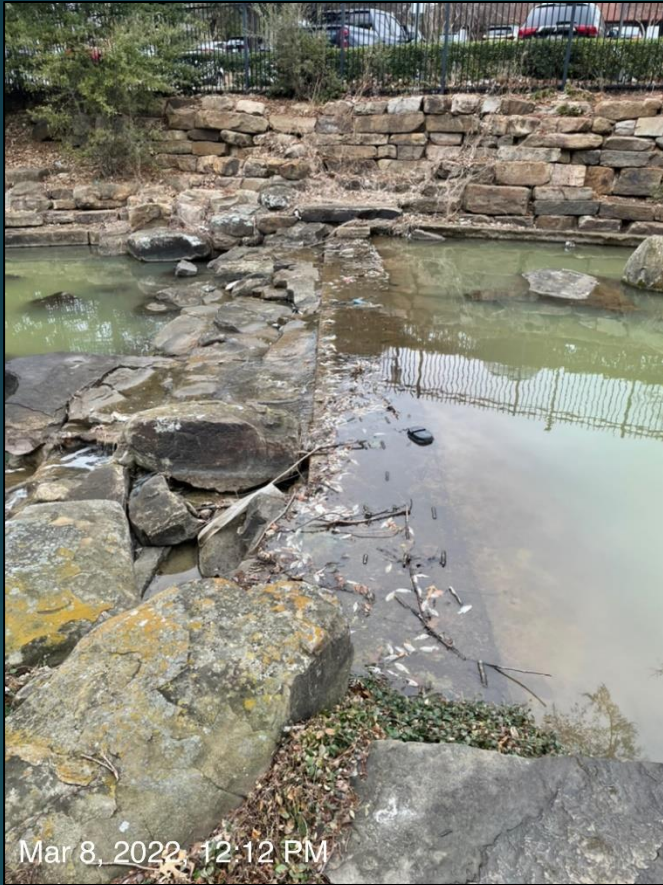
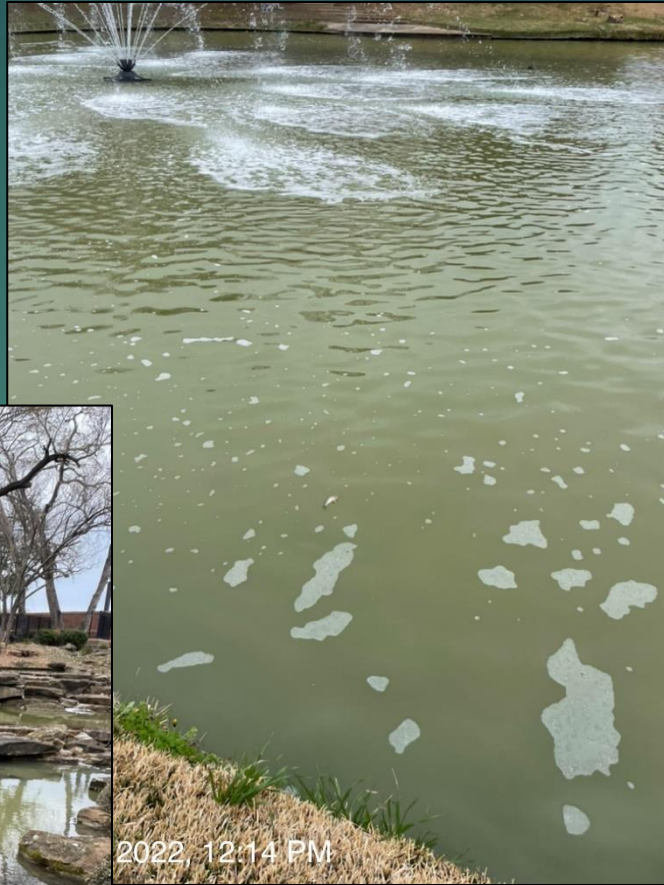
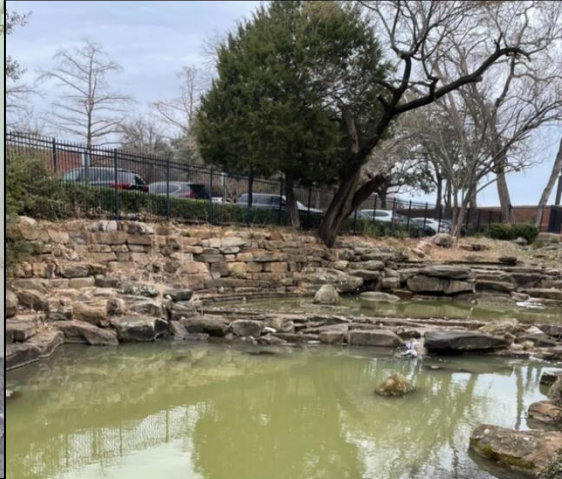
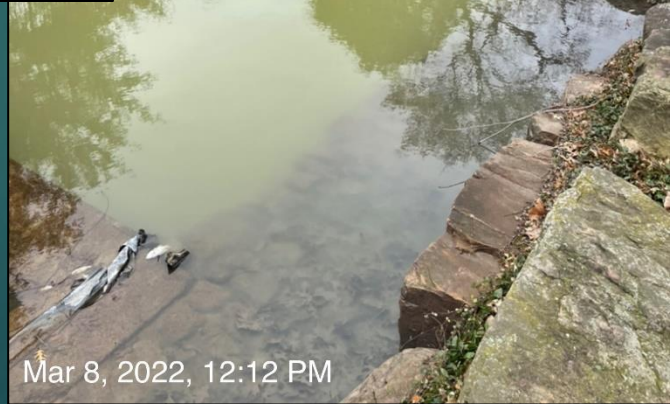
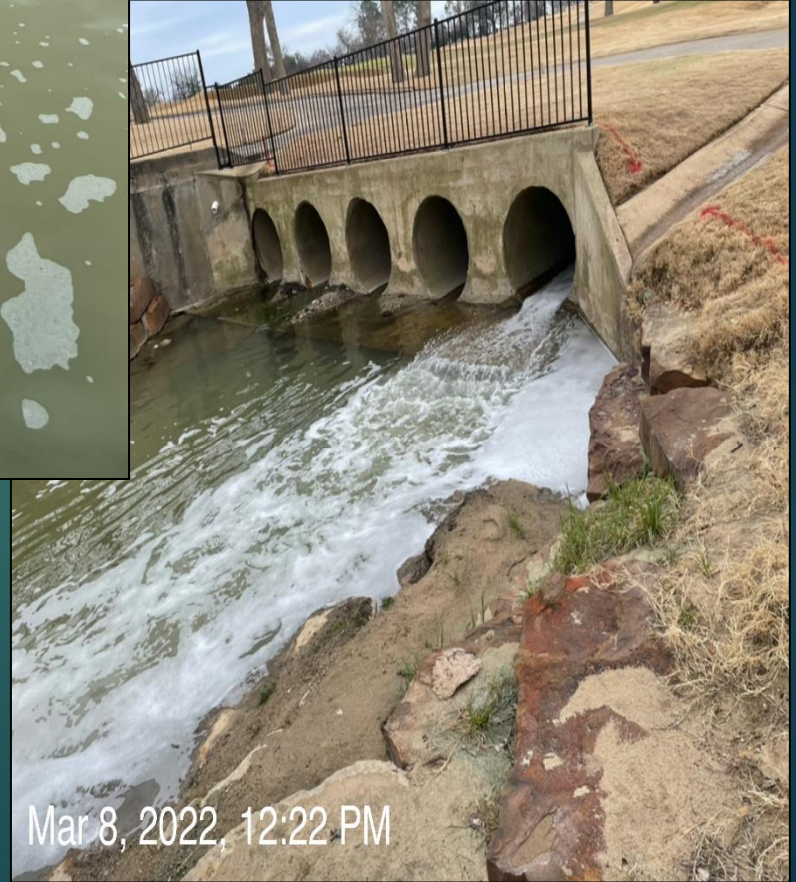
Initial Observations

- ▶ The creek channel and pond area near 1600 Viceroy Dr was inspected after arrival. DWU – SWO staff observed 1000+ dead fish (mostly sun fish) along a couple of check dams in the channel.
- ▶ The water in the creek was murky and greenish colored. There was a very distinguishable odor throughout the creek. The odor was likened to vinegar, tomatoes and even play-doh.
- ▶ The cloudy water in the creek was tracked back up into Brook Hollow Golf Course to what was believed to be a series of 5 outfalls.
- ▶ One of the “outfalls” had a heavy flow of rushing water coming from it that was sure to lead us to the source.

Mar 8, 2022, 12:22 PM

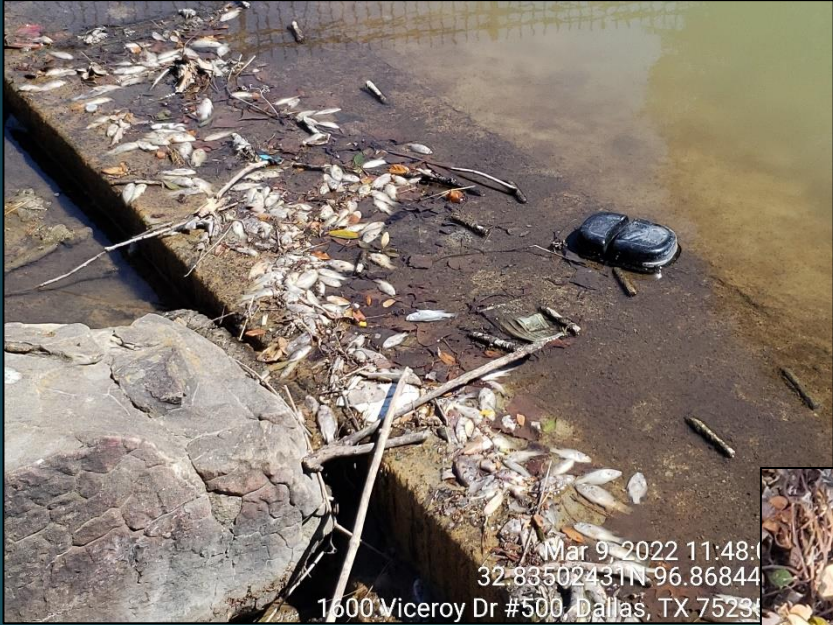
- ▶ While the original team continues tracking investigation, two other teams continue with day 2 sampling and begin fish collection and identification.
- ▶ Team 2 collects field samples from same upstream, downstream and kill site locations for tracking and reference purposes.
- ▶ Team 3 collects 2,370 dead fish, almost all of them sunfish. Most of the fish are picked up along check dams in the channel near 1600 Viceroy Dr.

Mar 9, 2022 11:48:00 AM
32.83502431N 96.868441W
1600 Viceroy Dr #500, Dallas, TX 75235, USA

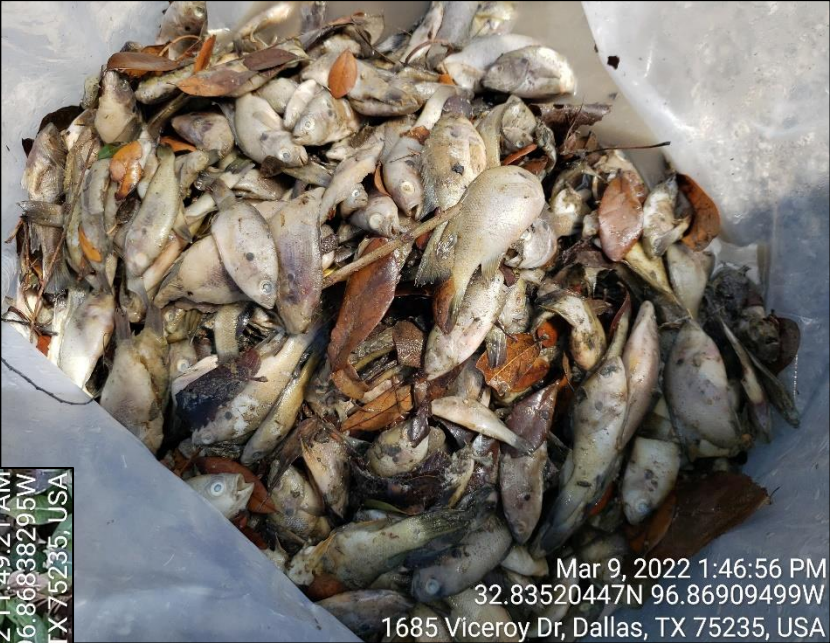
Mar 9, 2022 1:46:56 PM
32.83520447N 96.86909499W
1685 Viceroy Dr, Dallas, TX 75235, USA

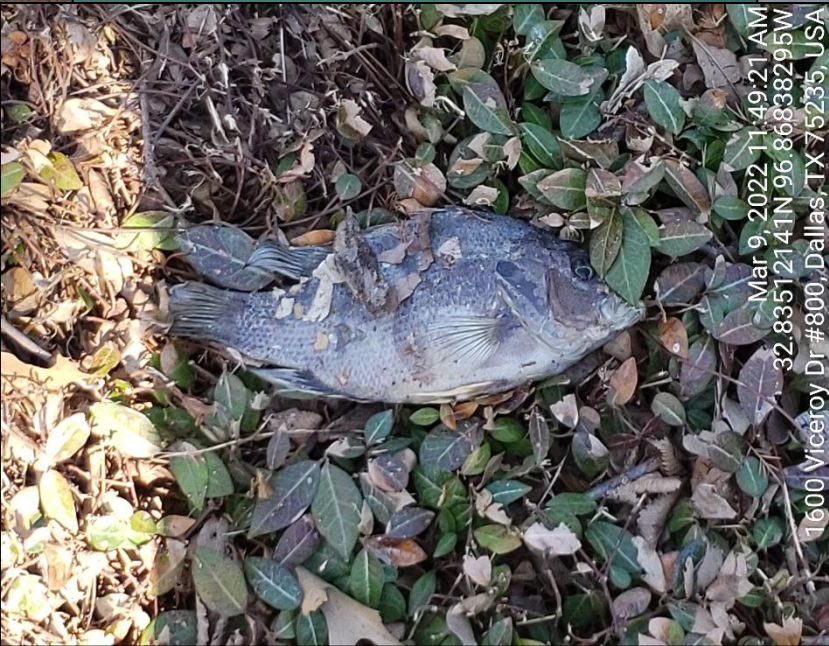
Mar 9, 2022 11:49:21 AM
32.83512141N 96.86838295W
1600 Viceroy Dr #800, Dallas, TX 75235, USA

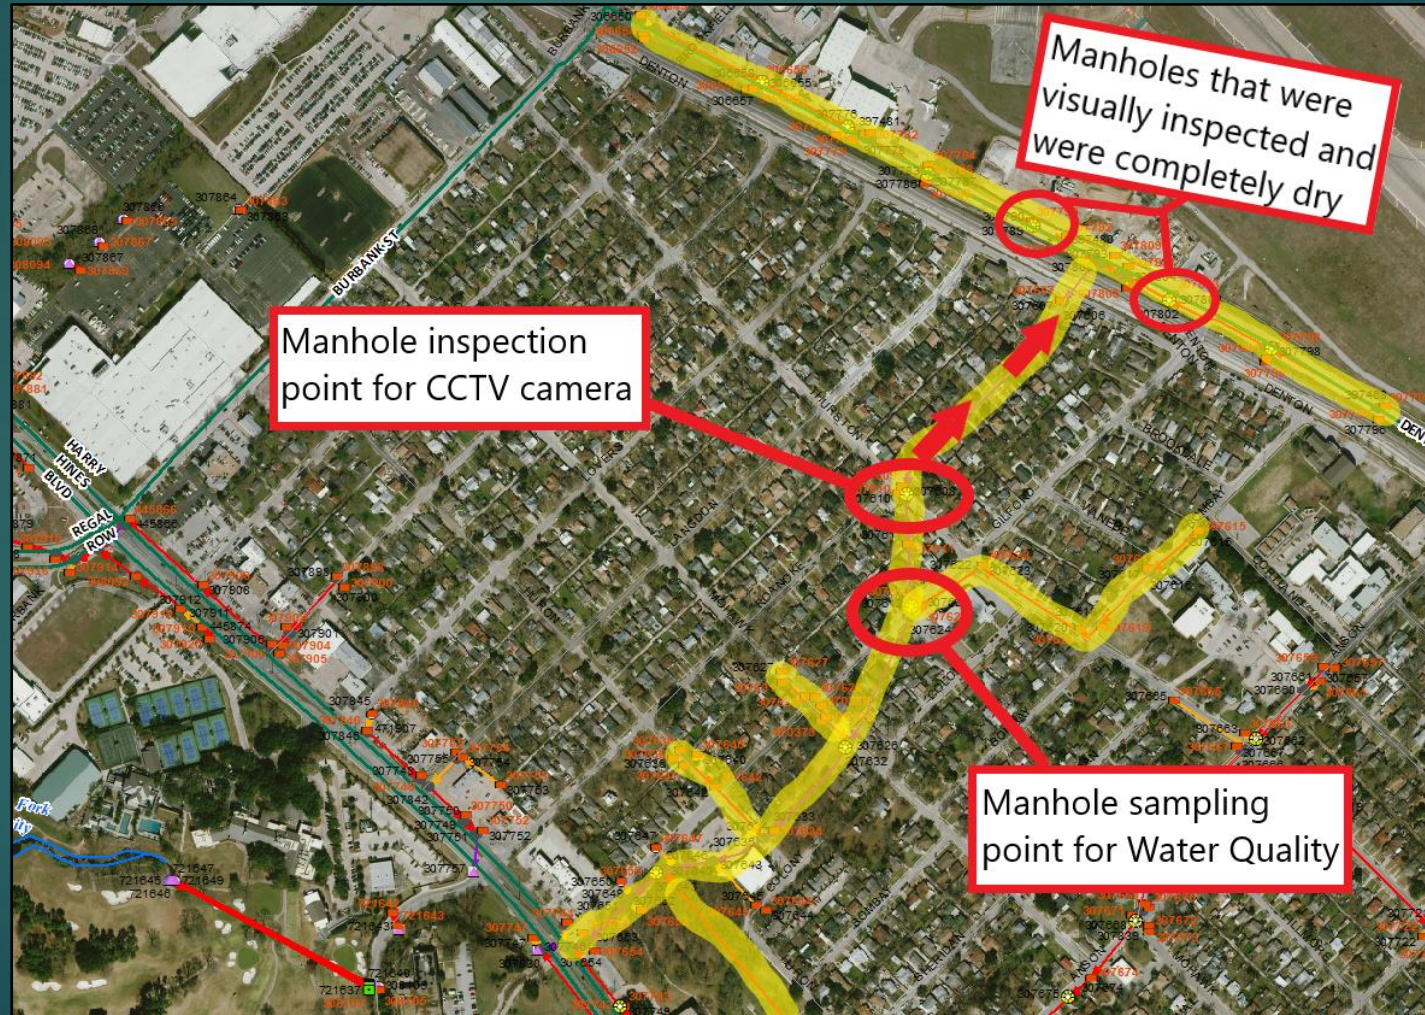
Tracking the Discharge DAY 2

- ▶ Two tie in lines along Denton Drive are visually inspected via manholes and observed to be completely dry.
- ▶ That leaves only the main line with a flow that seems to be coming from Love Field Airport.
- ▶ CCTV camera cannot reach access point from airport due to inaccessibility within the pipes.

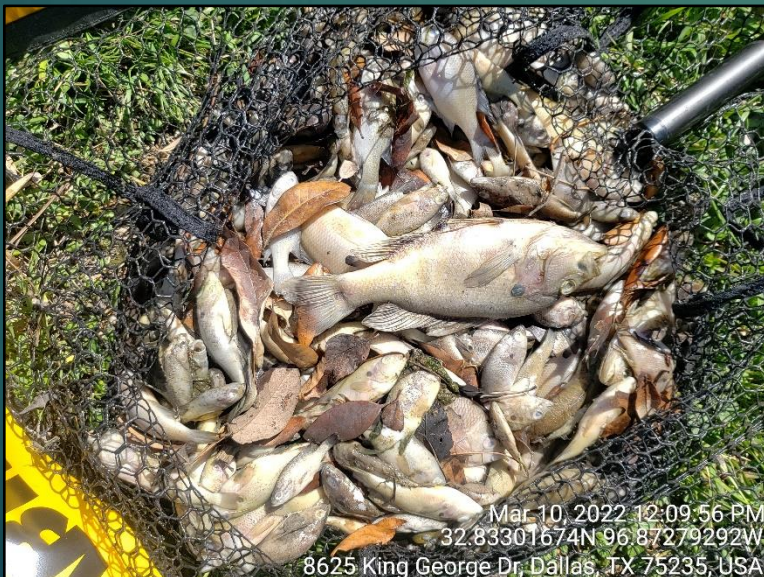
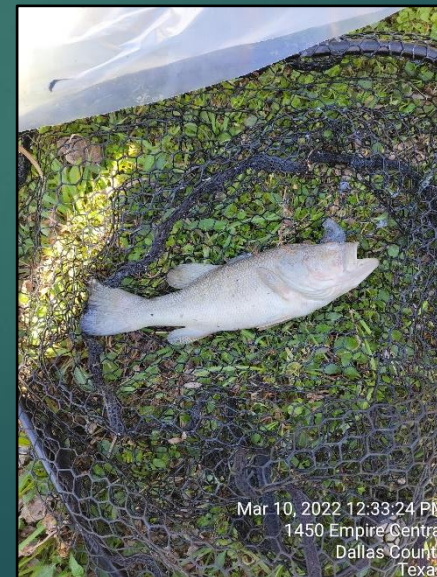
Field Sampling and Fish Collection

- ▶ Teams 2 and 3 continue day 3 field sampling from all three locations and fish collection and identification.
- ▶ Dead fish were collected from the kill site at 1600 Viceroy Dr all the way downstream to Mockingbird Ln.
- ▶ 1150 more dead fish (mostly sunfish) were collected on day 3.

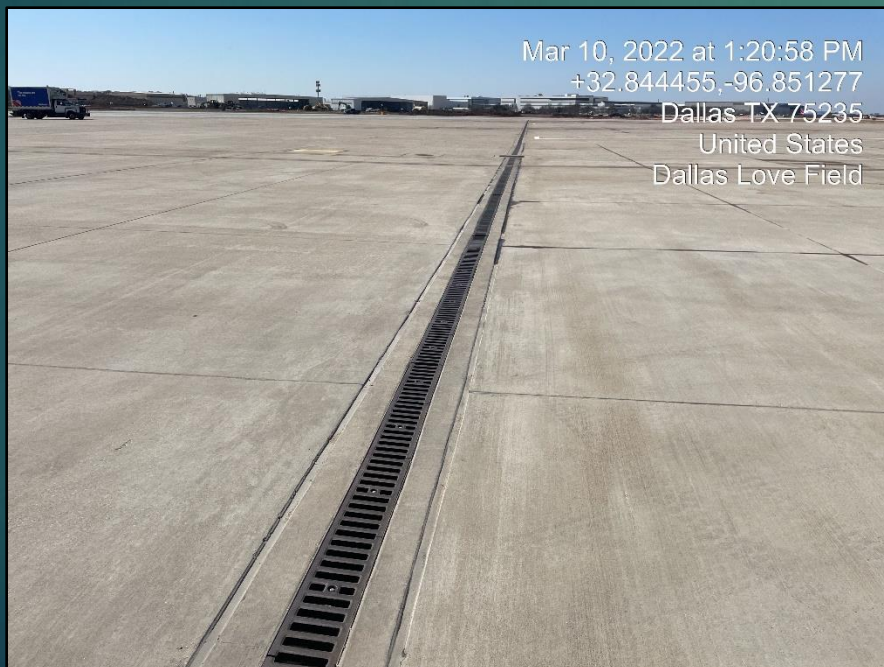
Tracking the Discharge DAY 3

- ▶ WQ Team 1 along with OEQS was escorted to the Southwest Airlines main De-icing pad and the same distinct odor that had been present throughout the creek was also present within their grate inlets.

- ▶ WQ team 2 returned to outfall 16 at love field airport to collect samples for the following parameters to be tested at a NELAP certified lab... Propylene Glycol, Propylene Acetate, TPH BTEX and E.coli.
- ▶ Test results later showed elevated levels of Propylene Glycol (chemical used in de-icing materials) for sampling performed on 3/11 and 3/28 (160 and 117 mg/L). It was noted that two rain events occurred between those two sampling dates.
- ▶ Biochemical Oxygen Demand was tested for at the outfall on 3/11 and at the kill site on 3/8 and both locations showed elevated levels of BOD which is common amongst PG degradation.

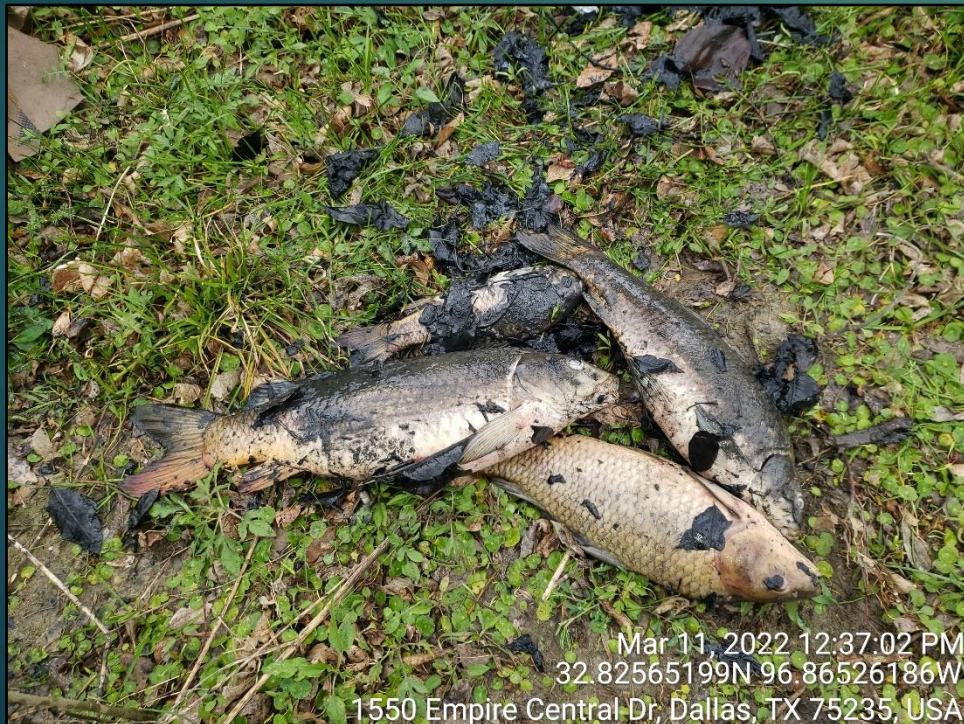
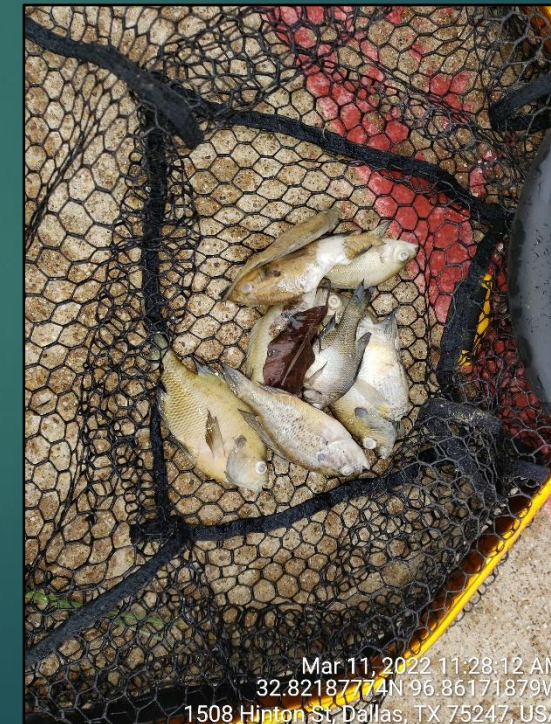
Fish Collection DAY 4

- ▶ WQ Team 3 collected 160 more dead fish most of which were sun fish.
- ▶ A total of 3,610 dead fish were collected over a three-day span.
