IDDE Source Tracking

CITY OF DALLAS – LOVE FIELD AIRPORT

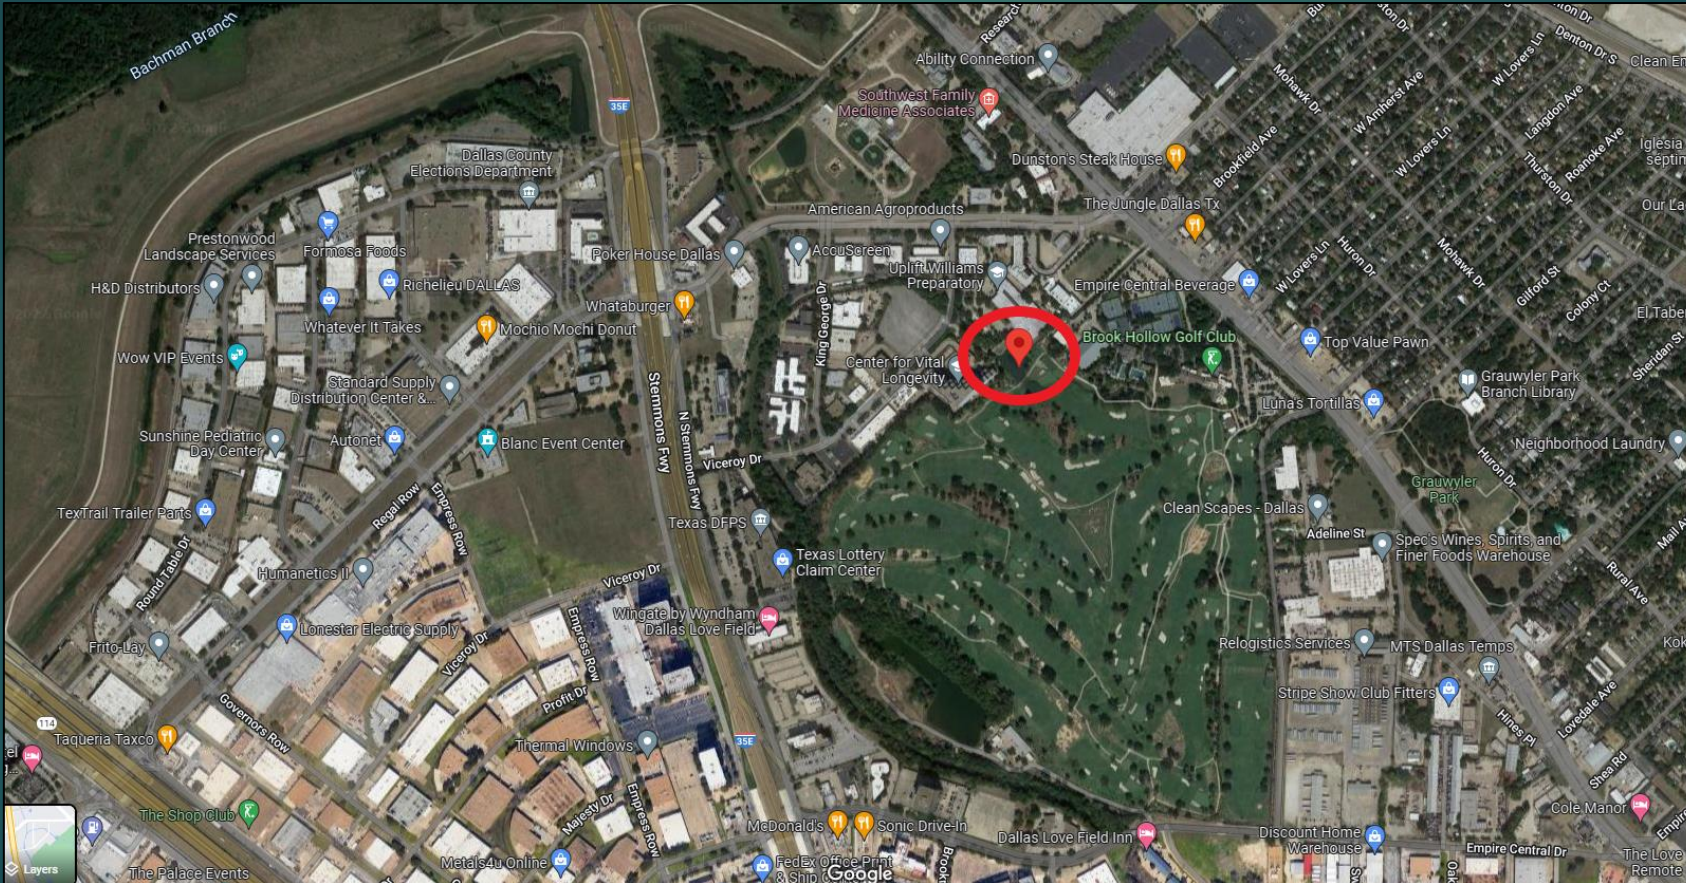
Location

This the exact location provided by TP&W. Near 1600 Viceroy Dr.

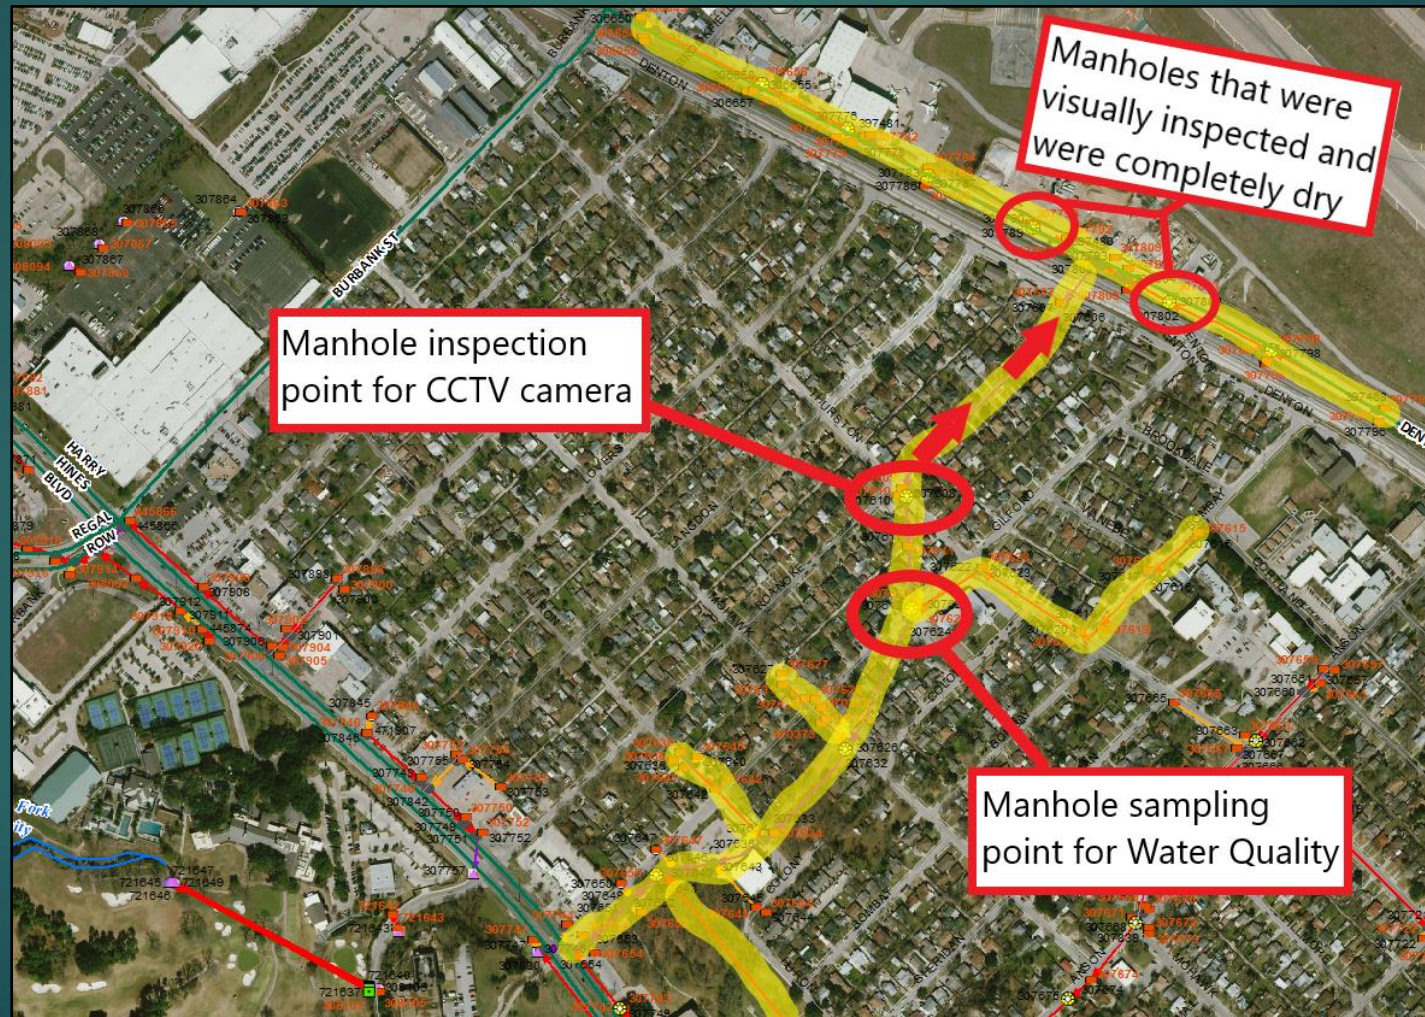
Tracking the Discharge DAY 2

- ▶ Two tie in lines along Denton Drive are visually inspected via manholes and observed to be completely dry.
- ▶ That leaves only the main line with a flow that seems to be coming from Love Field Airport.
- ▶ CCTV camera cannot reach access point from airport due to inaccessibility within the pipes.

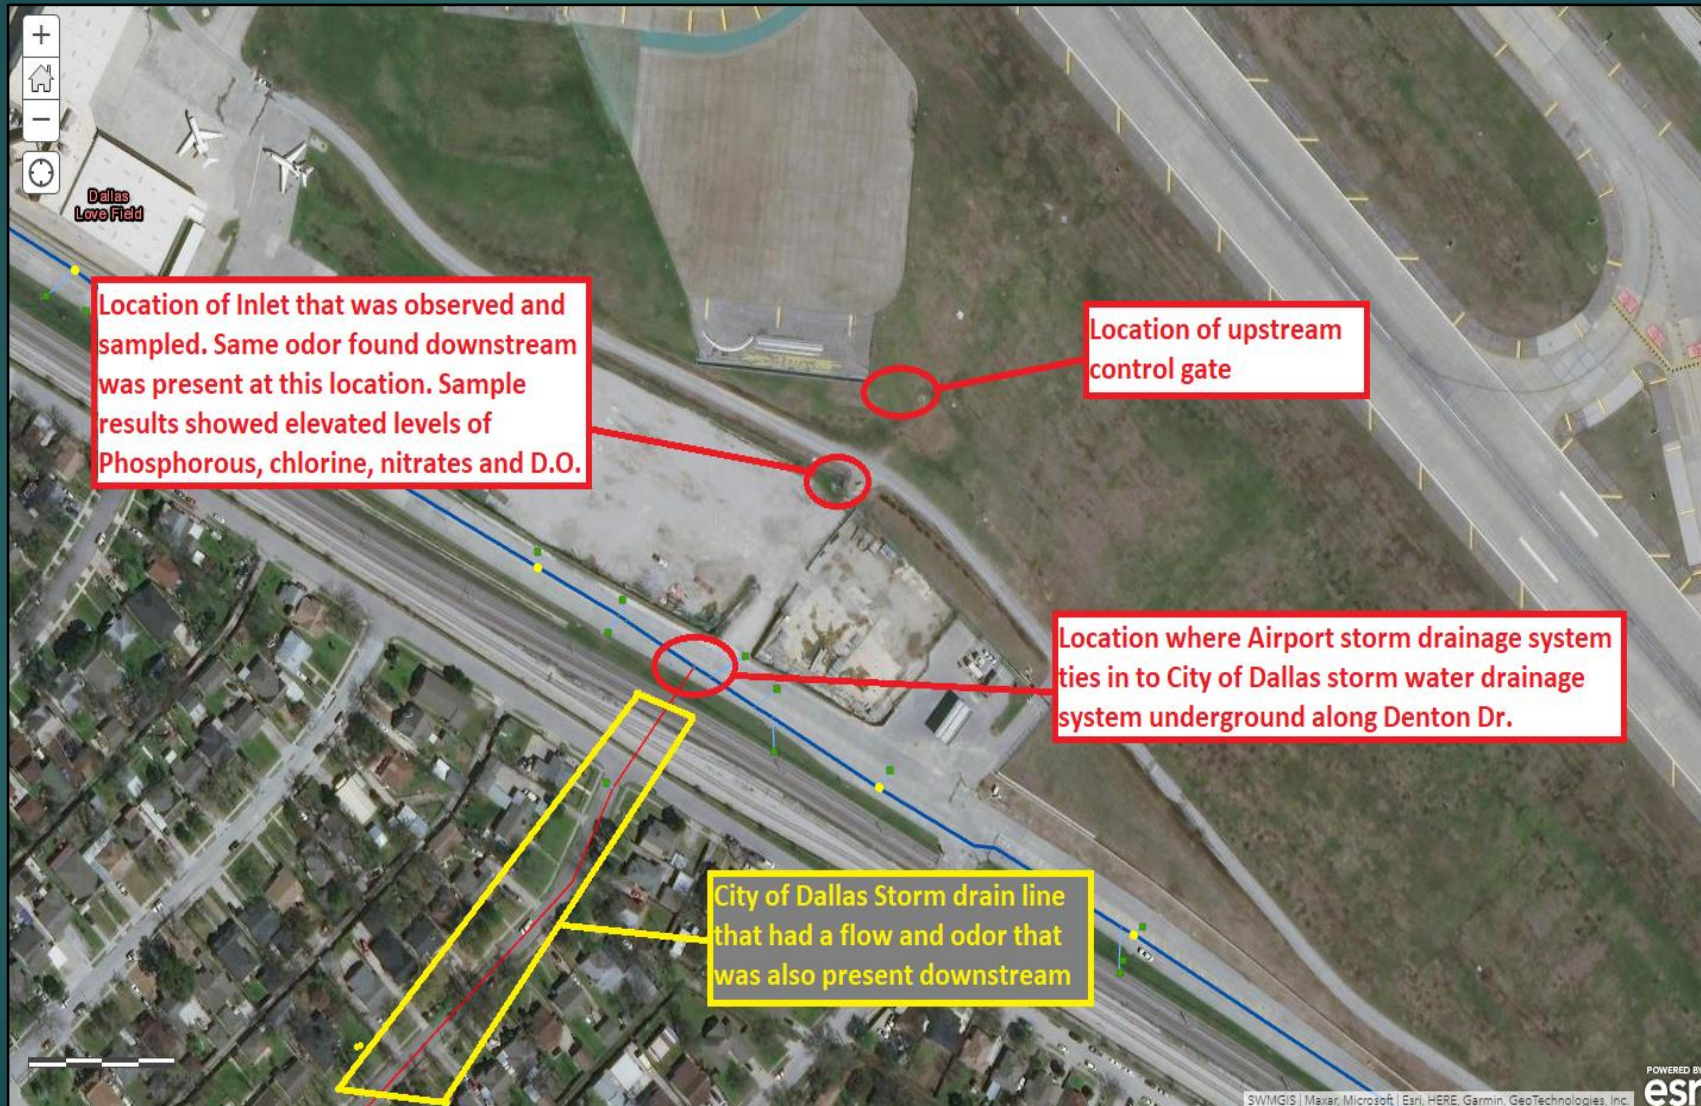
Dallas Love Field MS4 Map

- ▶ It was determined that the discharge was coming from Love Field Airport.
- ▶ Access to Love field Airport proved difficult and lengthy due to tight security and restrictions.
- ▶ Eventually Water Quality is escorted to the control gate near outfall 16 within airport property.
- ▶ The manhole used for sampling was located within another locked storage yard, so an appointment was scheduled with City of Dallas Aviation Department to gain access to that lot the next morning.

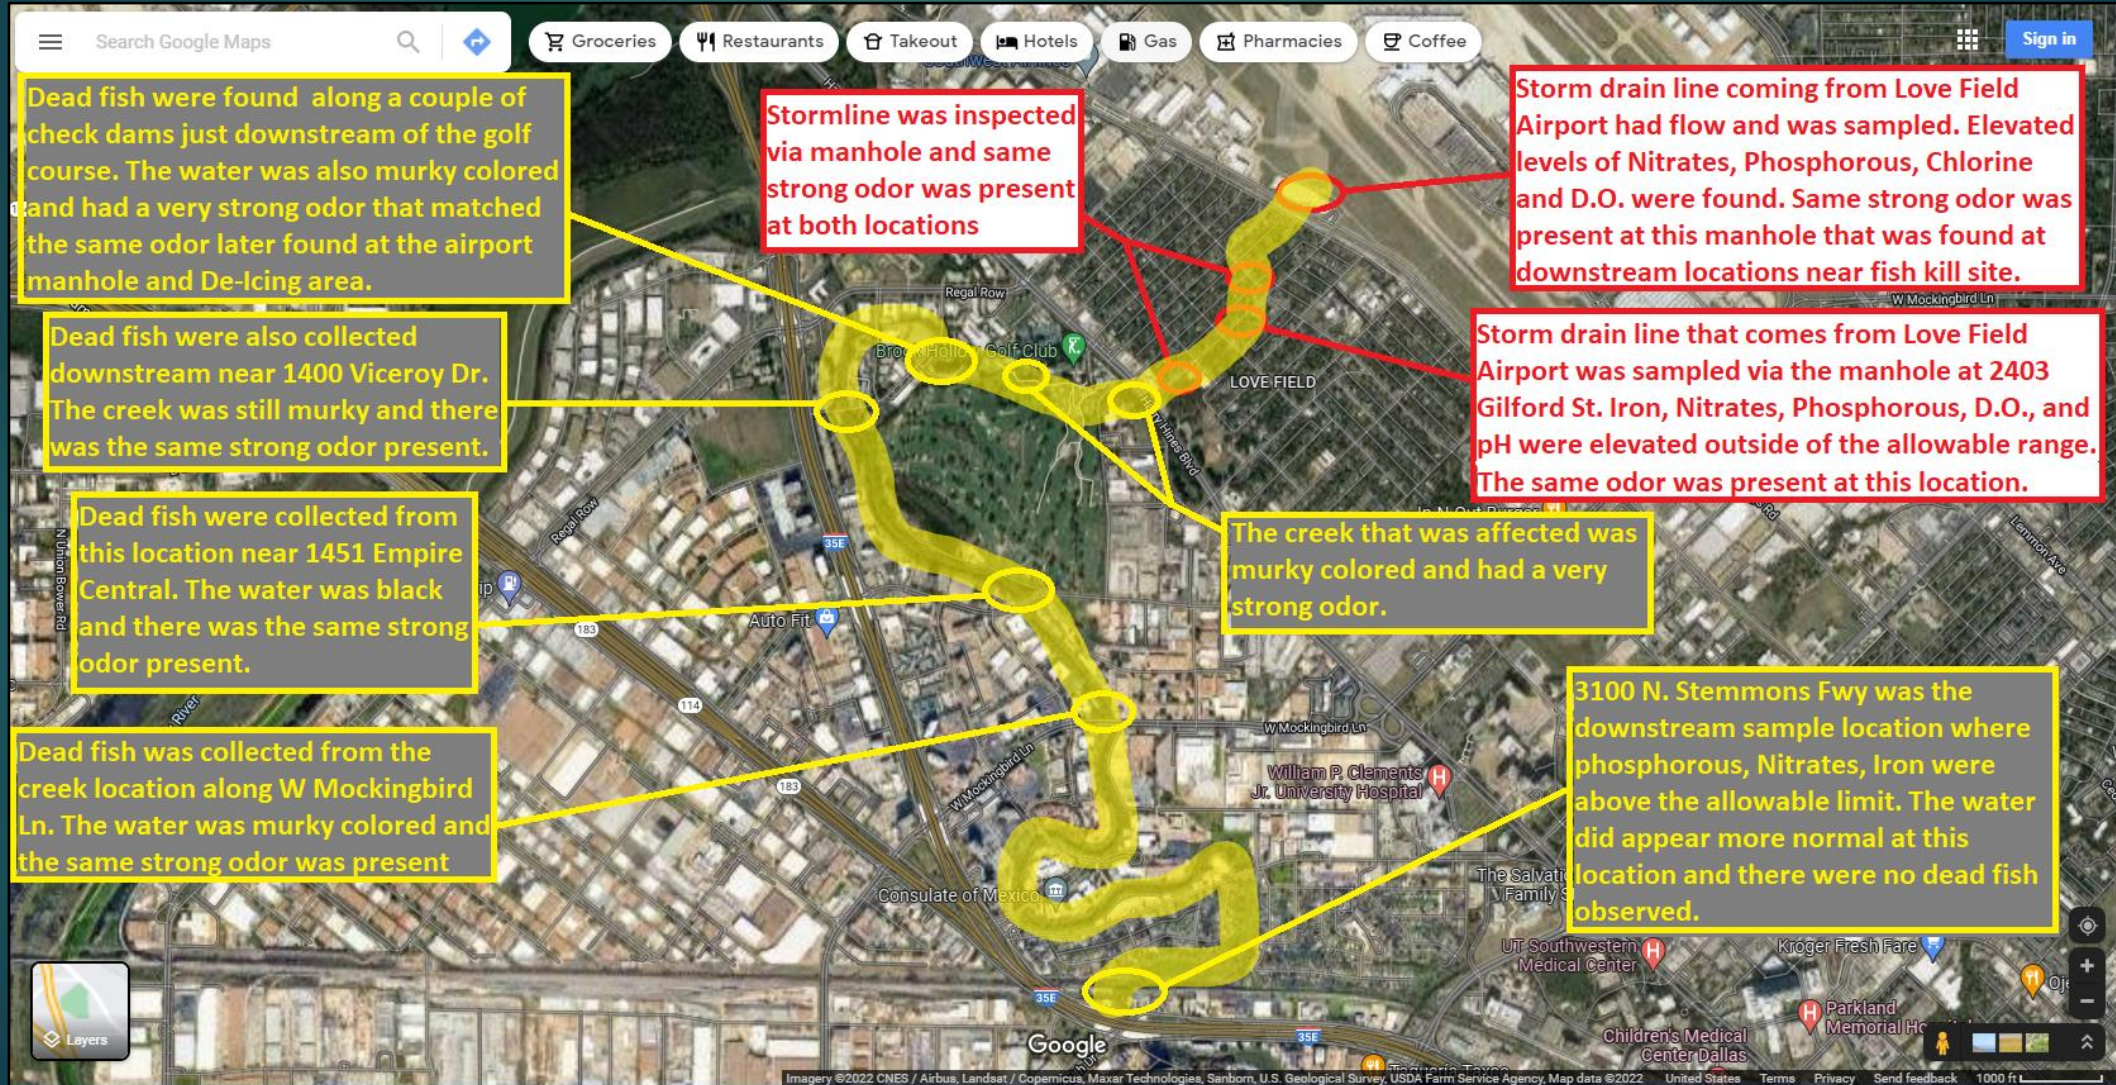
Total Affected Area

- ▶ WQ Team 3 collected 160 more dead fish most of which were sun fish.
- ▶ A total of 3,610 dead fish were collected over a three-day span.
