IDDE Source Tracking

CITY OF DALLAS – CASE STUDY

HILTON ANATOLE HOTEL, 1428 WYCLIFF AVE

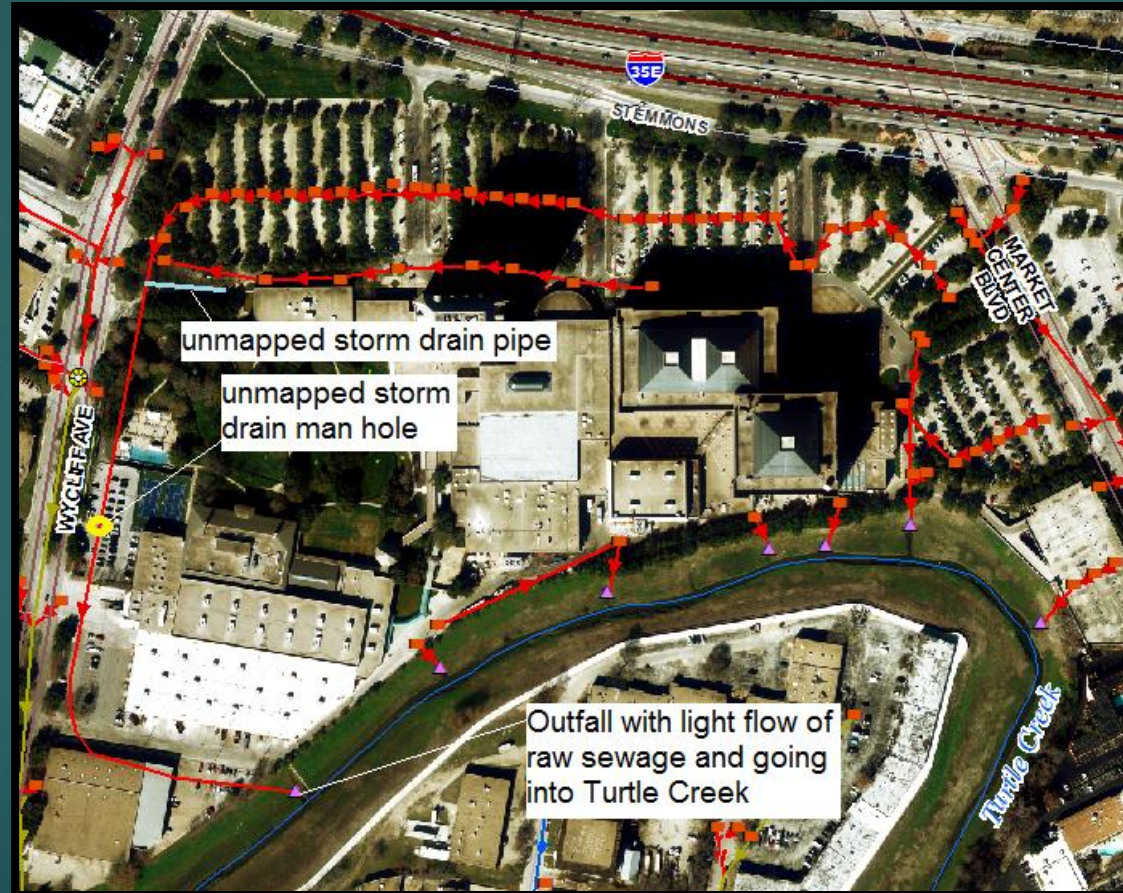
- ▶ CCTV crew walked the line from the outfall approximately 1350ft observing a manhole that was covered with cement from the top.
- ▶ CCTV crew also observed 42" lateral concrete pipe with signs of raw sewage coming from it. This pipe comes from in front of Hilton Anatole Hotel.
- ▶ Stormwater staff meets with hotel staff and begins dye testing on plumbing in area to see if any dye is visible in storm drain. Kitchens, bathrooms and swimming pool bar are all dye tested.
- ▶ CCTV crew attempted to camera the 42" lateral line and encountered steep inclines and debris in the line and another follow up was scheduled to continue investigation the next day.
