# Road Safety Audit Center Street and Cooper Street Arlington, TX

DECEMBER 2024

Facilitated by: Amelia (Millie) Hayes, P.E., PTOE, RSP<sub>21</sub>  
FHWA Texas Division

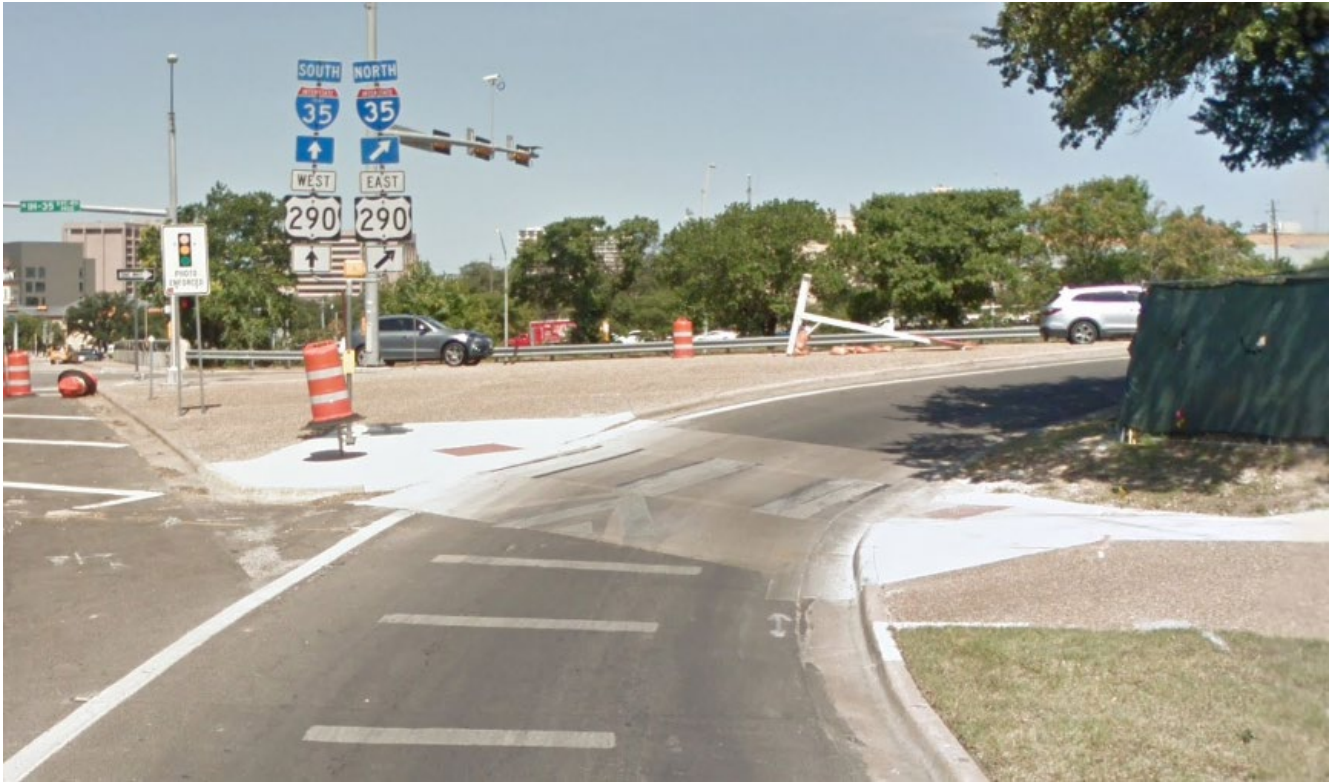
*Figure 8: Example of a raised crosswalk on a turn lane joining an Interstate frontage road in Austin, TX (Source: [Google Street View](#))*

- Consider raised crosswalks. The City should also consider raised crosswalks at these locations to slow turning vehicles. Raised crosswalks of even 2 to 3 inches in these locations could help control speed of turning movements and emphasizes the need to yield to people walking. Raised crosswalks have been successfully implemented in several locations in Austin and are becoming a more regular treatment for speed management and pedestrian safety across the US. Timeline: Medium-term.

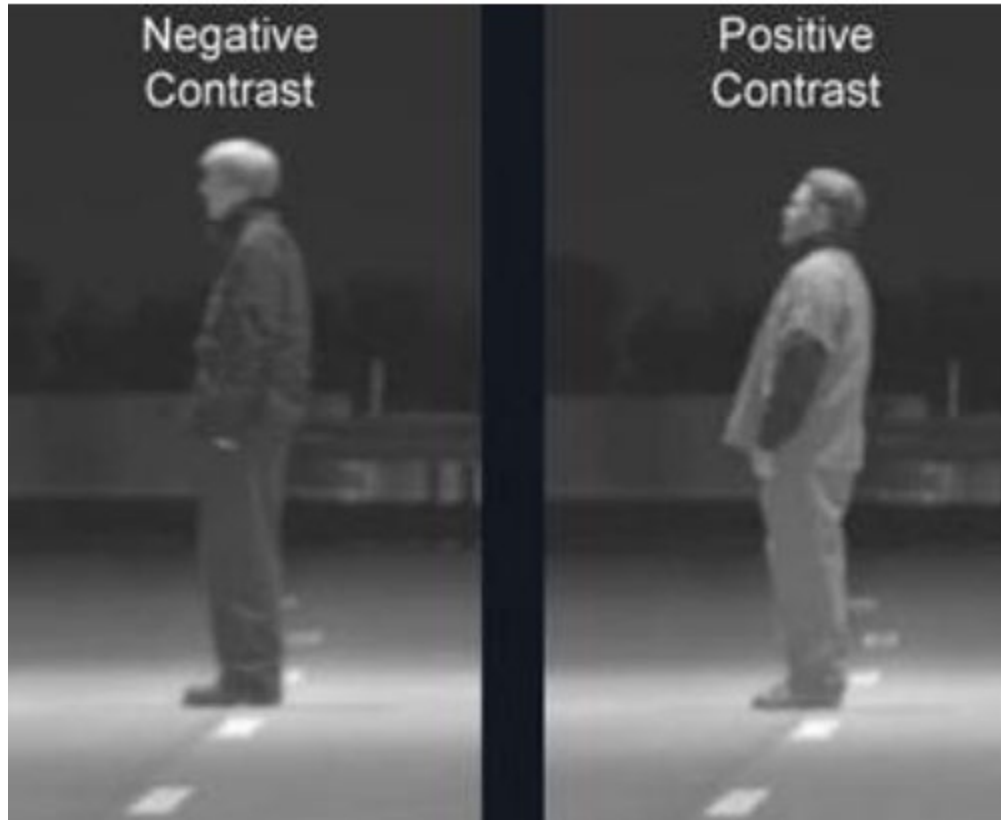
Figure 9: Negative versus positive contrast (Source: FHWA Pedestrian Lighting Primer, 2022.)

- Consider lighting improvements to enhance pedestrian visibility. This could include improvements to light pole placement and use of positive contrast. In design of lighting systems, contrast is the measurable visible difference between a target and the target's background. Positive contrast results in the target being brighter than its background and negative contrast results in the target being darker than its background, as illustrated in Figure 9. See FHWA's [Pedestrian Lighting Primer](#) and FHWA's [Informational Report on Lighting Design for Midblock Crosswalks](#) for additional information regarding proper light pole location. In the RSA Team's review of crash reports, we observed that right-turn crashes at Randol Mill/Cooper Street were caused by drivers failing to yield right-of-way to pedestrians. Lighting improvements, particularly a positive contrast of the pedestrians struck within crosswalks, would have helped addressing the vulnerability of pedestrians during dark conditions and improving the safety and security of all road users spanning different ages and abilities. Timeline: Medium-term.

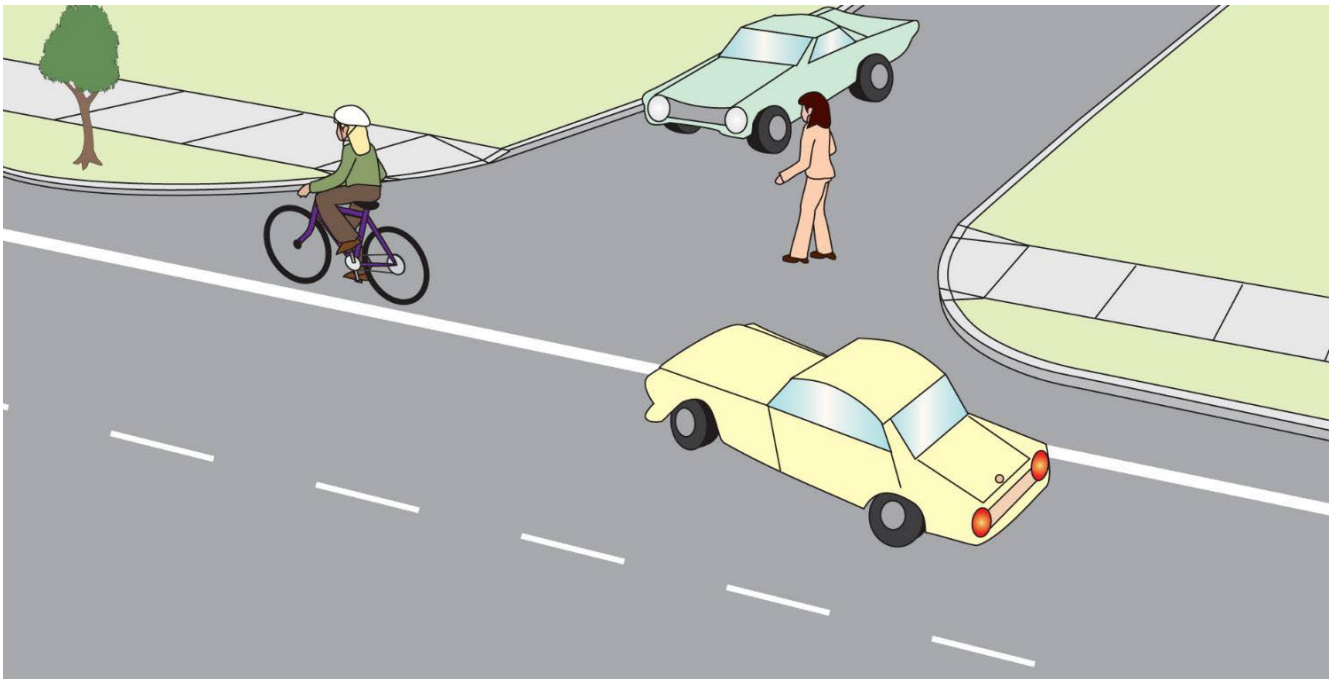
*Figure 11: Driveways built like intersections encourage high-speed turns (Source: FHWA)*

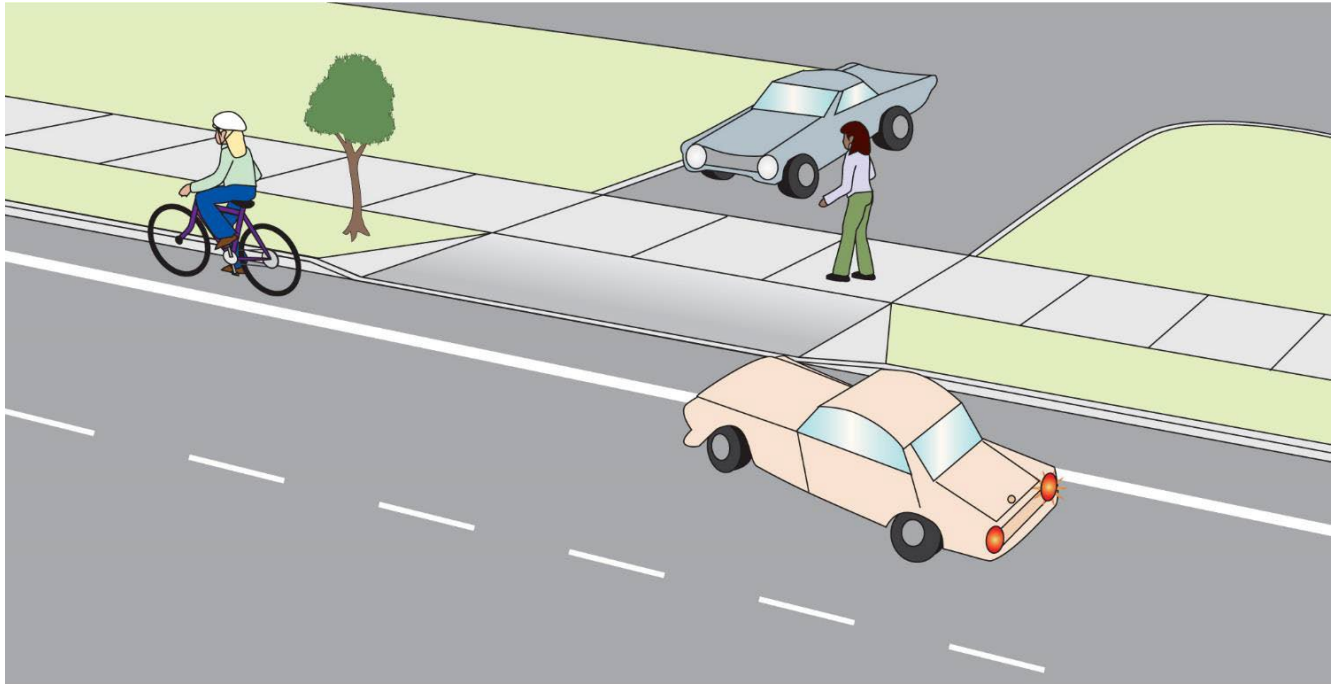
*Figure 12: This design makes it clear to drivers that they are crossing a sidewalk and encourages low-speed turns (Source: FHWA)*

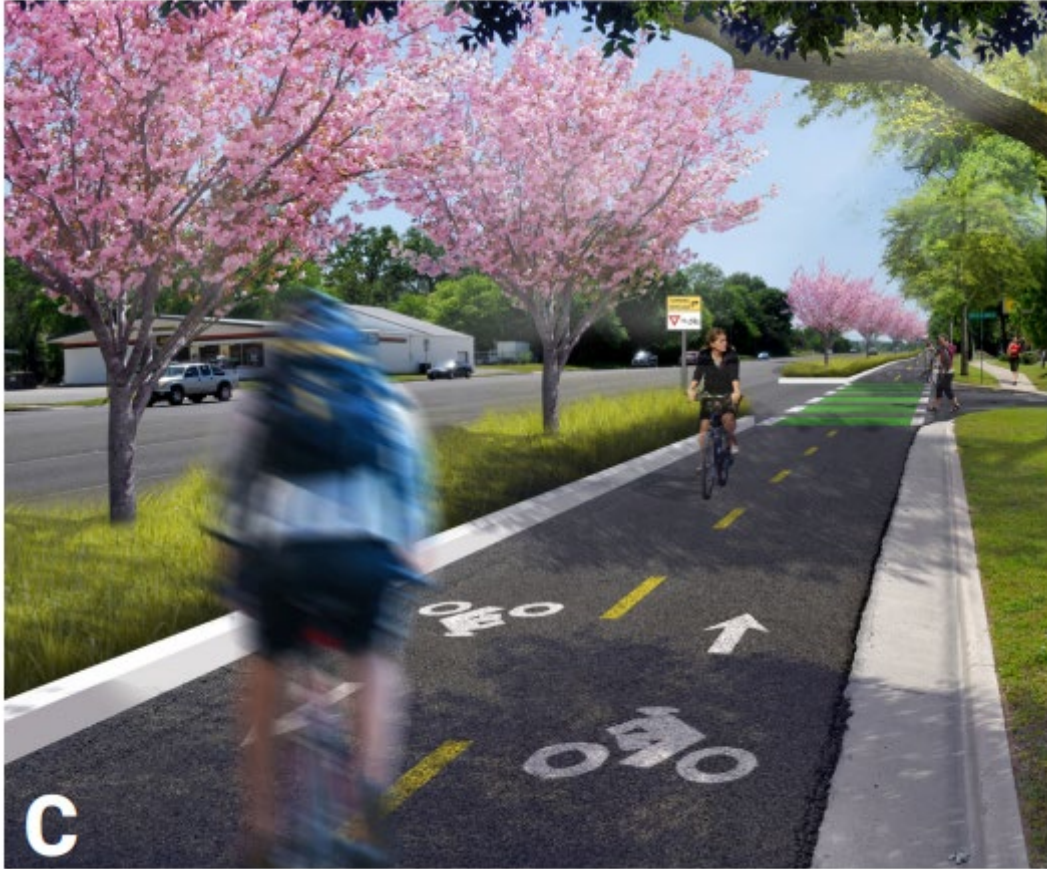
Figure 14: Example of separated bike lane option recommended with 5-6 lane roadway section (Source: Active Tyler: Active transportation Plan for the Tyler, TX Area MPO)

**Recommendation:** Determine preferred bicycle accommodation. Consider changes to cross-section that include a high quality separated bike facility per FHWA’s [Bikeway Selection Guide](#). As discussed in the General Recommendations, at a network level, the City must decide which streets are needed to give more priority to people walking and biking (and thus slower speeds) and those where motor vehicles may have more priority (where investments in separating walking and biking from the roadway may be required).

Considering stakeholder feedback and the Bikeway Selection Guide, the City should determine its preferred bicycle accommodation type. With the available space observed in the field, the following could be preferred alternatives over the current shared use lanes, in increasing order of protection and safety for vulnerable road users:

- One 10 ft sidewalk/sidepath, or
- One 10 ft sidewalk/sidepath with separation of ~5 ft, or
- Add trees in the separation (and/or other landscaping that can influence slower speeds by drivers by creating visual friction)

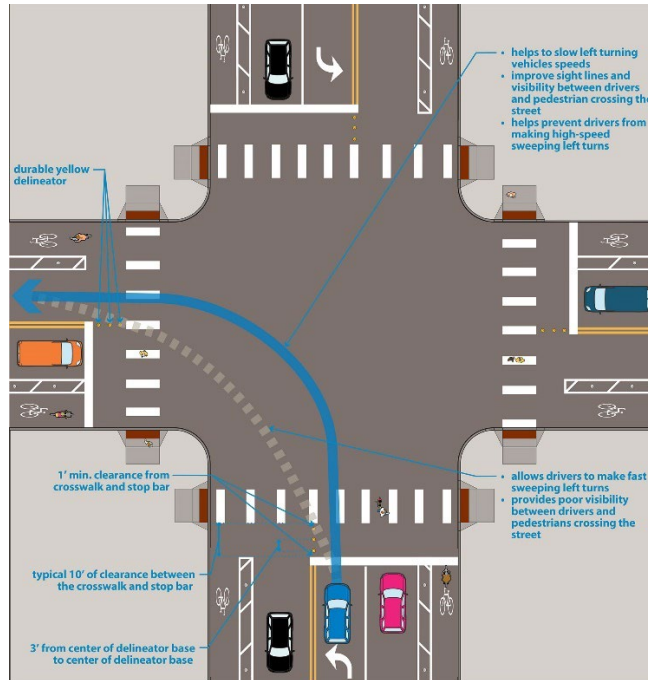
Figure 15: Delineator hardened centerlines (source: [City of Minneapolis Street Design Guide](#))

- **Observation:** There is no pedestrian refuge for the marked crosswalk on Cooper Street, and pedestrians have seven lanes to cross. The RSA Team observed most drivers failing to yield to pedestrians in the crosswalk. The RSA Team also observed that during school zone hours, the majority of drivers ignored crossing guards' instructions when making U-turns on the north side. **Recommendation:** The City could consider a wider median to provide a full refuge. In the interim, consider other countermeasures such as in-street pedestrian crossing sign (TxMUTCD R1-6) or centerline hardening such as the example in Figure 15. Timeline: Short-term for interim solutions, medium-term for pedestrian refuge.
