BRIDGE/CULVERT DESIGN

STREAMBANK STABILIZATION

Bridge & Culvert Design

Scour & Streambank Stabilization

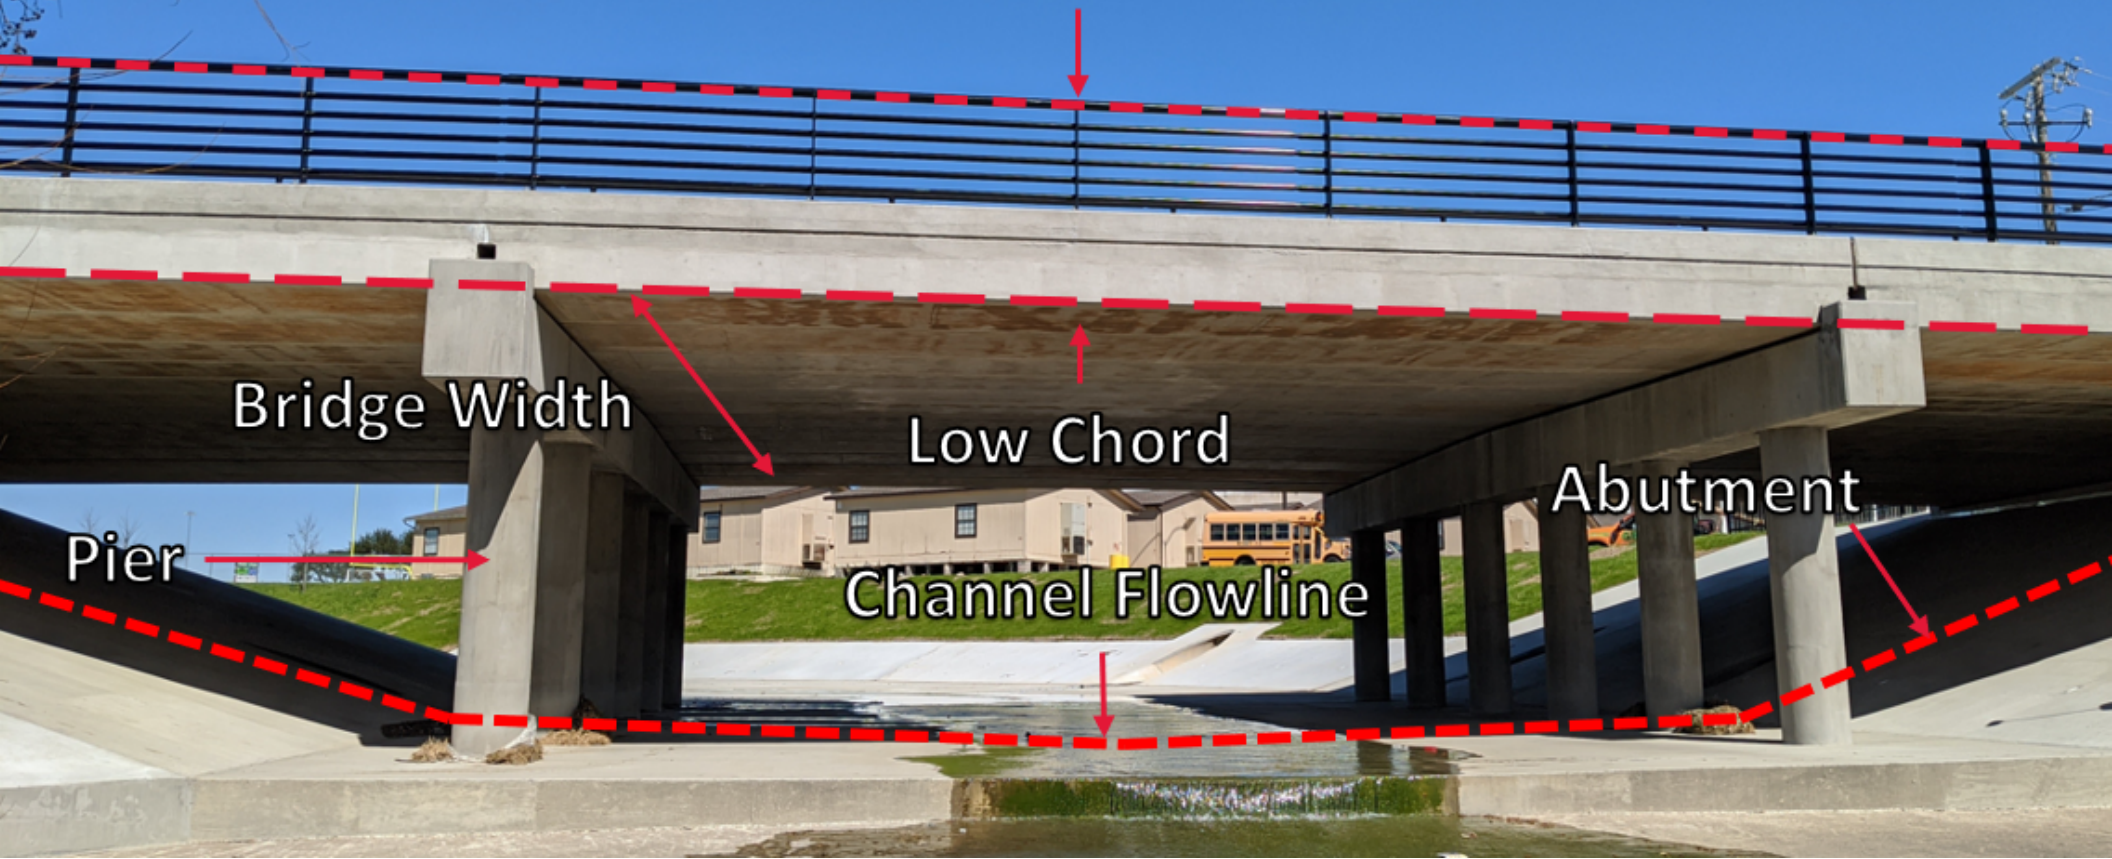
N Mesquite Dr at S Mesquite Creek

Overtopping Elevation

Bridge Width

Low Chord

Abutment

Pier

Channel Flowline

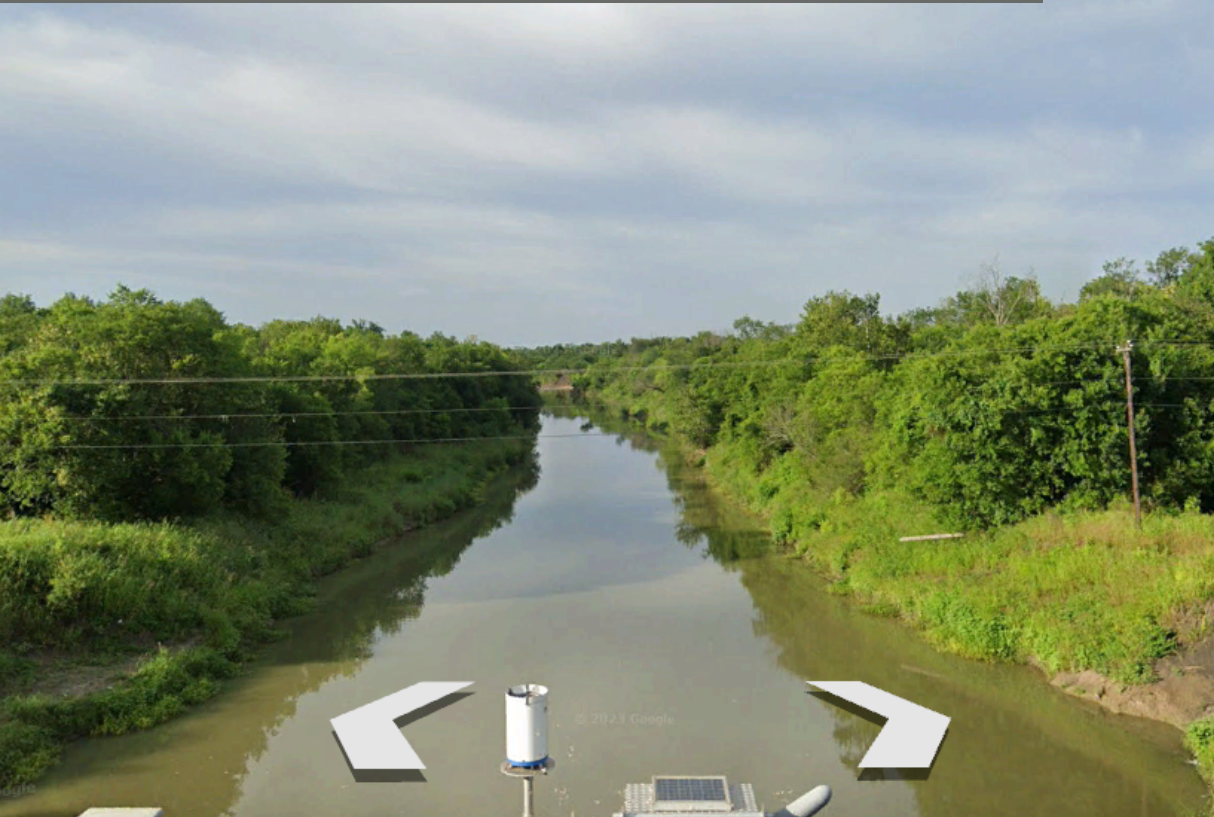
East Fork Trinity River, Seagoville

Channel Evolution Model

Stage

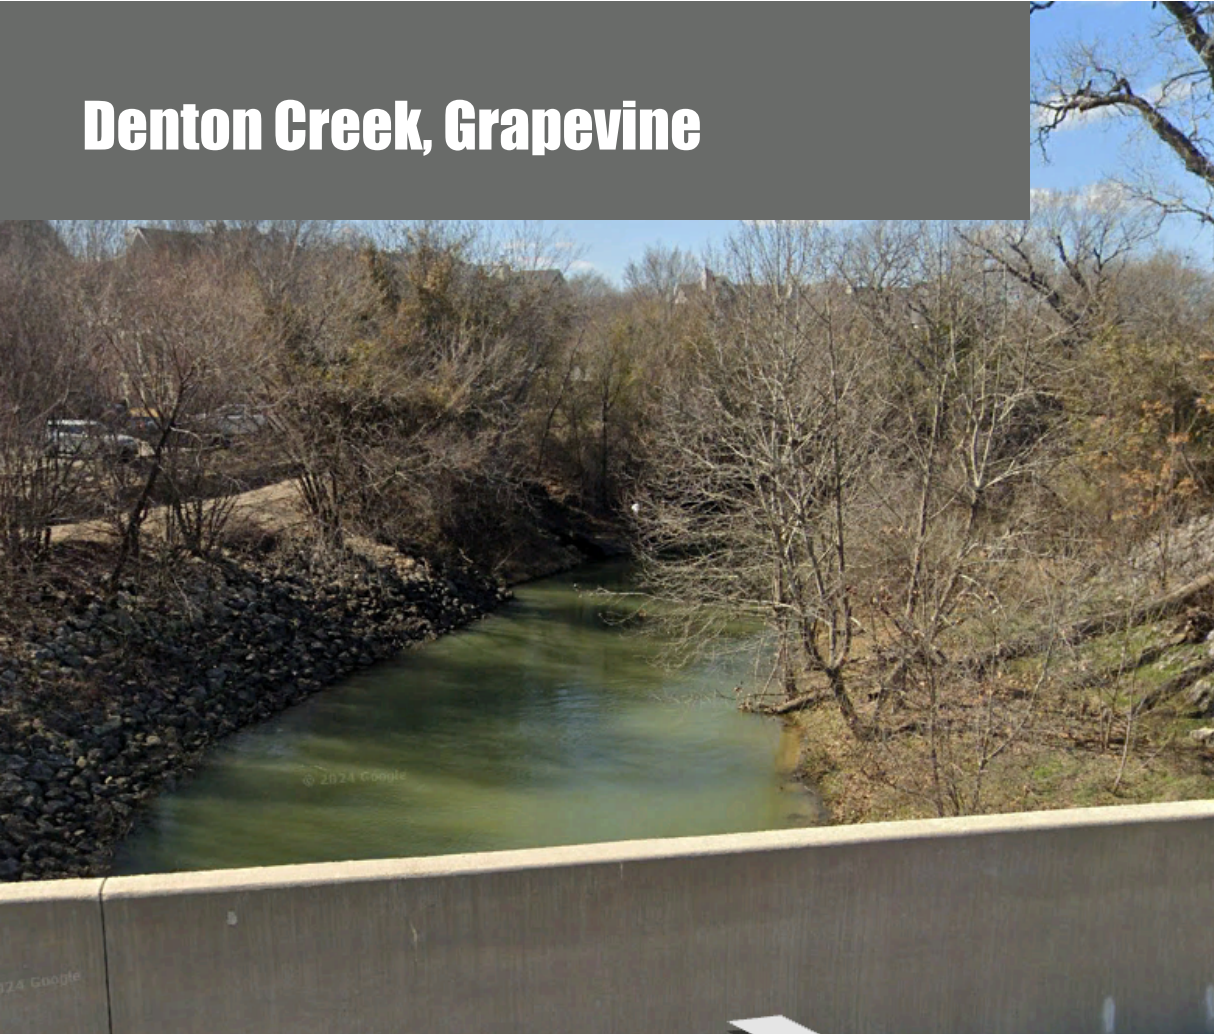
Denton Creek, Grapevine

Channel Evolution Model

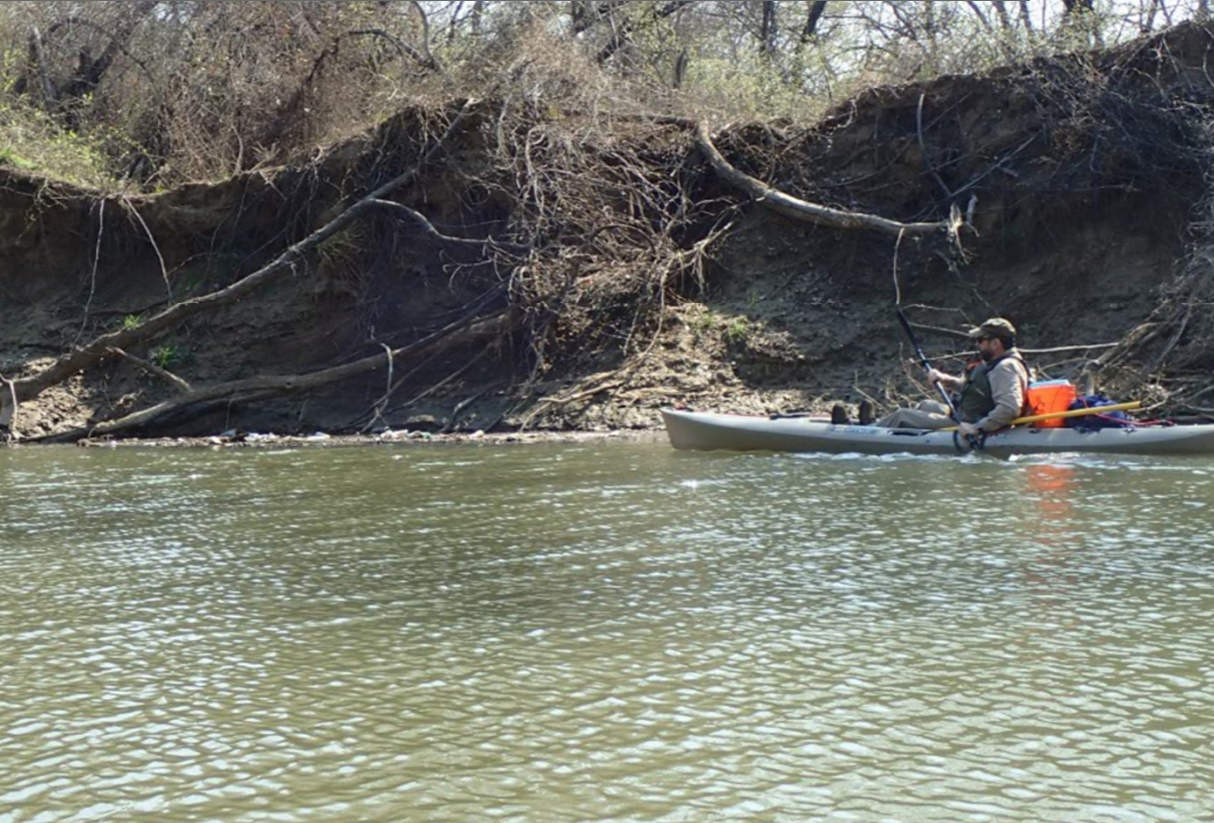
Denton Creek, Coppell

Channel Evolution Model

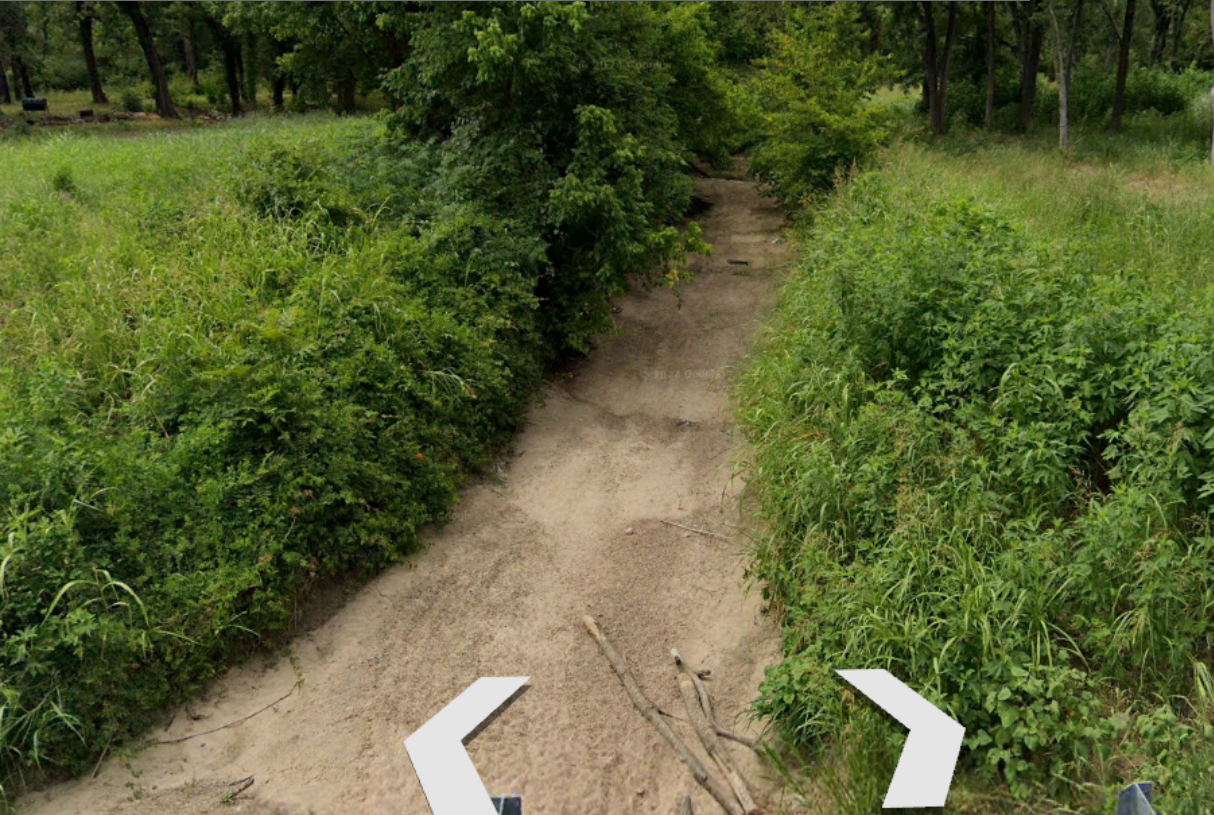
Hickory Creek, Balch Springs

Channel Evolution Model

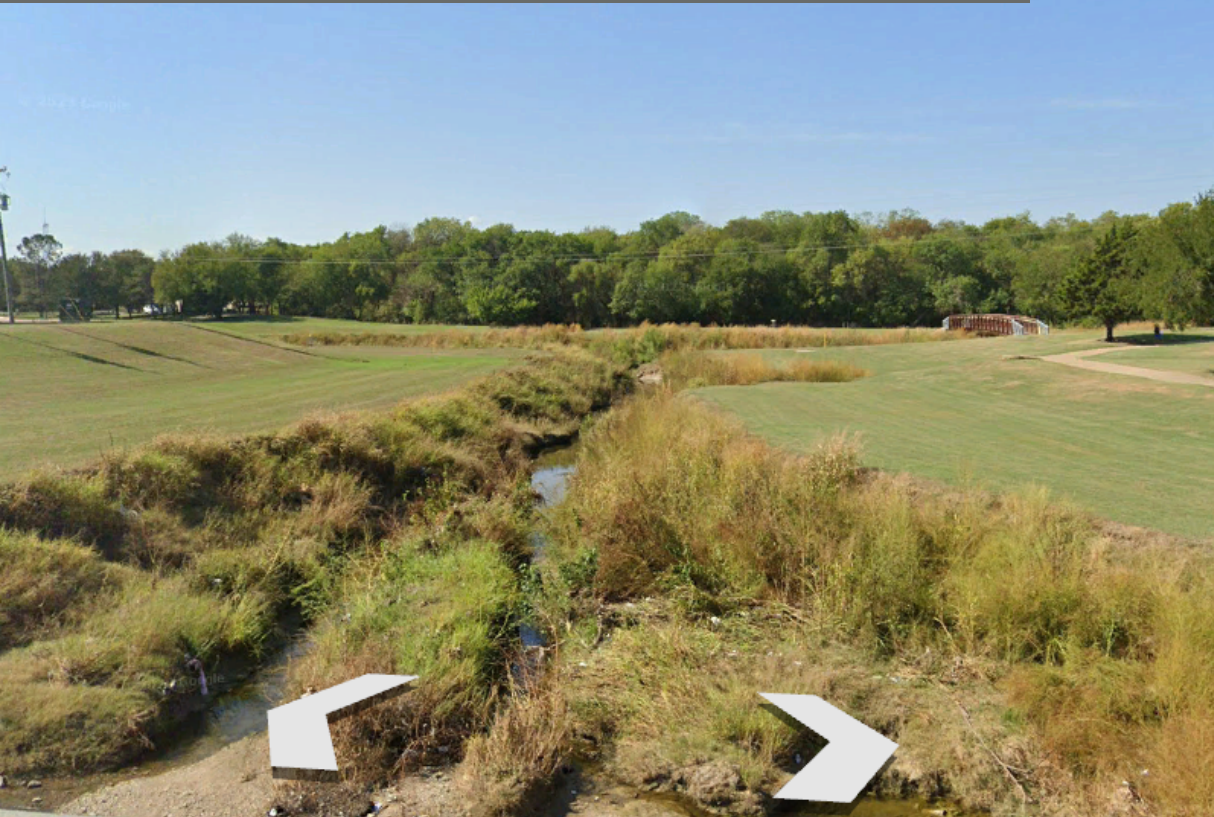
South Mesquite Creek, Mesquite

Channel Evolution Model

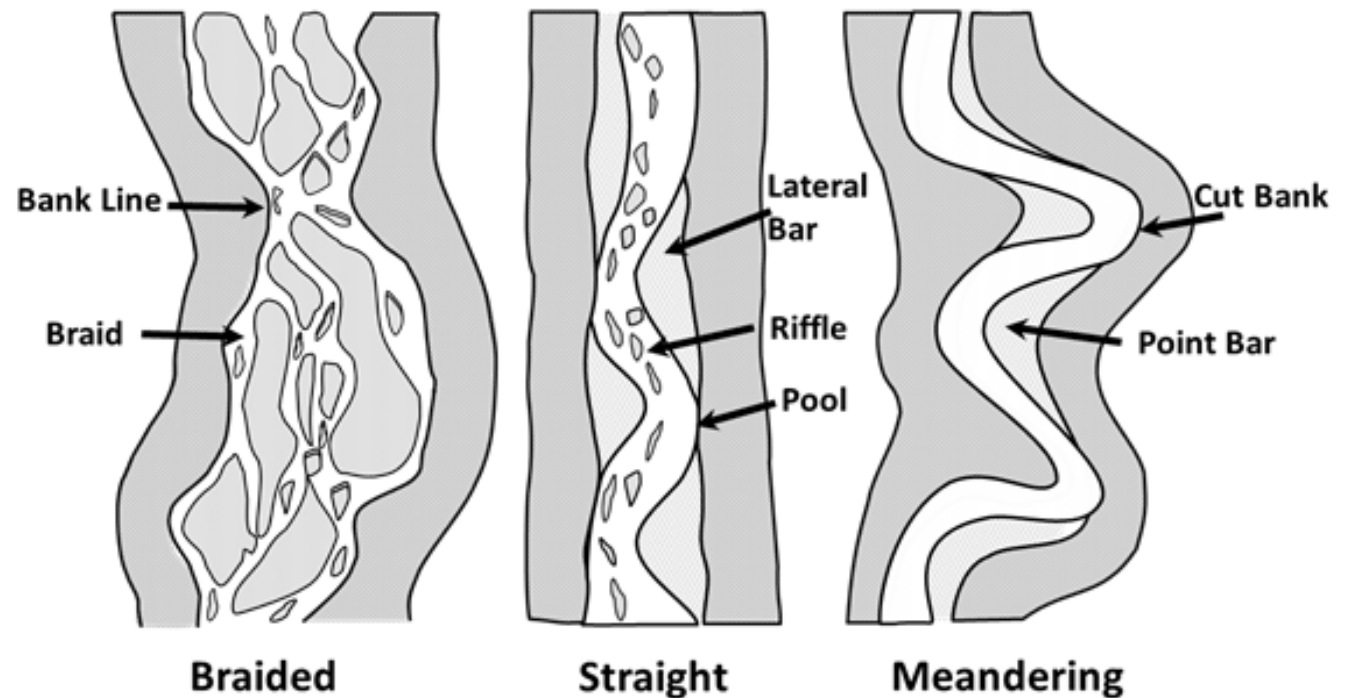
Instability and Stream Planform

Stream planform is:

- the shape of a stream when viewed from above
- useful in understanding stream morphology and potential stream response to change

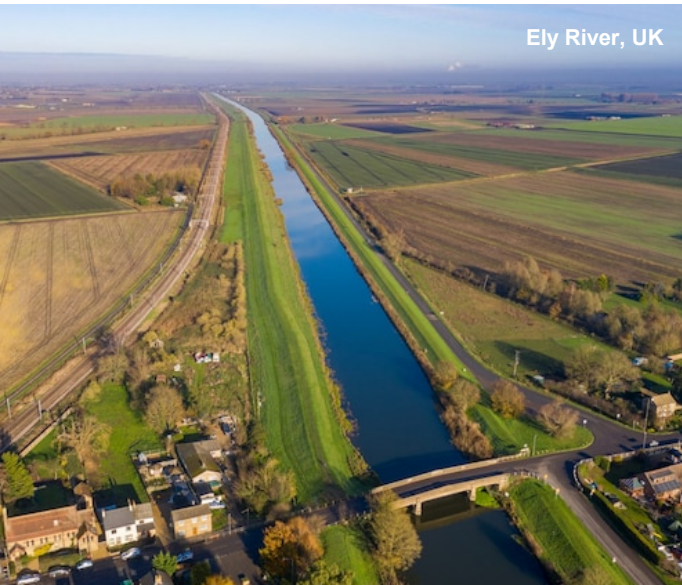
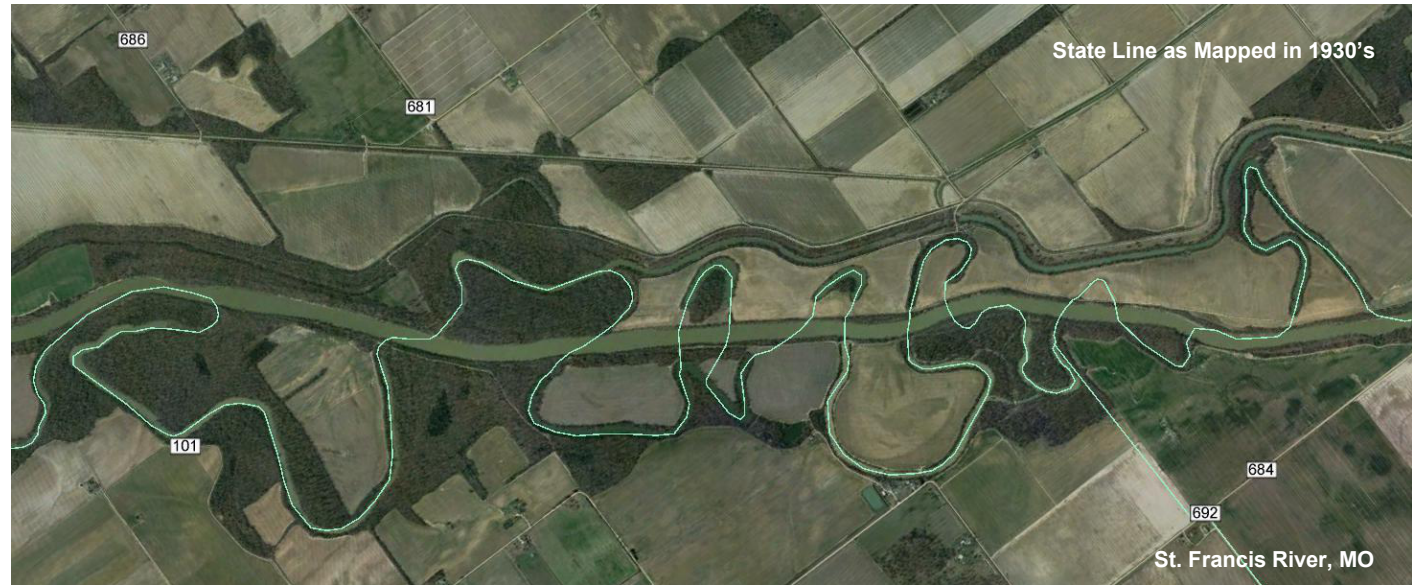
Straight Streams

- Considered a transitional stage
- Many straight streams/reaches are man-made/modified
- Even in straight channels, the thalweg will meander

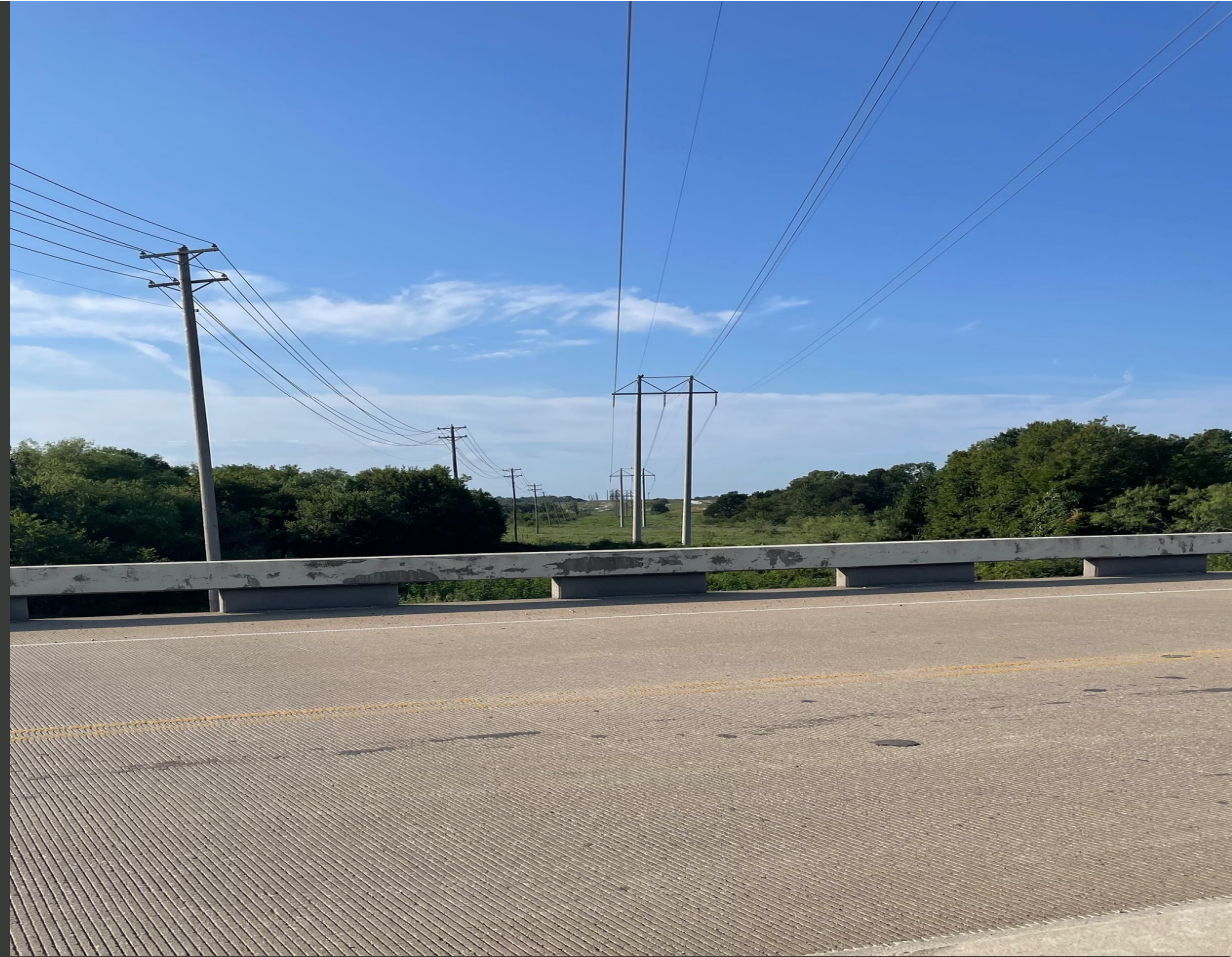
UTILITY IDENTIFICATION AND COORDINATION

Electric transmission lines- check for clearance, impacts to construction activity

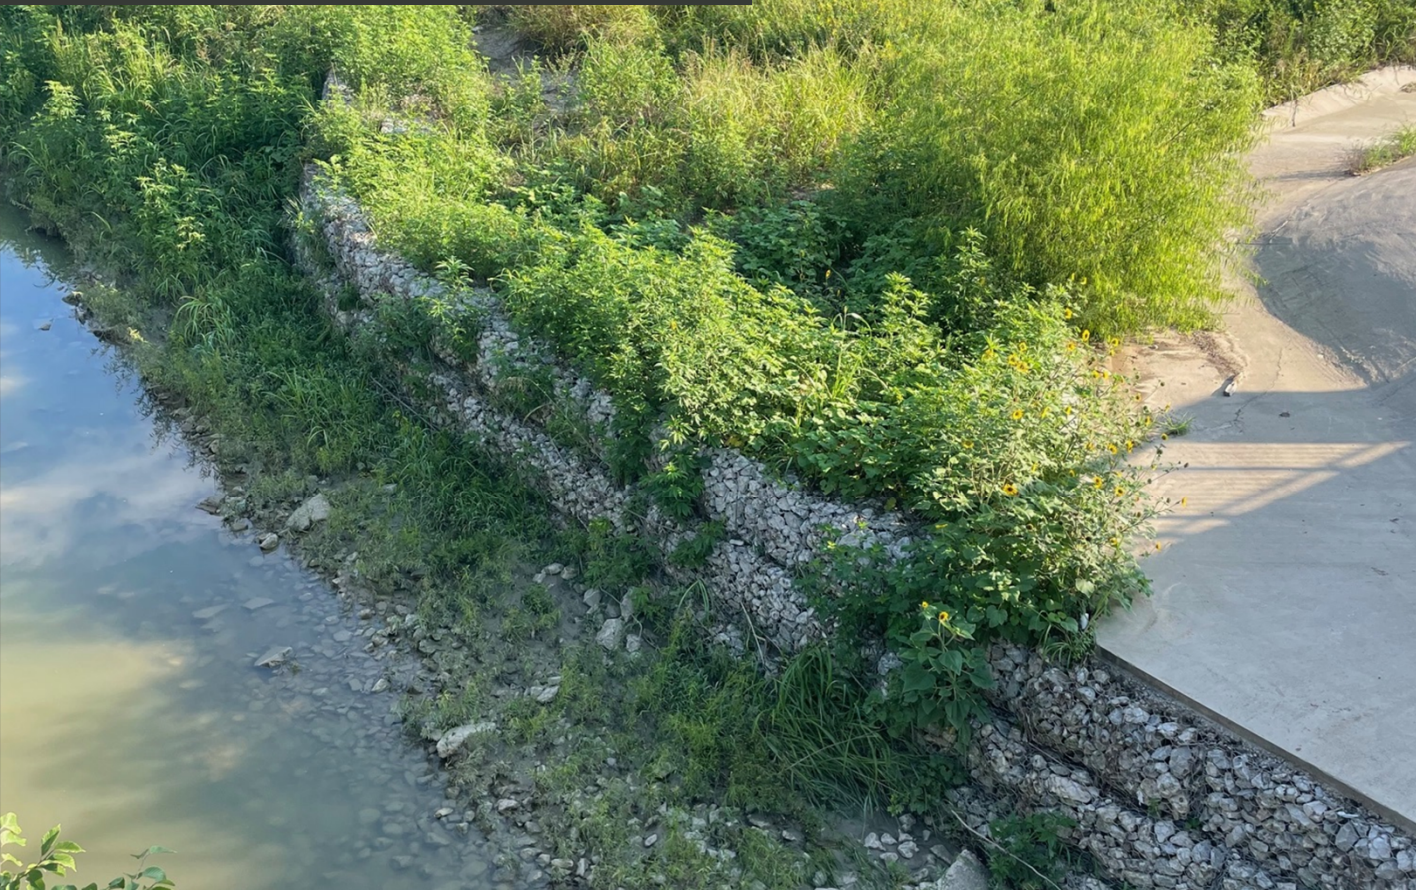
CHANNEL STABILIZATION
Additional gabion blocks
added to protect bridge
abutment from scour

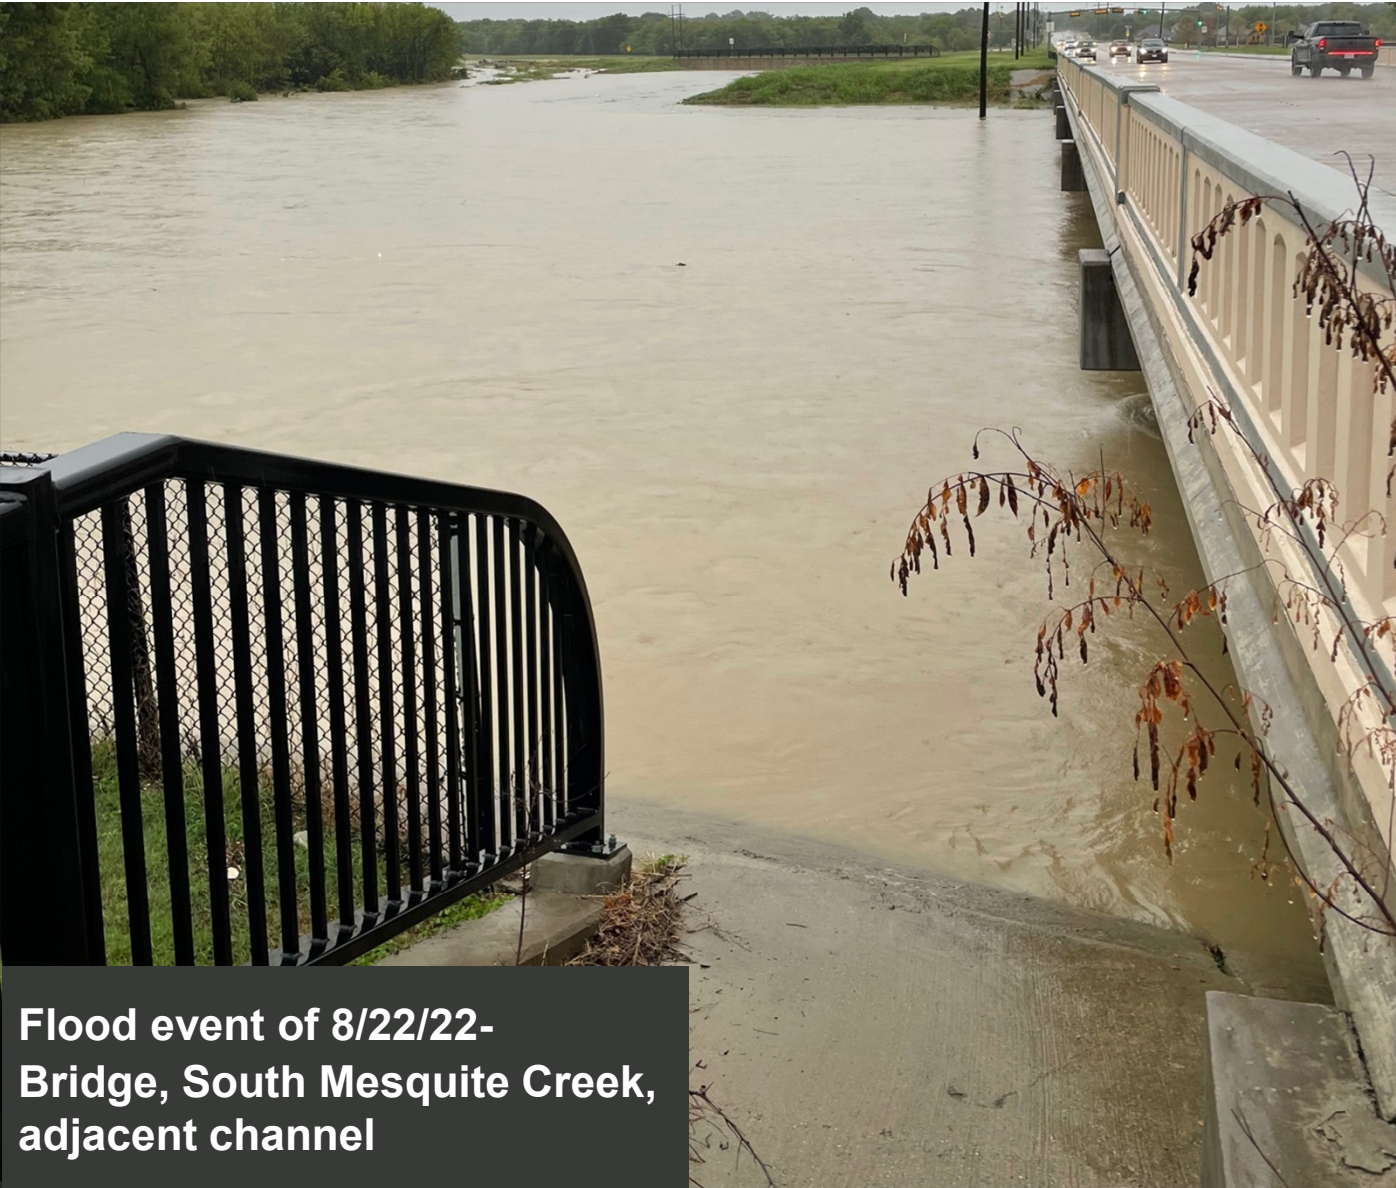
**Flood event of 8/22/22-
Bridge, South Mesquite Creek,
adjacent channel**

- Construction **accommodated wood electric transmission poles without relocation**
- **Flood event of 8/22/22**- 14 inches of rain upstream and 12 inches locally, main channels and bridge structure functioned properly, one intersection closed due to high water

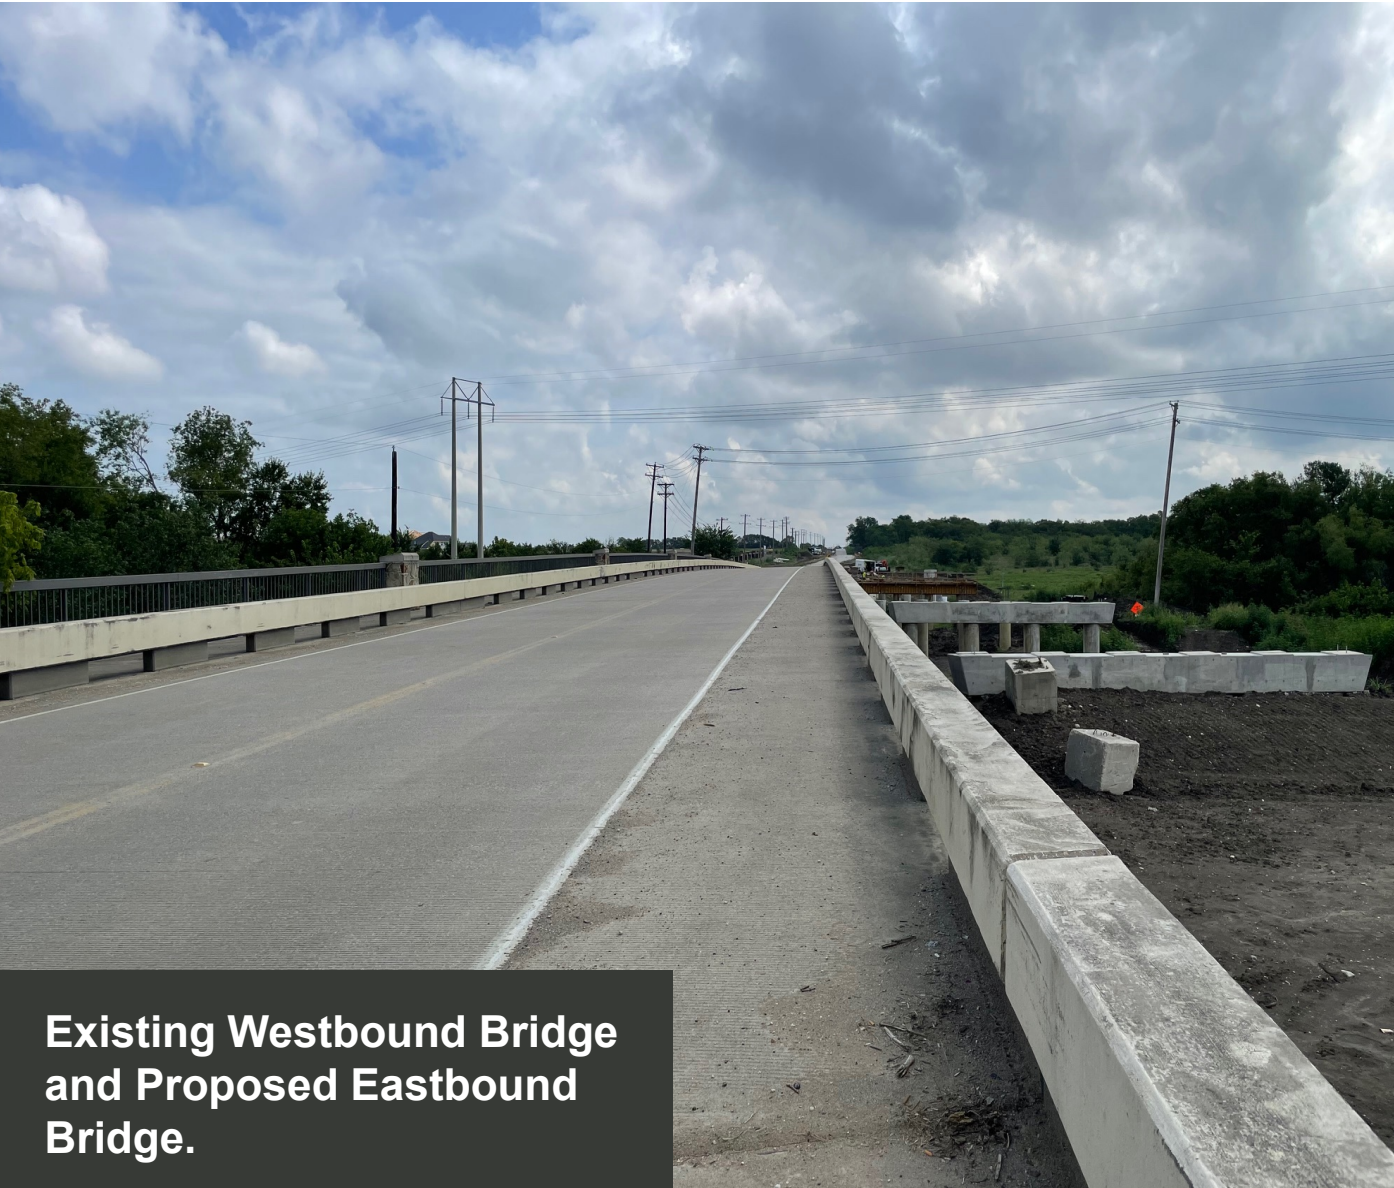
**Existing Westbound Bridge
and Proposed Eastbound
Bridge.**
